## Report of Eddy Current Inspection

Manufacturer: Carrier

Model: 17DA743

Location: DUPONT EXPERIMENTAL STATION  
RTE. 141 BETWEEN 52 & 202  
WILMINGTON, DE 19735

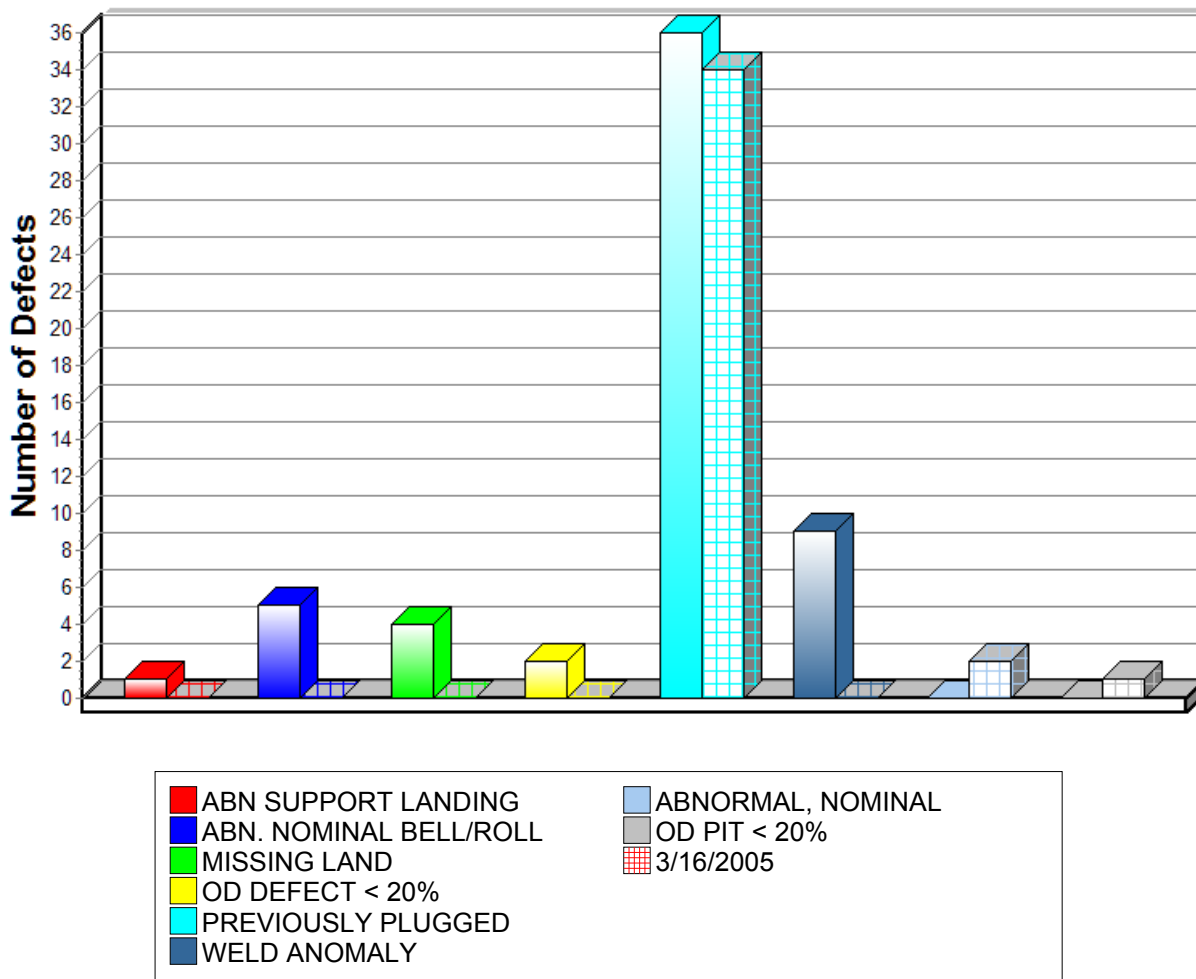
### Condenser Defects

Condenser: 3990 Tubes		
Tubes Tested: 3990 Tubes		
Significant/Measurable Indications	Number of Tubes Marked	Percent of Bundle
ABN. NOMINAL BELL/ROLL	5	.13
ABN SUPPORT LANDING	1	.03
OD DEFECT < 20%	2	.05
MISSING LAND	4	.10
PREVIOUSLY PLUGGED	36	.90
DIFF WALL THICKNESS	9	.23
<b>Totals</b>	<b>57</b>	<b>1.44</b>

NOTE: Although not marked, the majority of tubes gave indications of minor generalized ID Corrosion and Pitting. No individual tubes gave indications of significant damage, and therefore none were marked.

NOTE: The tubes in this vessel showed minor indications of tube wall thinning. These indications were attributed to permeability variations and not loss of mass.

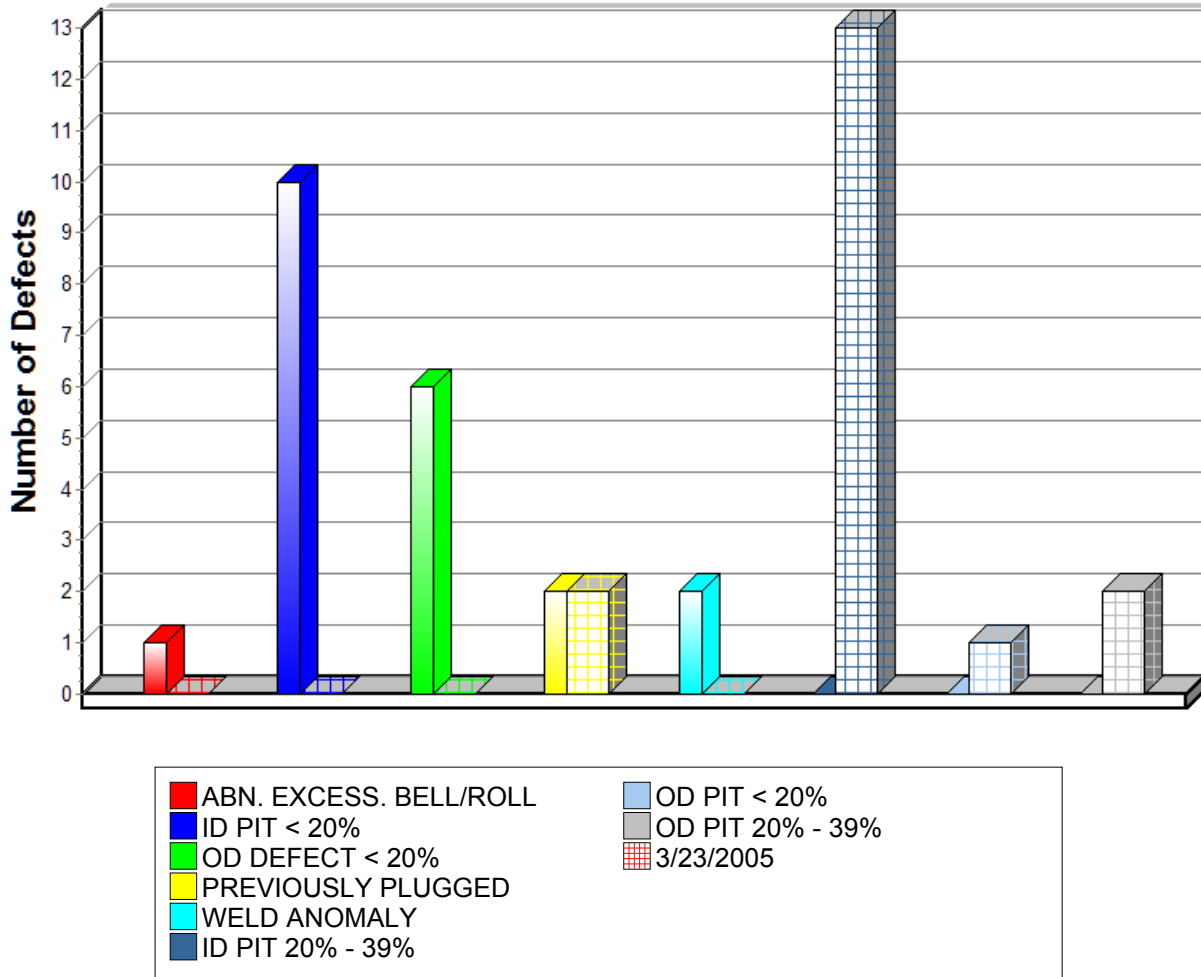
### Sub-Cooler Defects

Sub-Cooler: 441 Tubes		
Tubes Tested: 441 Tubes		
Significant/Measurable Indications	Number of Tubes Marked	Percent of Bundle
ABN. EXCESS. BELL/ROLL*	1	.23
OD DEFECT < 20%	6	1.36
ID PIT < 20%	10	2.27

Sub-Cooler: 441 Tubes		
Tubes Tested: 441 Tubes		
Significant/Measurable Indications	Number of Tubes Marked	Percent of Bundle
PREVIOUSLY PLUGGED	2	.45
DIFF WALL THICKNESS	2	.45
<b>Totals</b>	<b>21</b>	<b>4.76</b>

NOTE: Although not marked, the majority of tubes gave indications of minor generalized ID Corrosion. No individual tubes gave indications of significant damage, and therefore none were marked.

NOTE: The tubes in this vessel showed minor indications of tube wall thinning. These indications were attributed to permeability variations and not loss of mass.

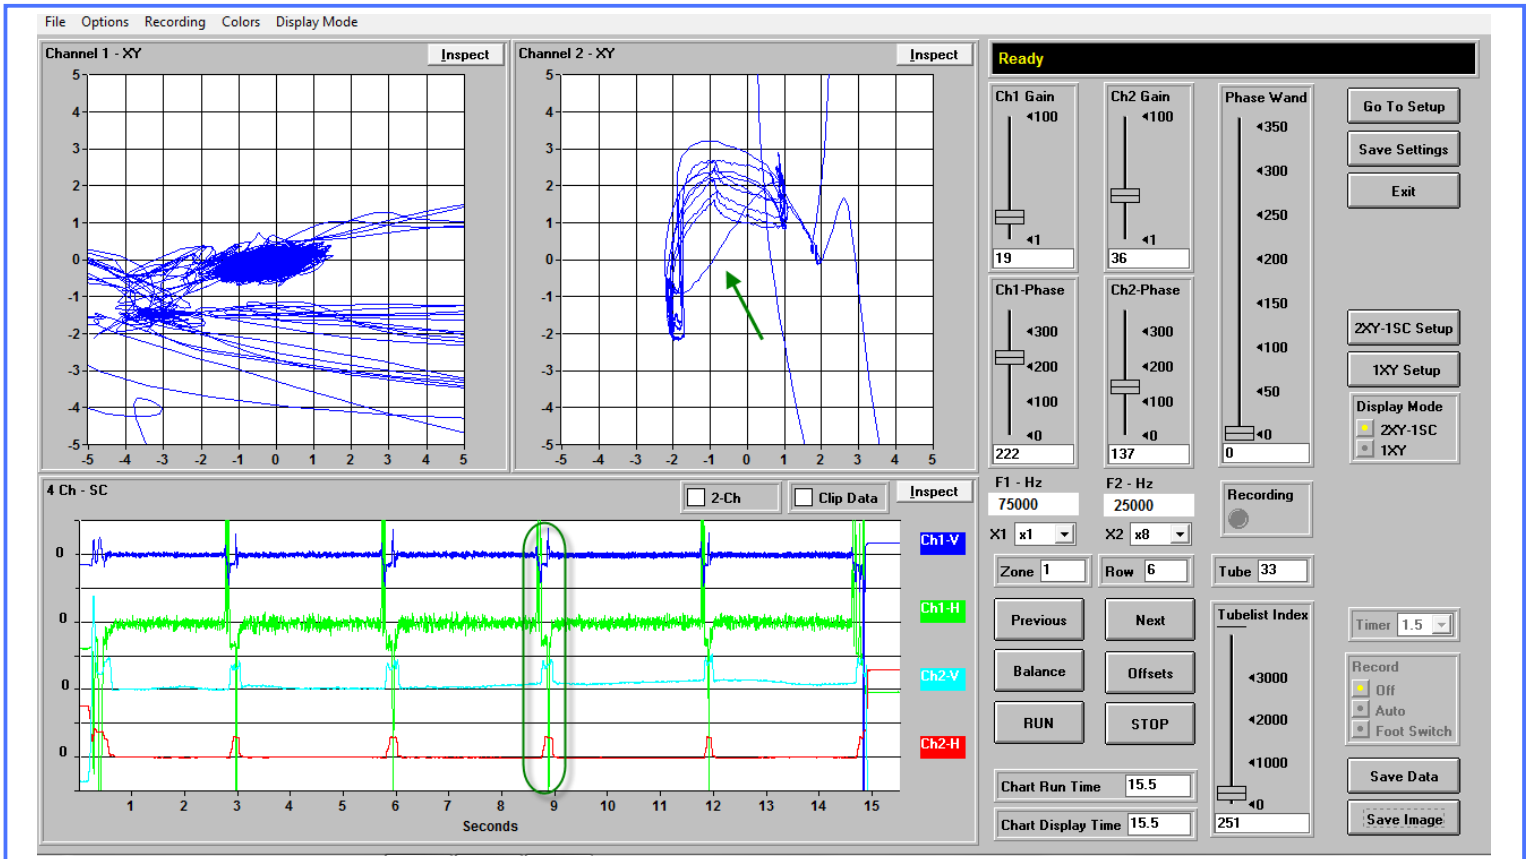
The tube indicating Abnormal Support Landing Indications requires no corrective action at this time. This tube showed a distorted transition zone at the indicated support. The exact cause of the indication is unknown, but is believed to be the result of manufacturing.

ABN SUPPORT LANDING (Row 6 Tube 33)

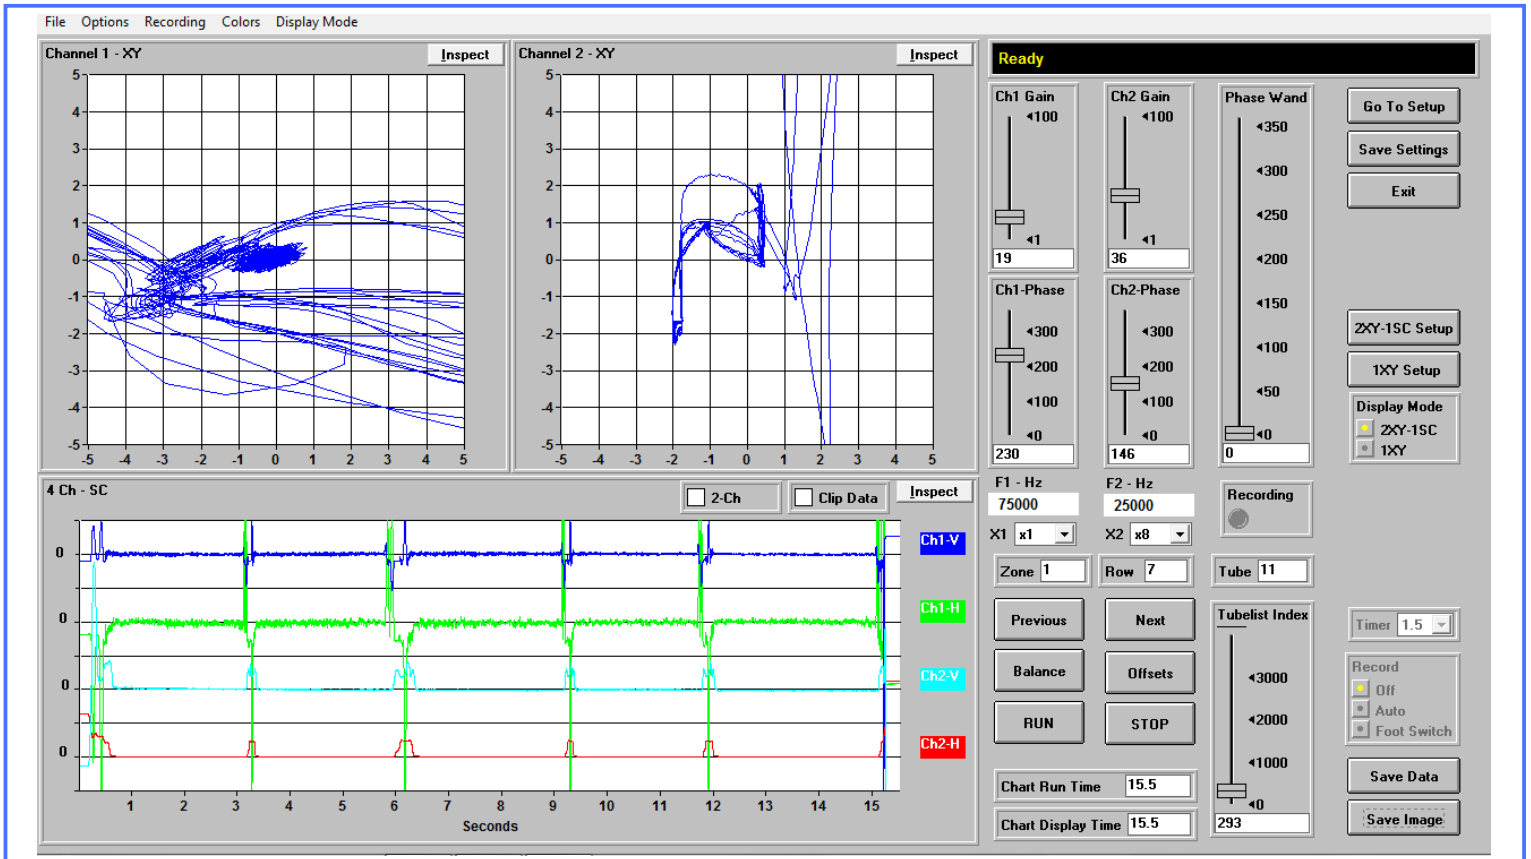
WELD ANOMALY (Row 7 Tube 11)

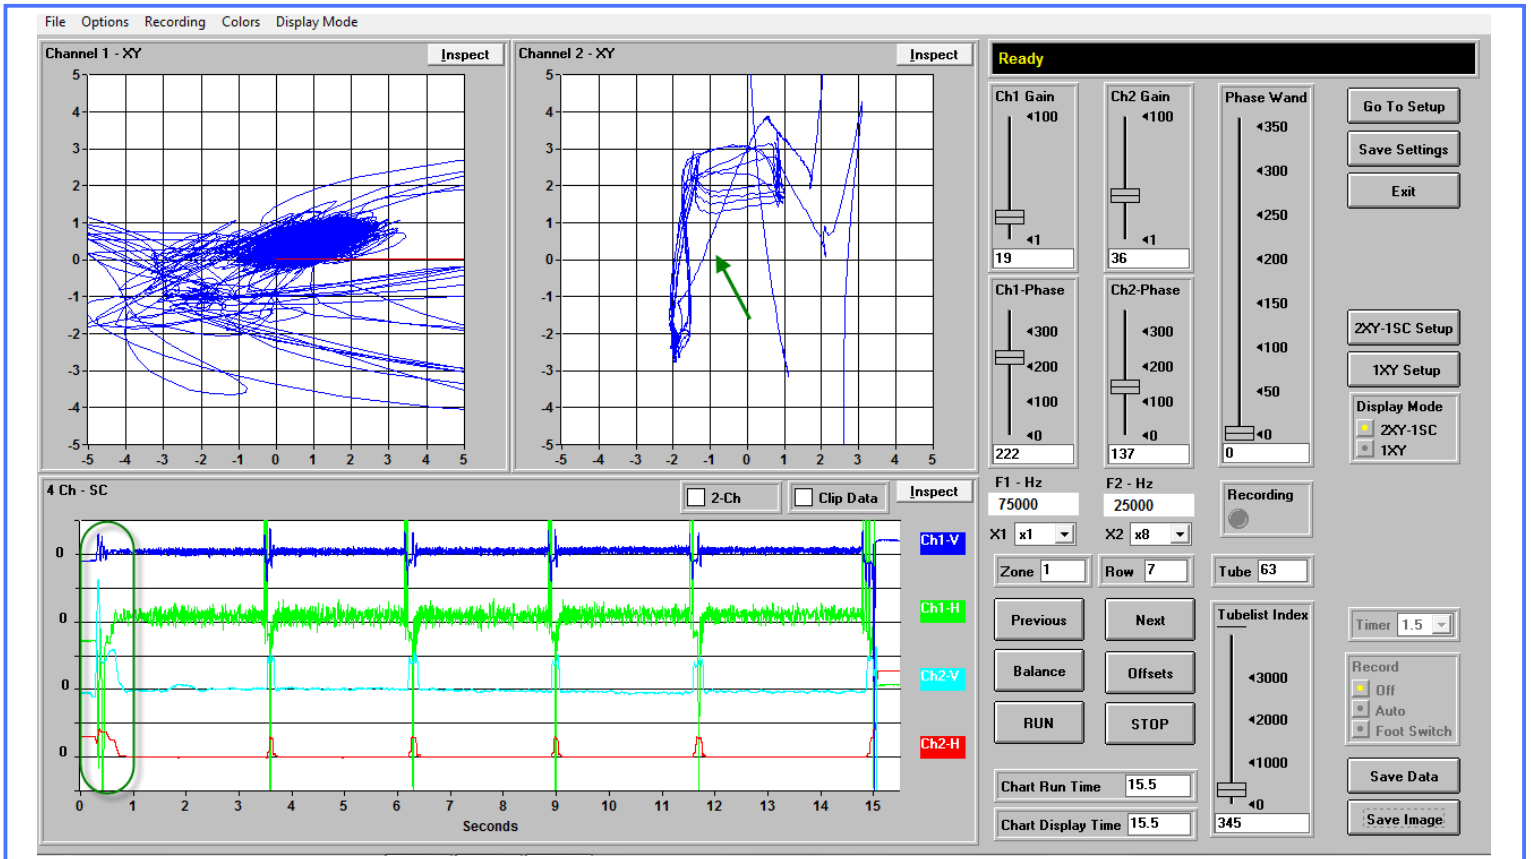
The tubes indicating Abnormal Bell End Indications require no corrective action at this time. The indications are that of thinning at the Bell End. The exact cause and description of the anomaly is unknown. However, it is believed to be a non-progressive manufacturing anomaly and should not affect the performance or longevity of the effected tubes.

ABN. NOMINAL BELL/ROLL (Row 7 Tube 63)

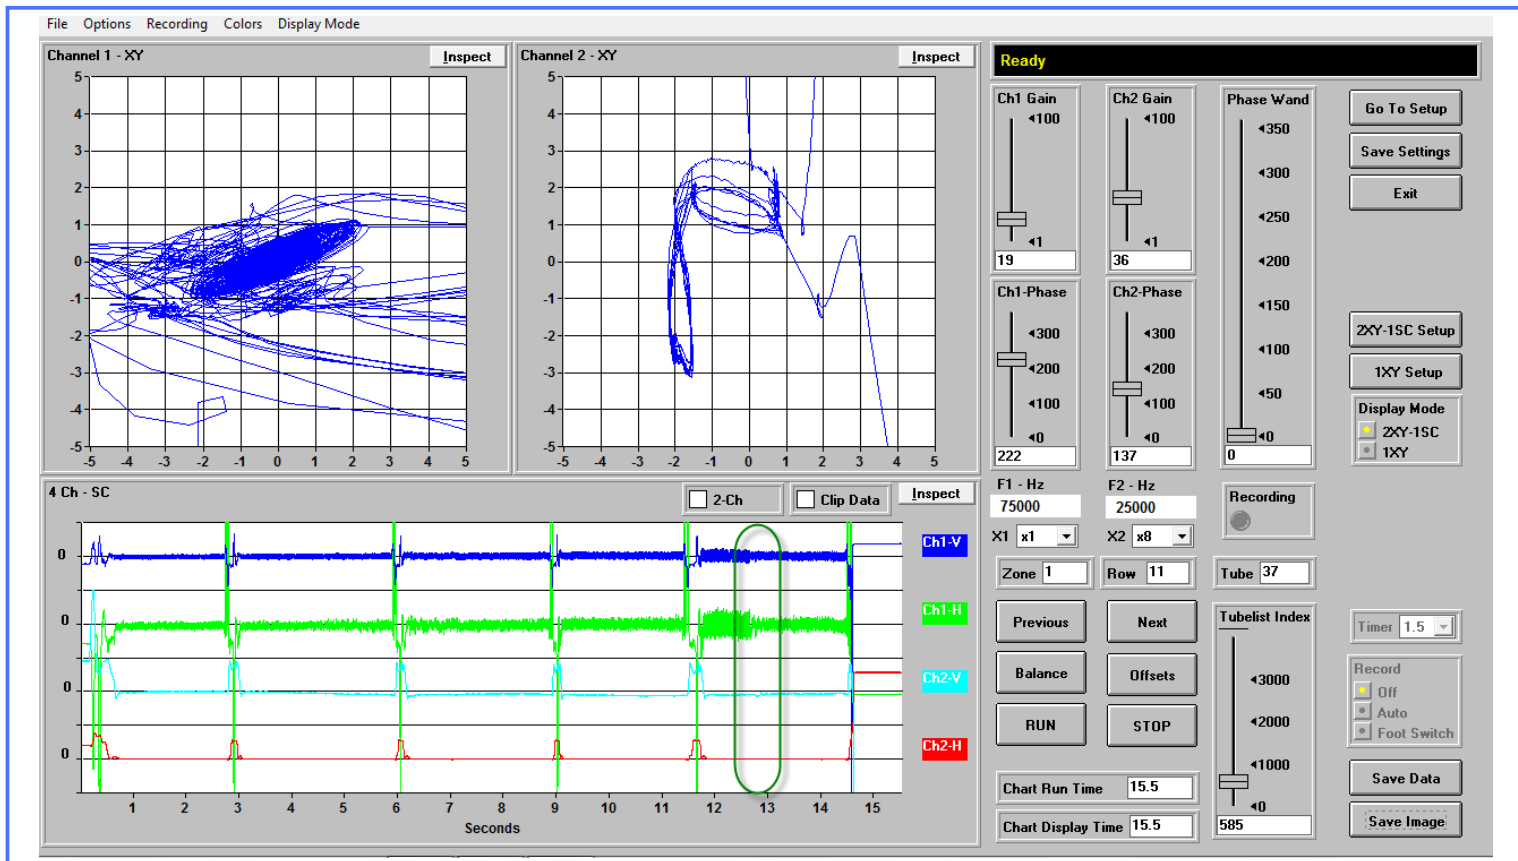
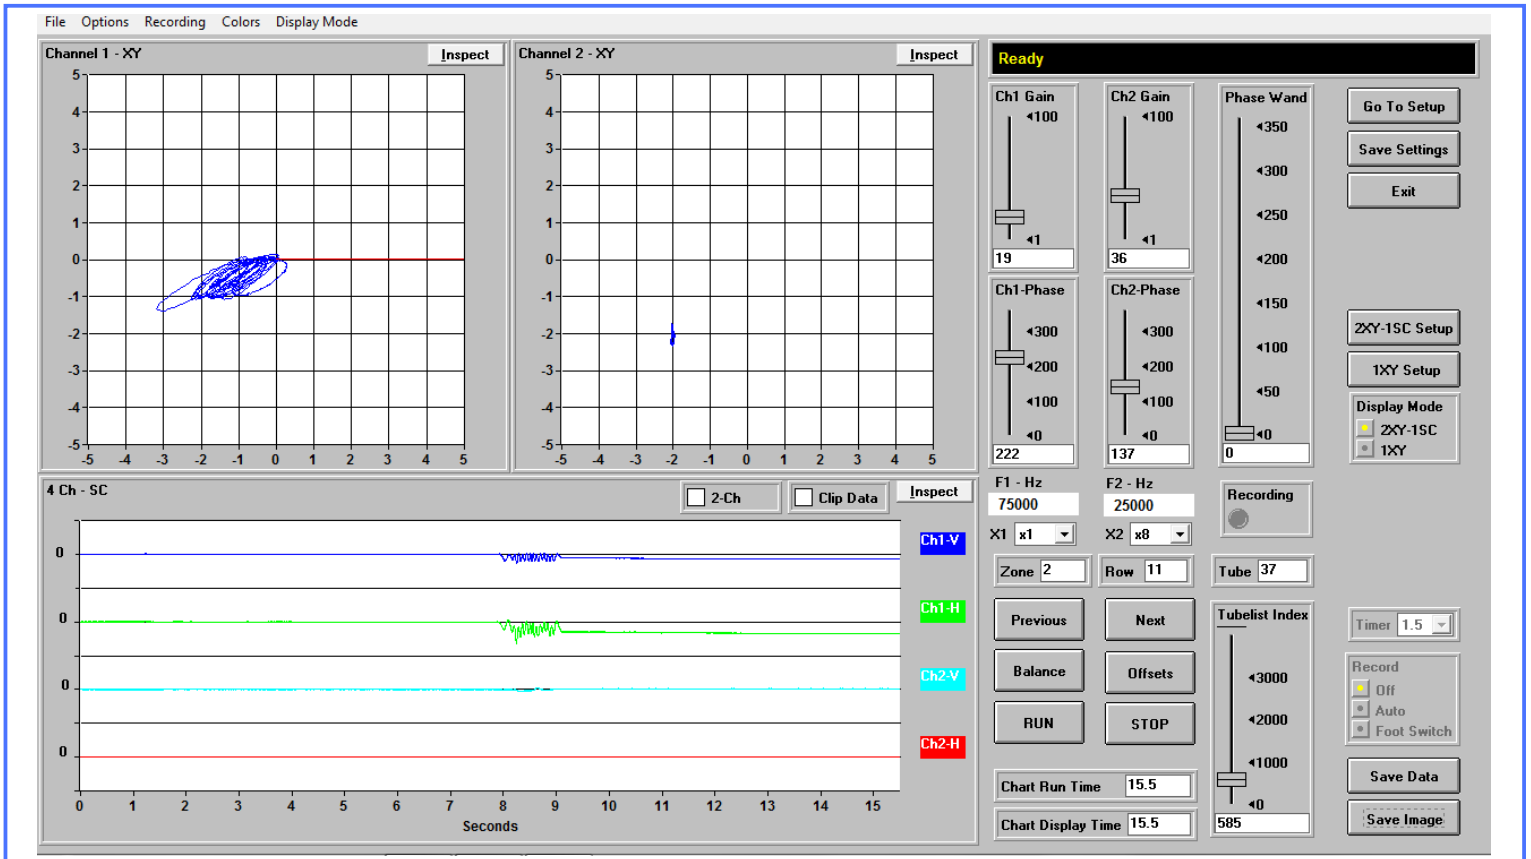
The OD Defects detected appear minor at this time, and require no immediate corrective action. However, the damage mechanism and growth rates are unknown.

OD DEFECT < 20% (Row 11 Tube 37)

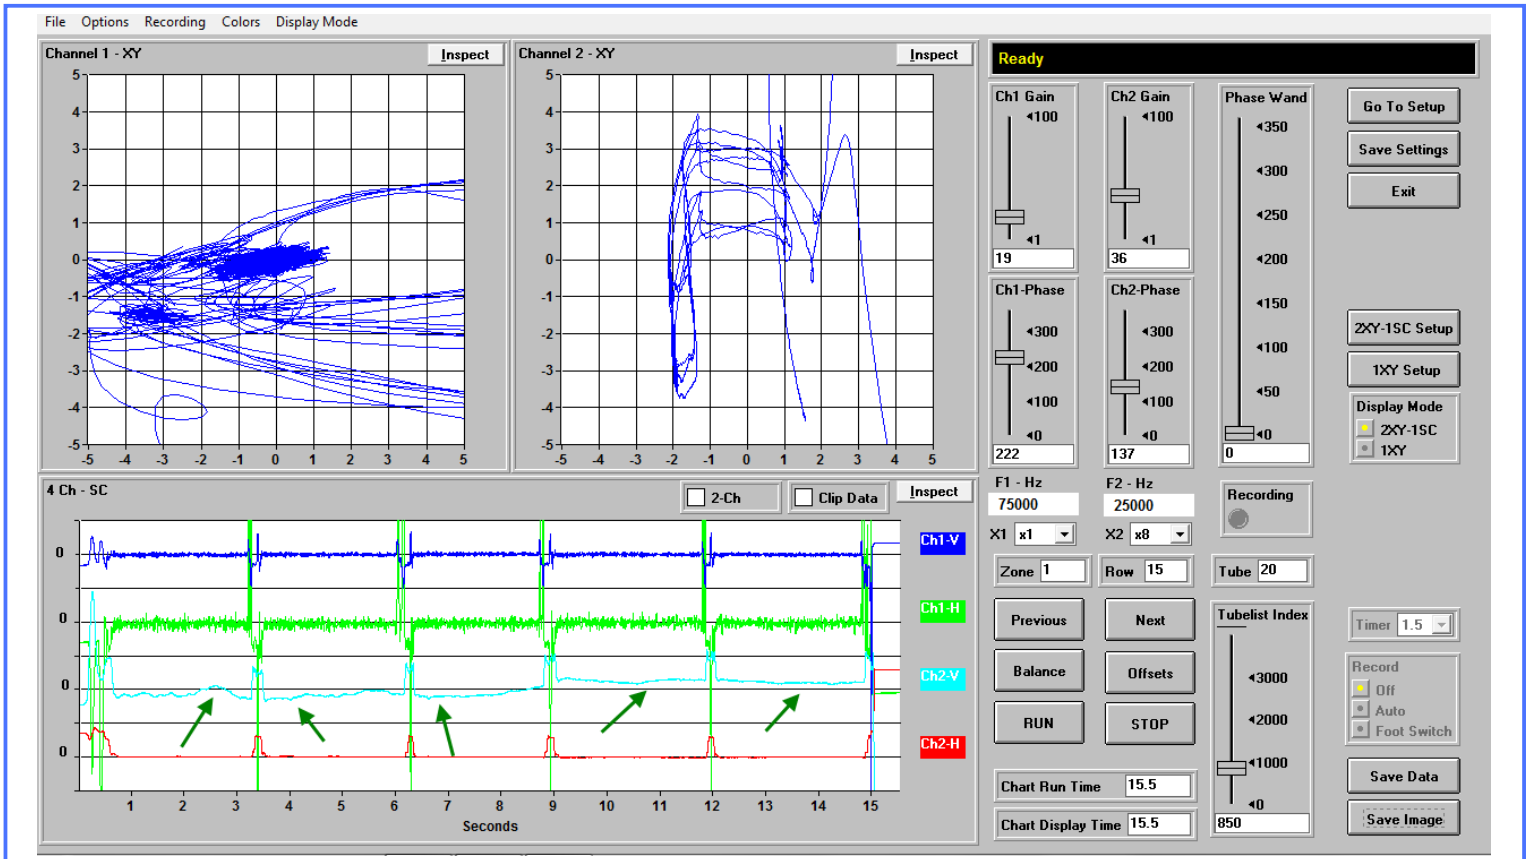
NOTED PERMEABILITY VARIAT (Row 15 Tube 20)

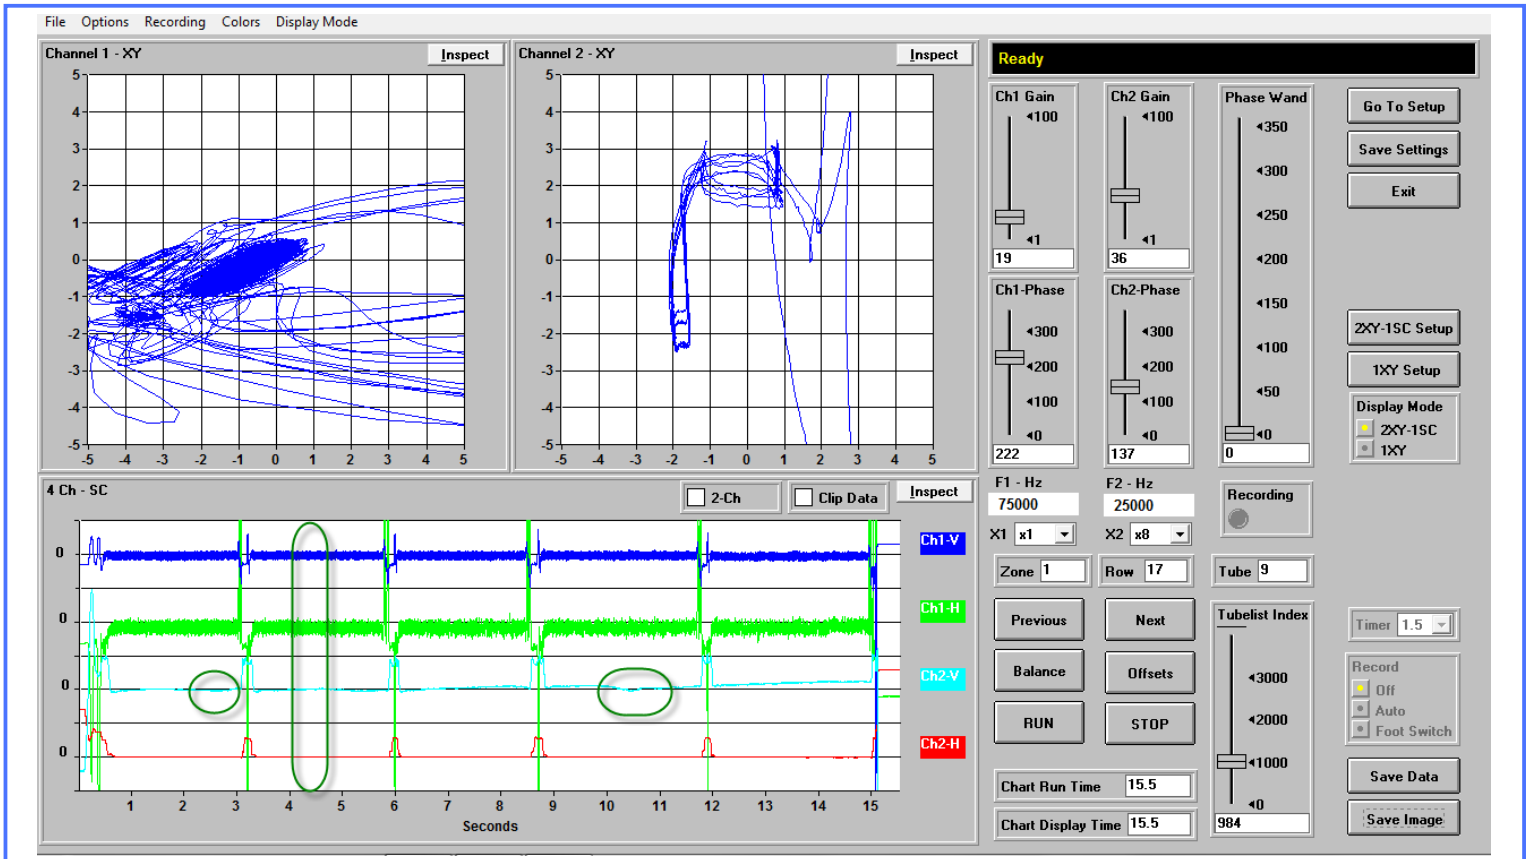
NOTED ID DAMAGE (Row 17 Tube 9)

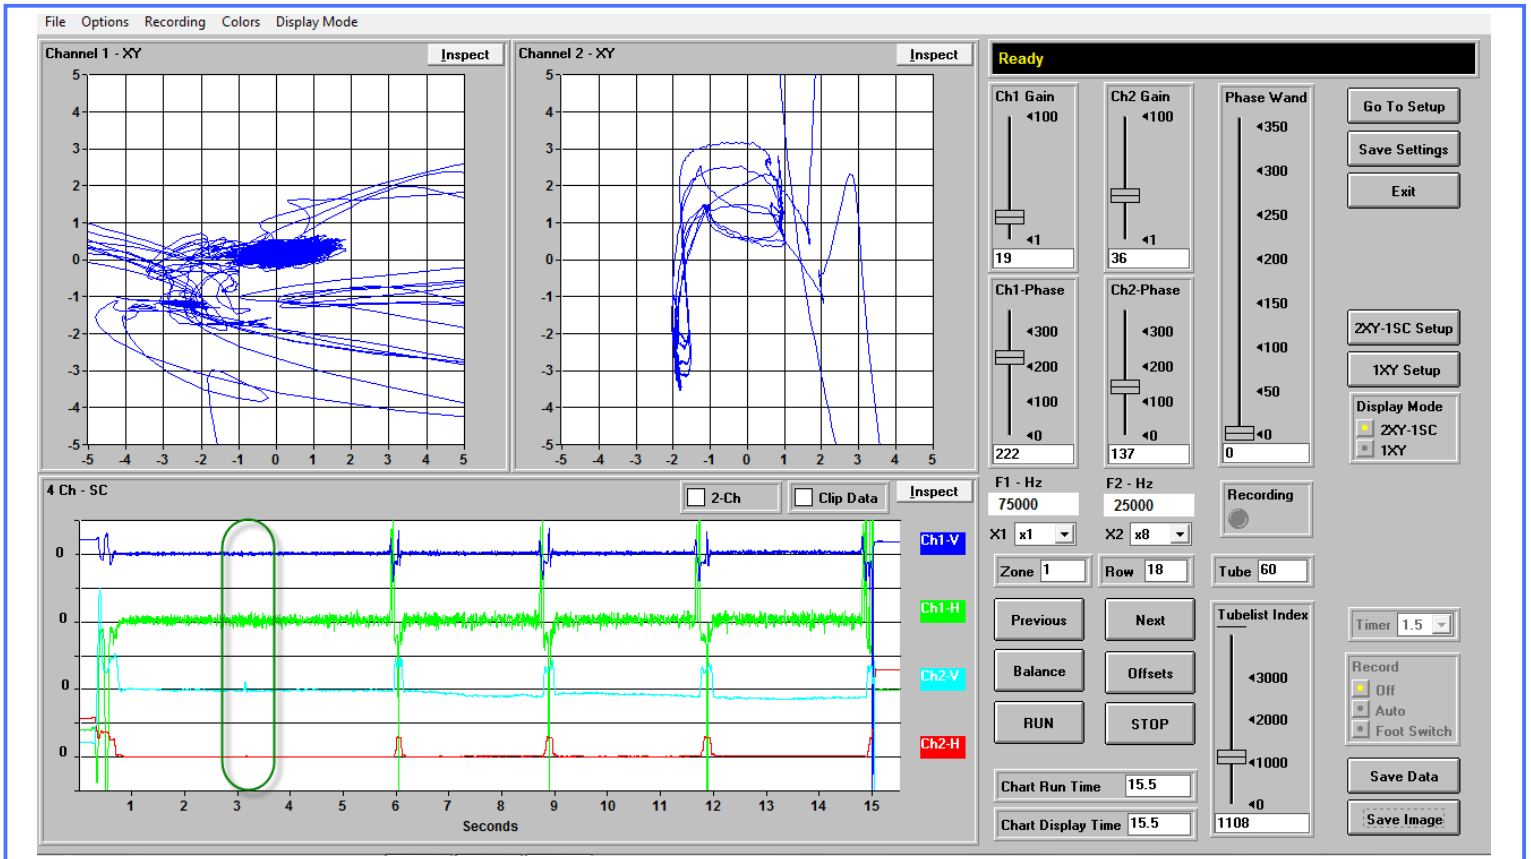
Tubes missing support landings showed no detectable loss and require no corrective action.

MISSING LAND (Row 18 Tube 60)

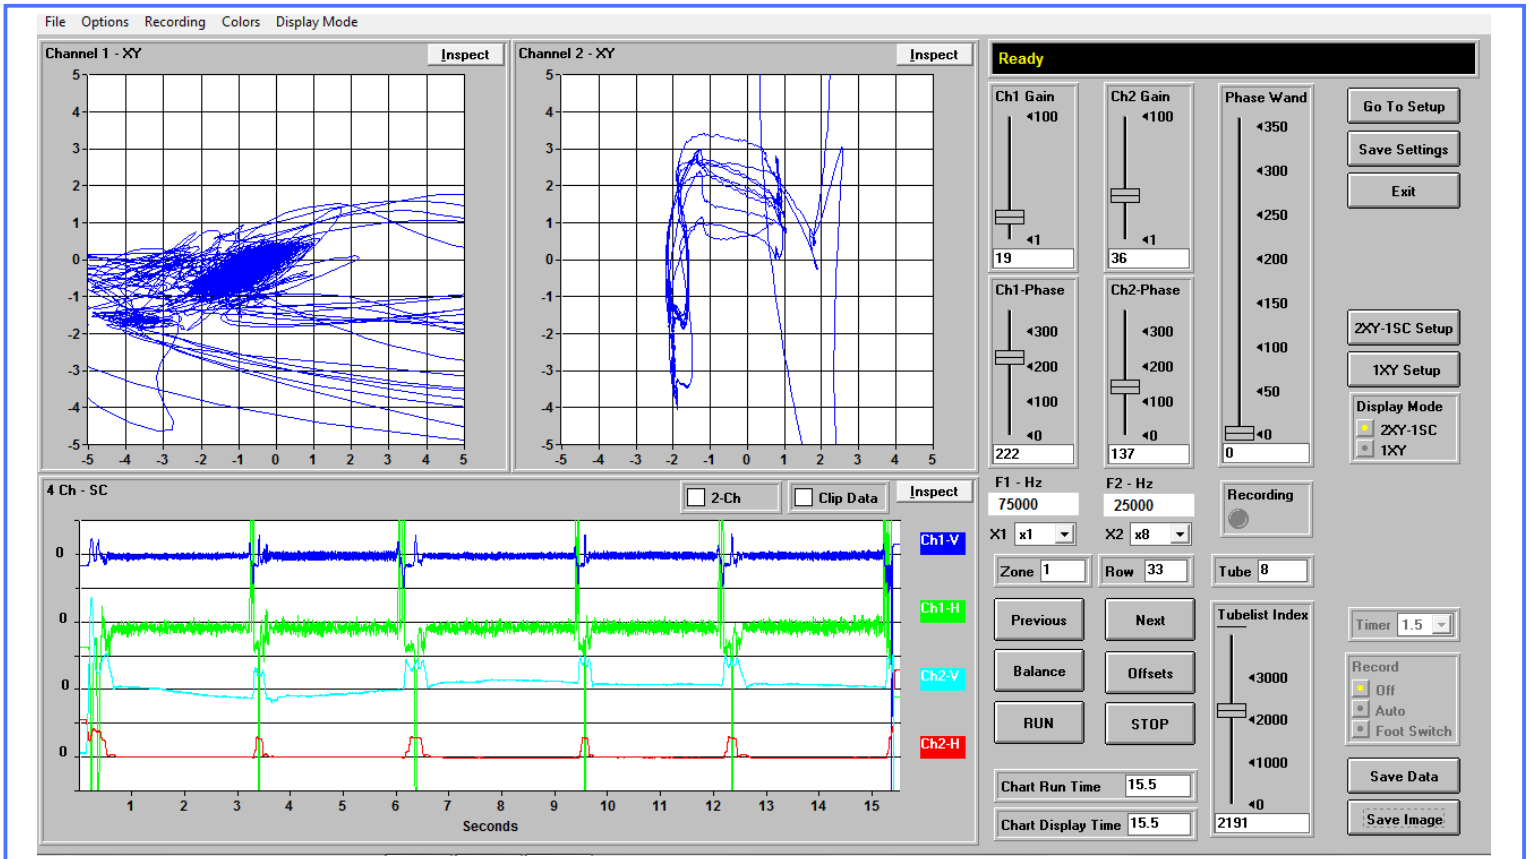
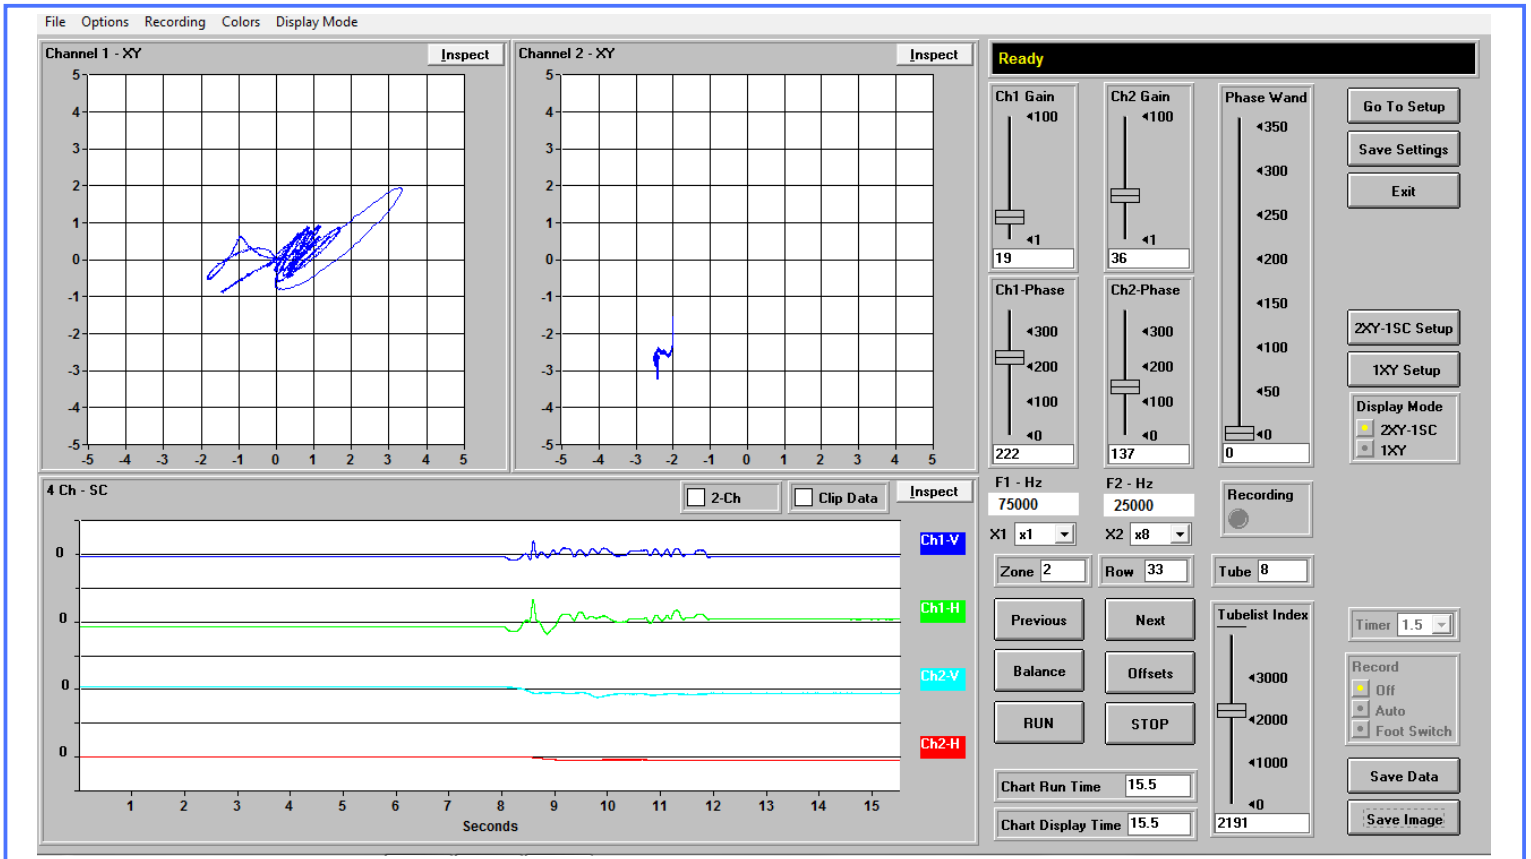
OD DEFECT < 20% (Row 33 Tube 8)

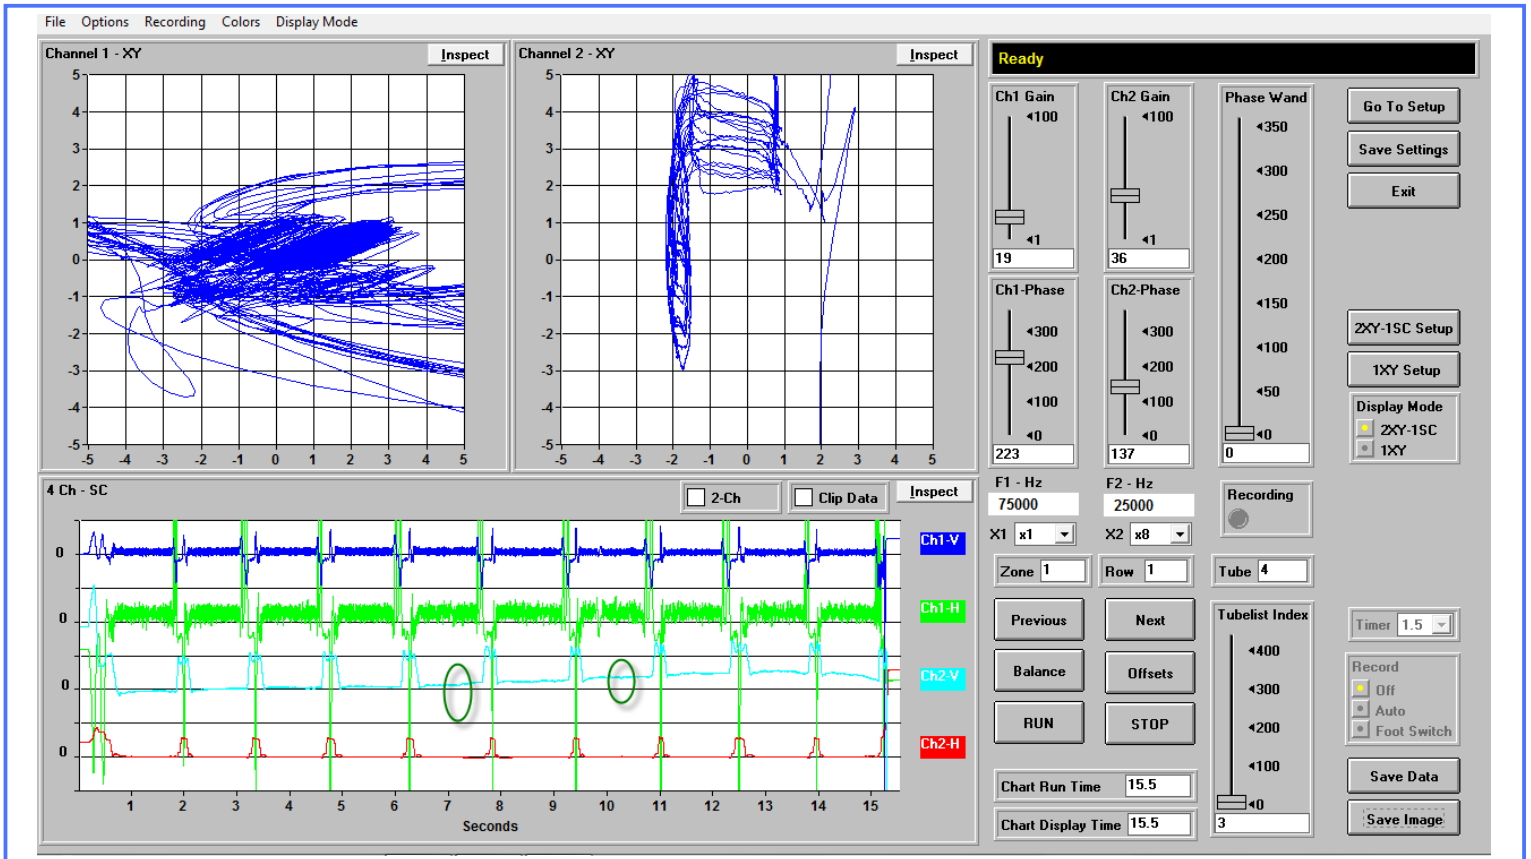
NOTED ID CORROSION (Row 1 Tube 4)

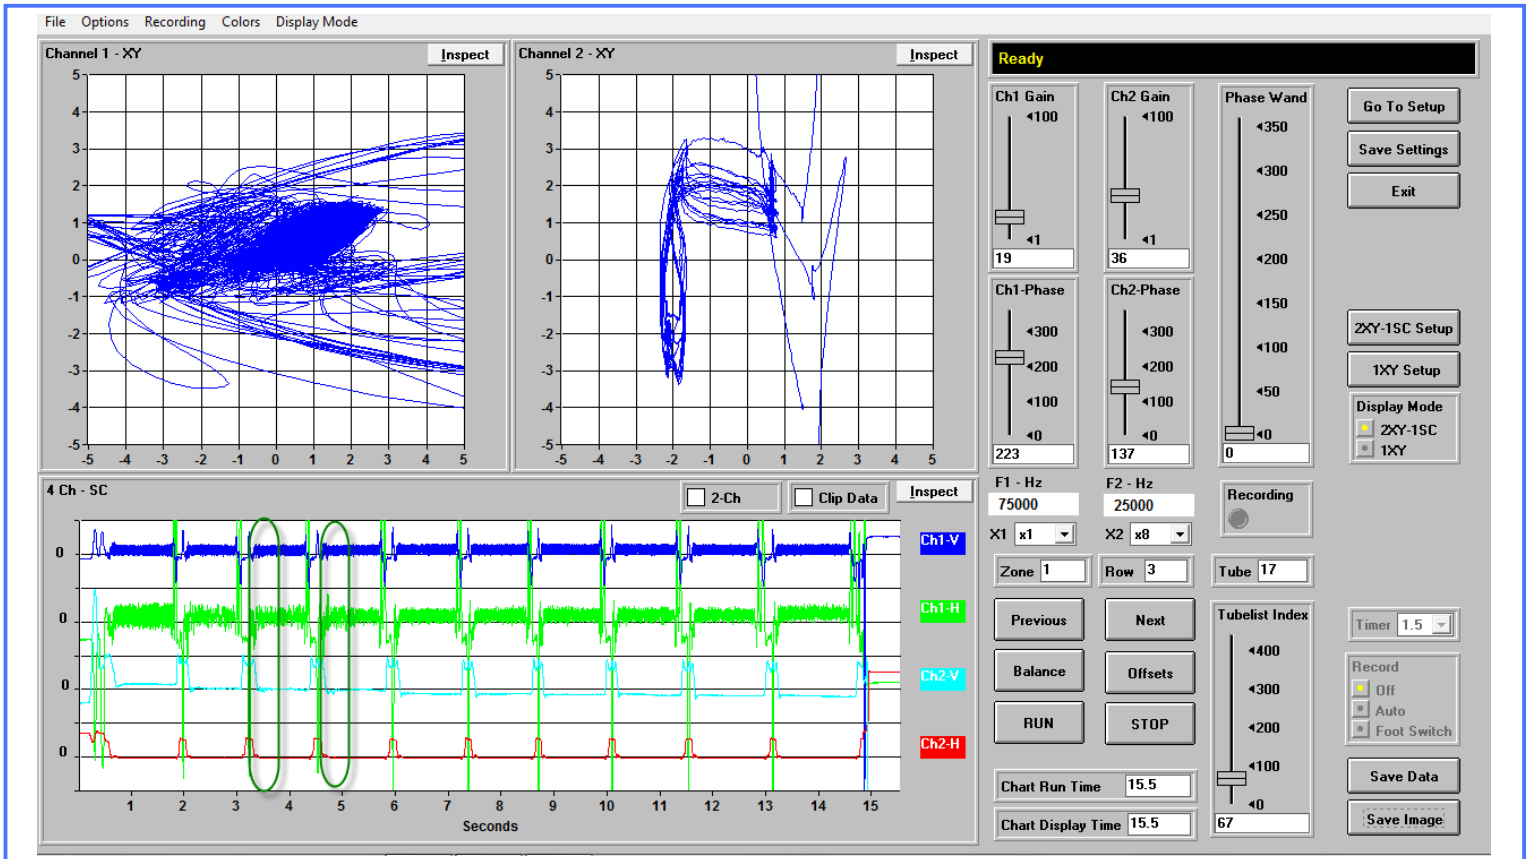
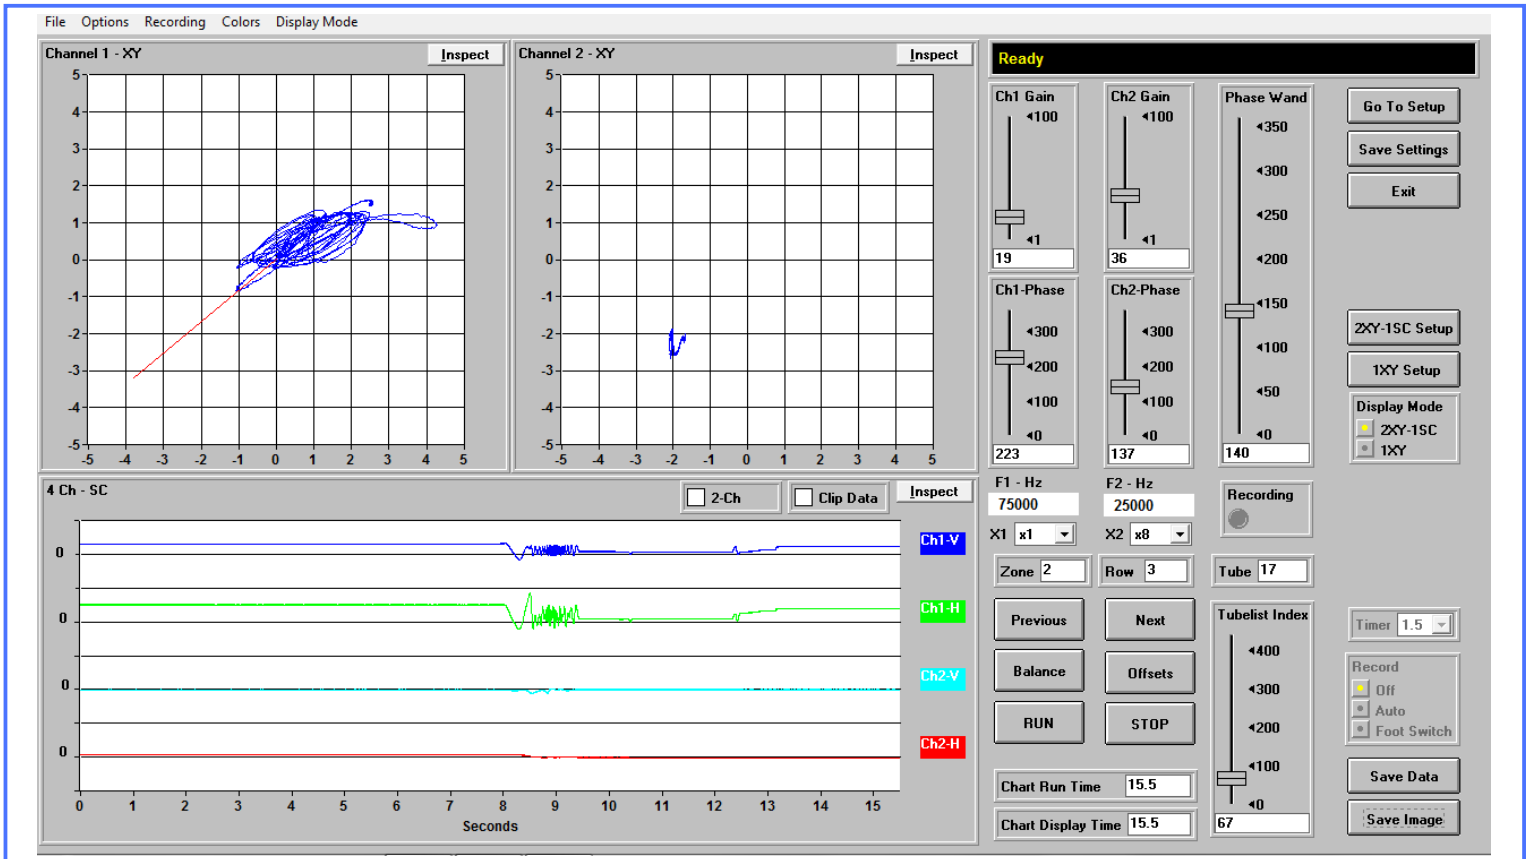
The OD Defects detected appear minor at this time, and require no immediate corrective action. However, the damage mechanism and growth rates are unknown.

OD DEFECT < 20% (Row 3 Tube 17)

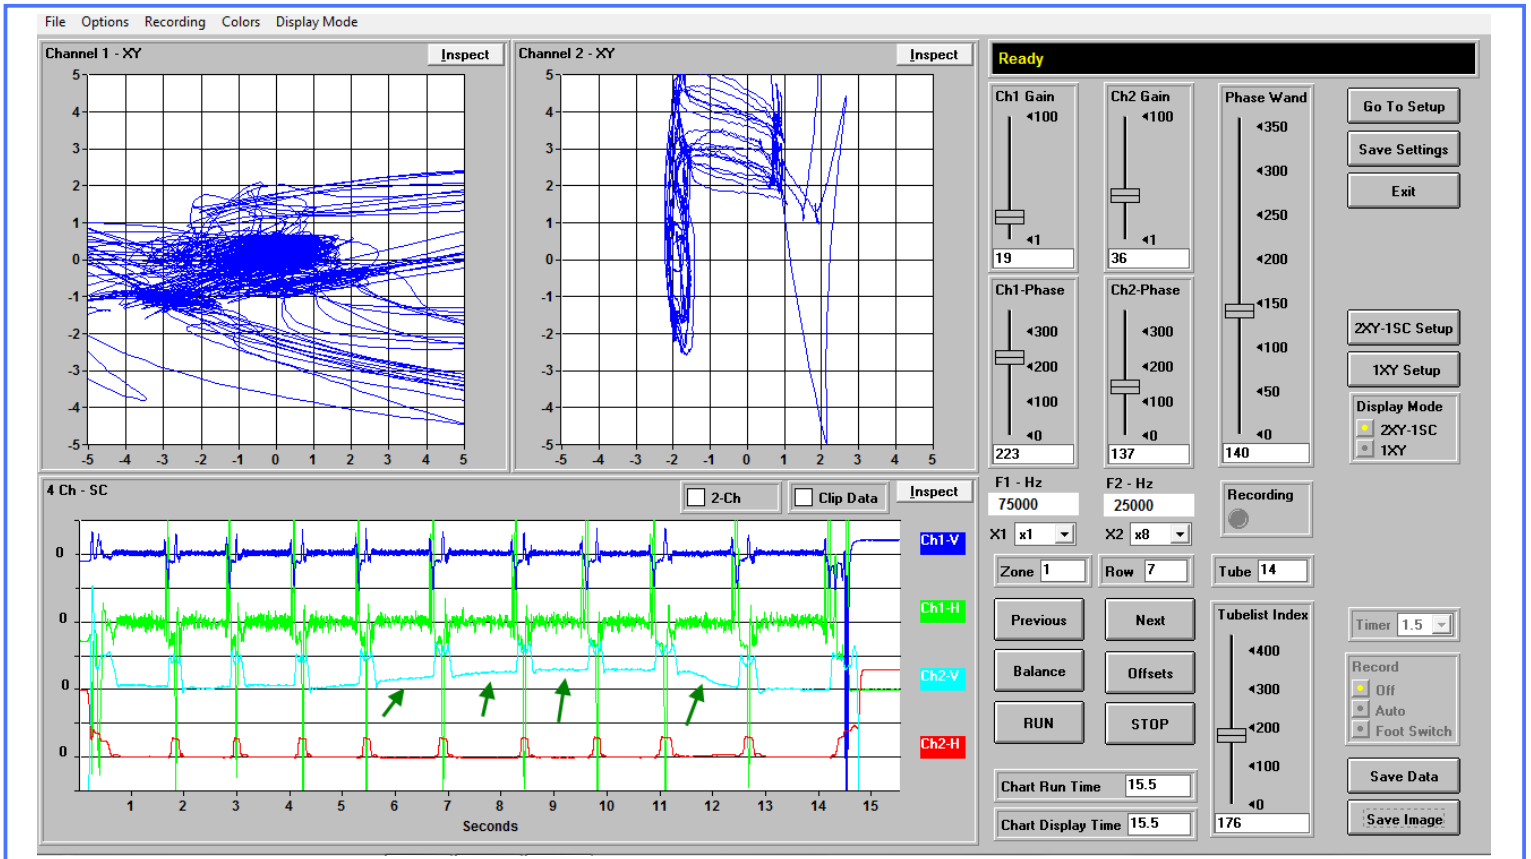
NOTED PERMEABILITY VARIAT (Row 7 Tube 14)

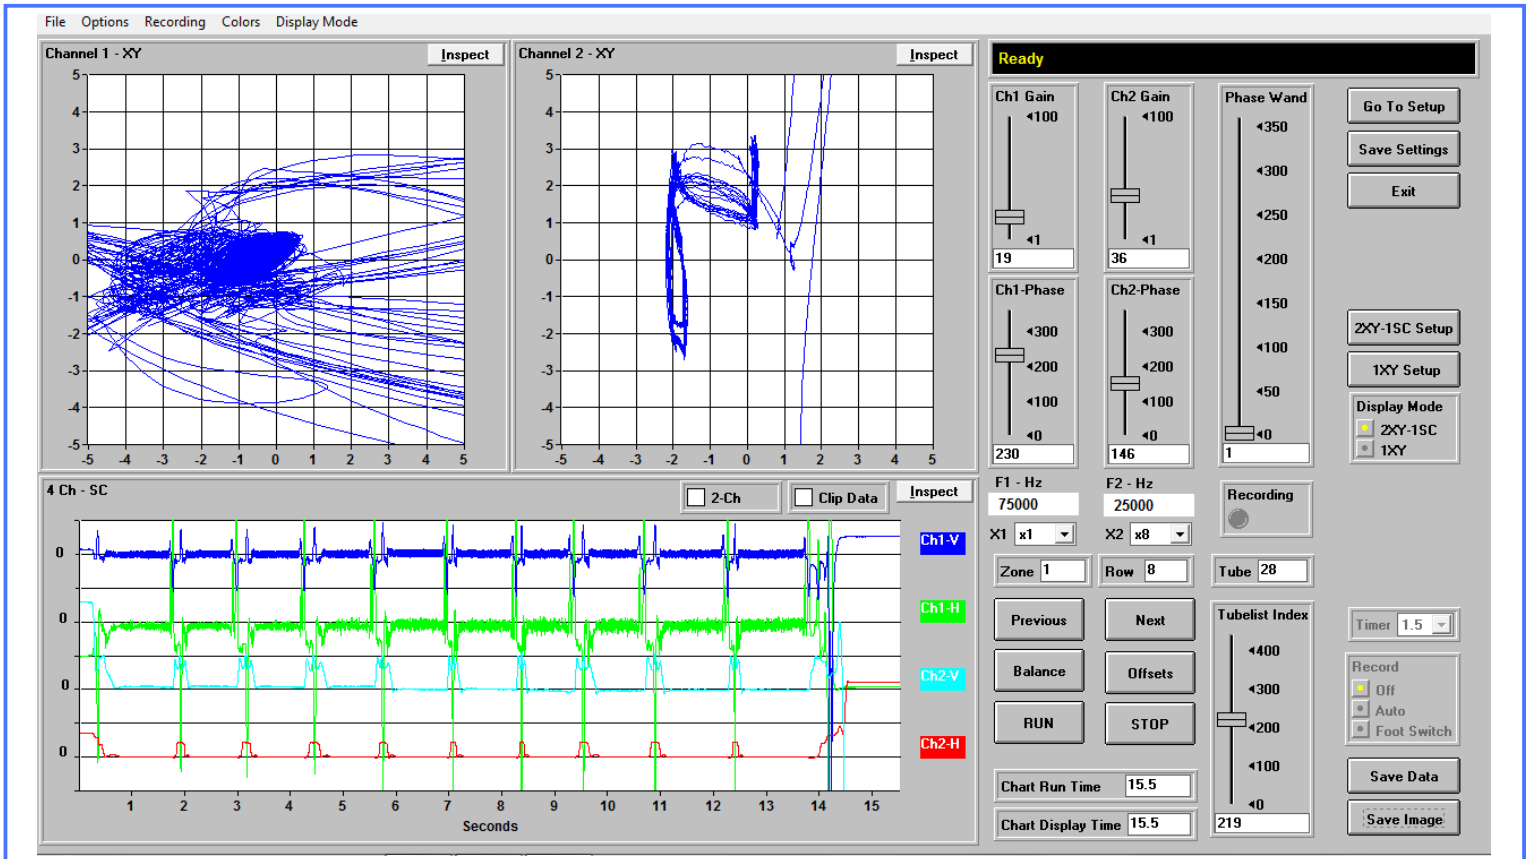
WELD ANOMALY (Row 8 Tube 28)
