## Report of Eddy Current Inspection

Manufacturer: Carrier

Model: 17DA743

Location: DUPONT EXPERIMENTAL STATION  
RTE. 141 BETWEEN 52 & 202  
WILMINGTON, DE 19735

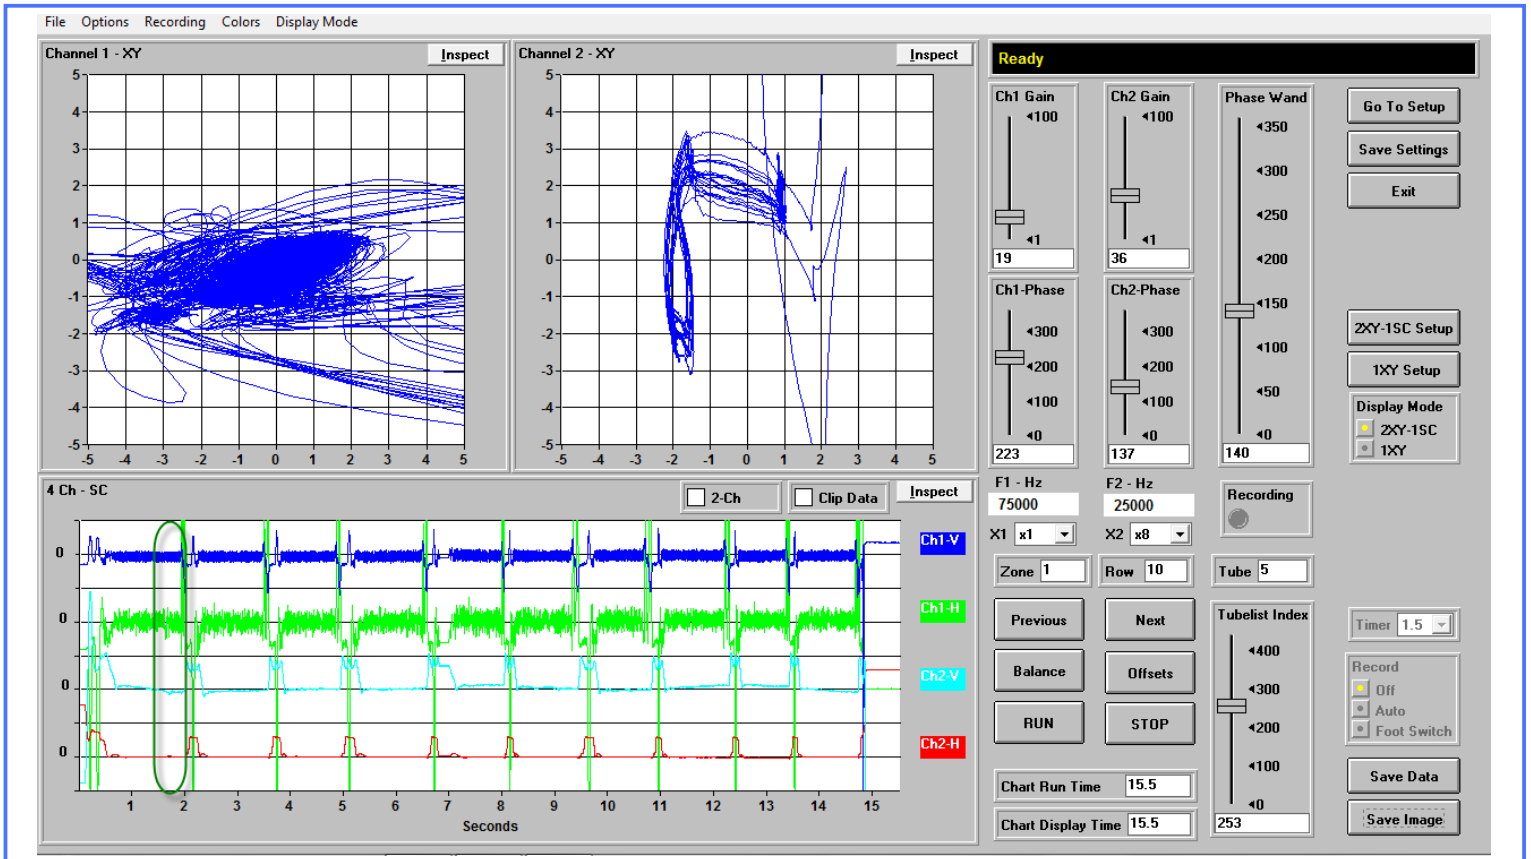
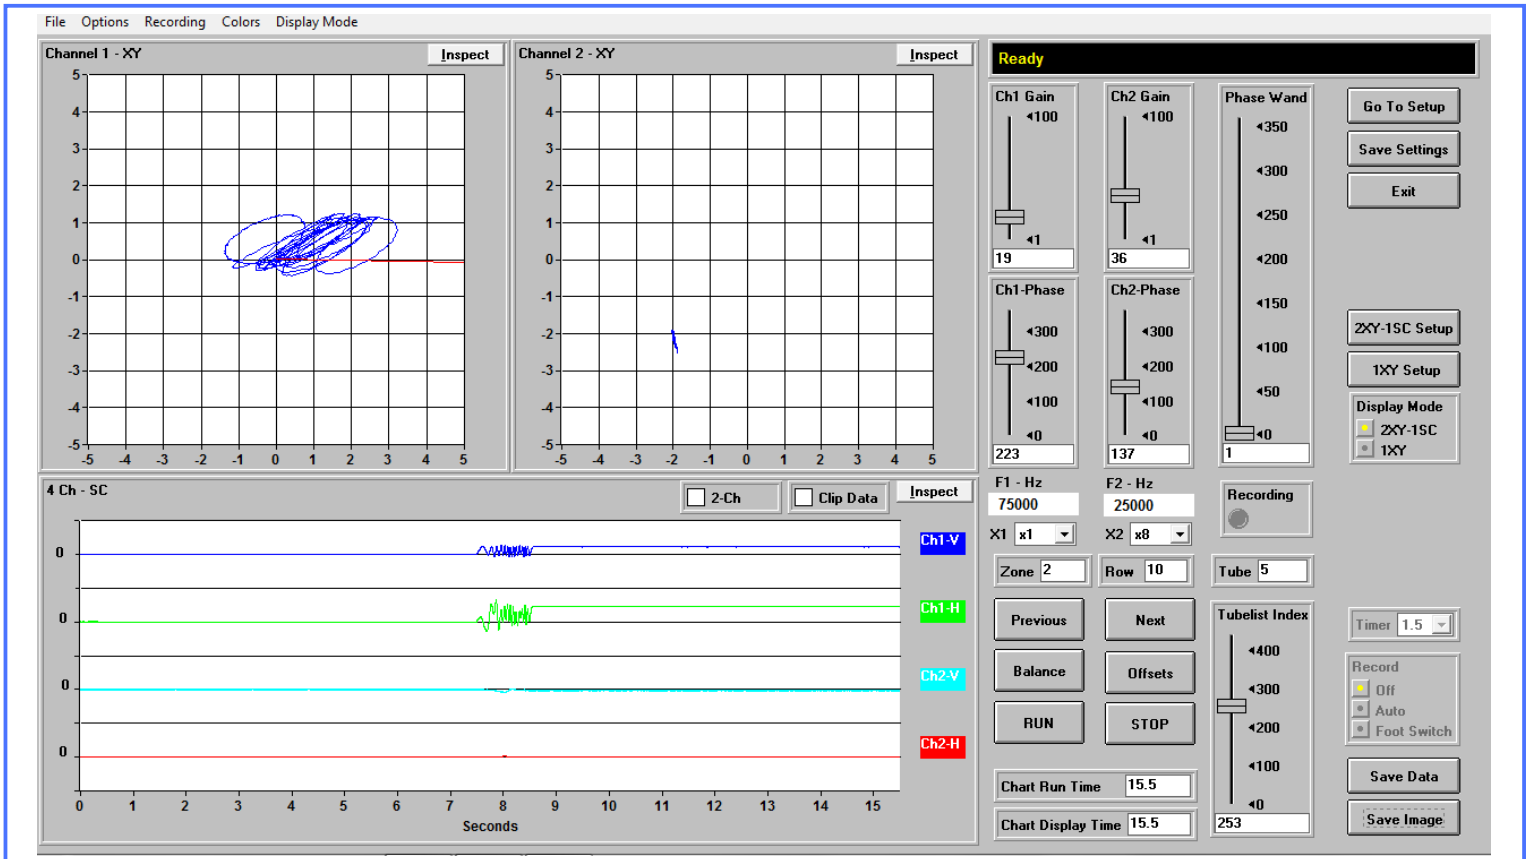
Tubes indicating ID Pits require no corrective action at this time. However, this type damage should be monitored for defect growth, as it can be progressive.

ID PIT < 20% (Row 10 Tube 5)

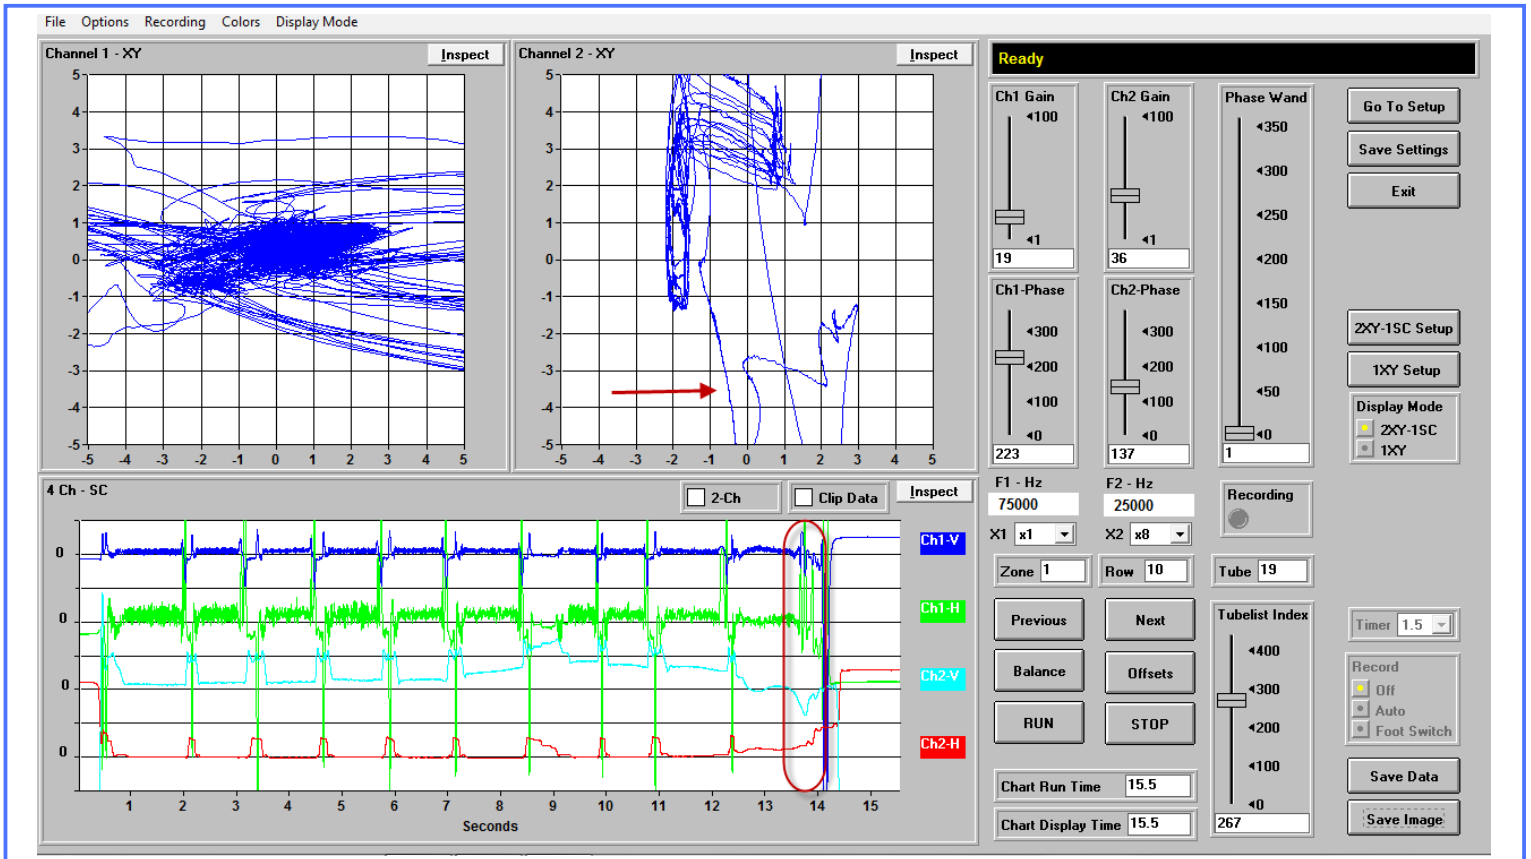
ABN. EXCESS. BELL/ROLL (Row 10 Tube 19)

We recommend the tube indicating an Abnormal Bell End Indication be isolated from the system at this time. The exact cause of the indication is unknown. However, excessive thinning is indicated.
