## Report of Eddy Current Inspection

Manufacturer: Carrier

Model: 17DA743

Location: DUPONT EXPERIMENTAL STATION  
RTE. 141 BETWEEN 52 & 202  
BUILDING 315  
WILMINGTON, DE 19735

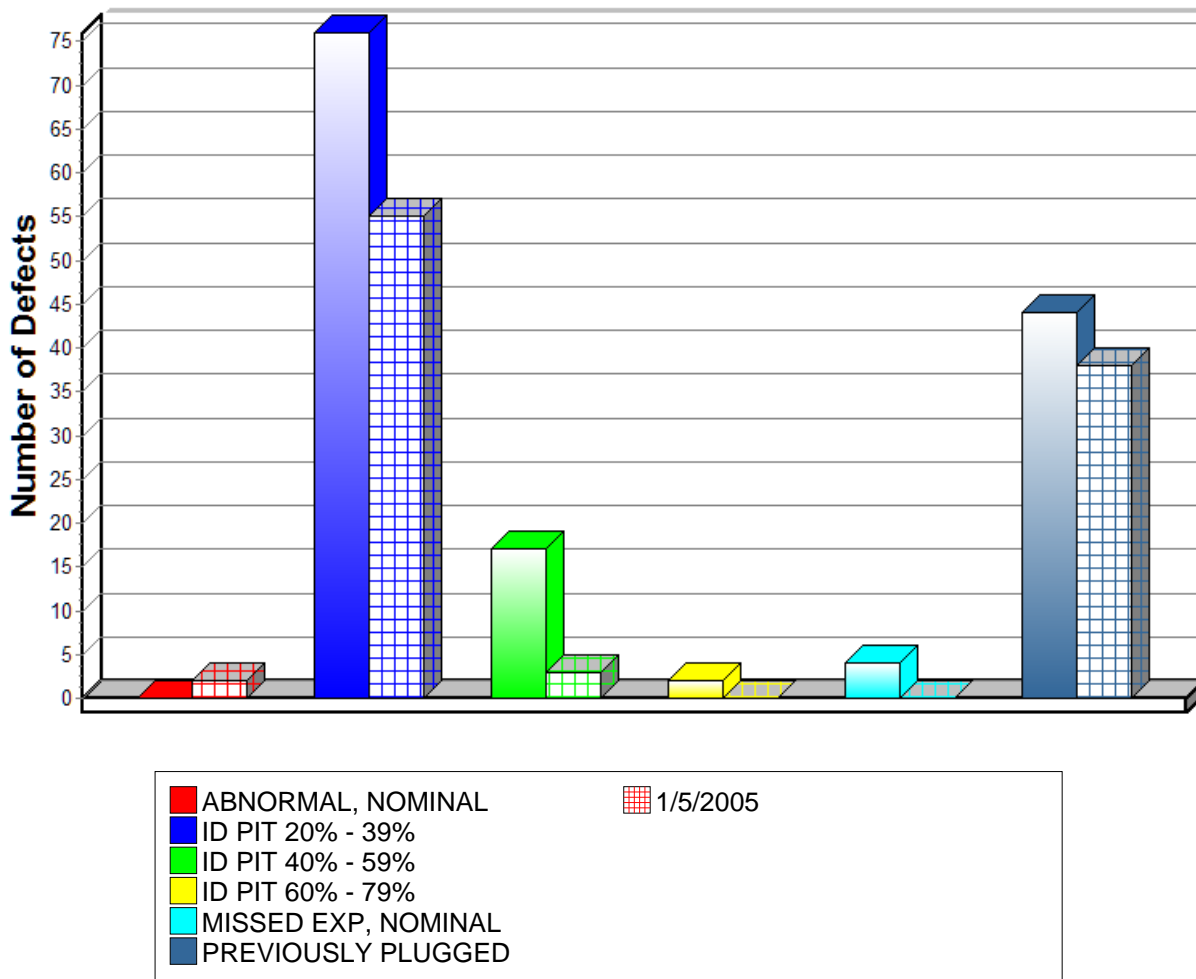
### Evaporator Defects

Evaporator: 2586 Tubes		
Tubes Tested: 2586 Tubes		
Significant/Measurable Indications	Number of Tubes Marked	Percent of Bundle
MISSED EXP, NOMINAL	4	.15
ID PIT 20% - 39%	76	2.94
ID PIT 40% - 59%*	17	.66
ID PIT 60% - 79%*	2	.08
PREVIOUSLY PLUGGED	44	1.70
<b>Totals</b>	<b>143</b>	<b>5.53</b>

Tubes marked as Missed Expanded require no corrective action at this time.

Tubes indicating ID Pits of 40% or more should be isolated from the system at this time. ID Pits of less than 40% require no immediate corrective action. This type damage is usually progressive and should be monitored.

Tubes marked as Previously Plugged, had been plugged prior to this inspection.

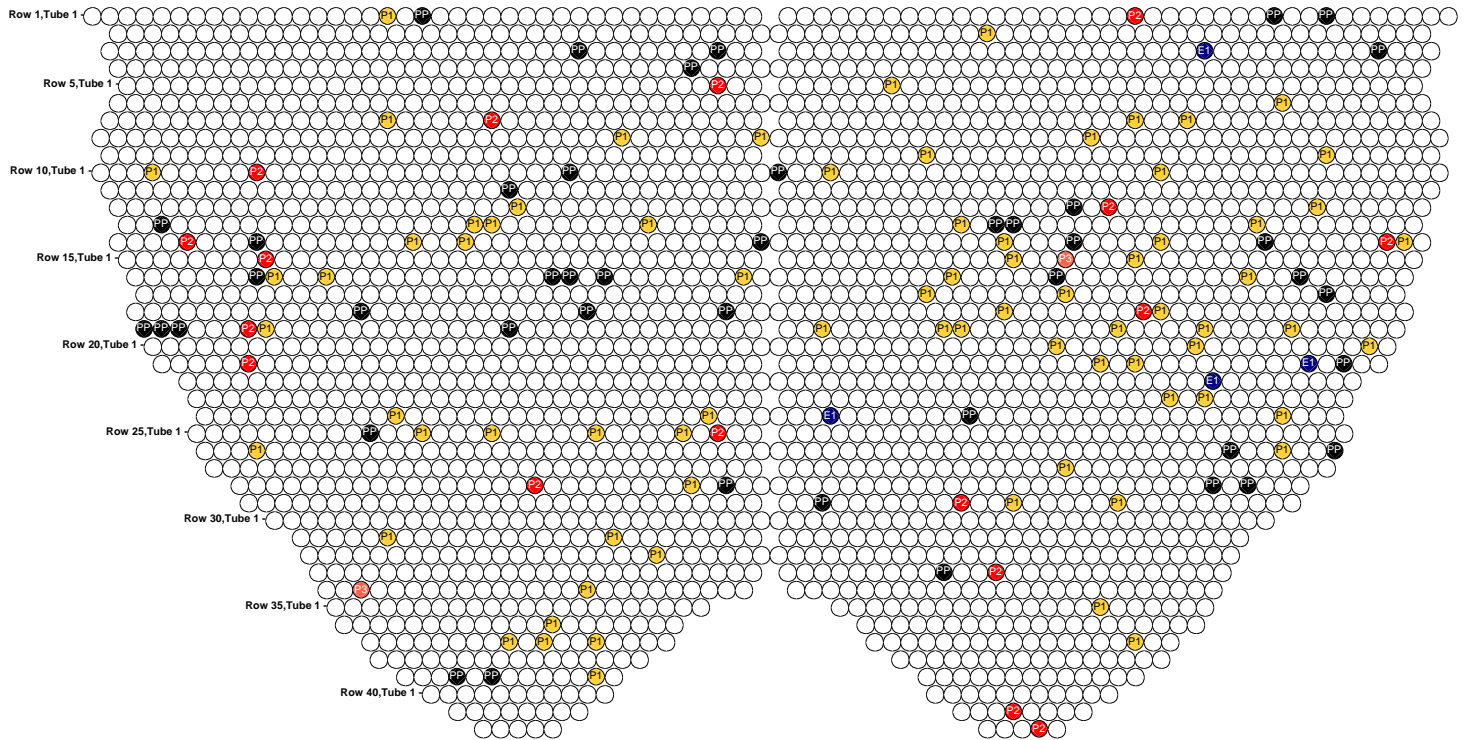
# Evaporator Section

- = MISSED EXP, NOMINAL
- = ID PIT 20% - 39%
- = ID PIT 40% - 59%      **REQUIRES ACTION**
- = ID PIT 60% - 79%      **REQUIRES ACTION**
- = PREVIOUSLY PLUGGED

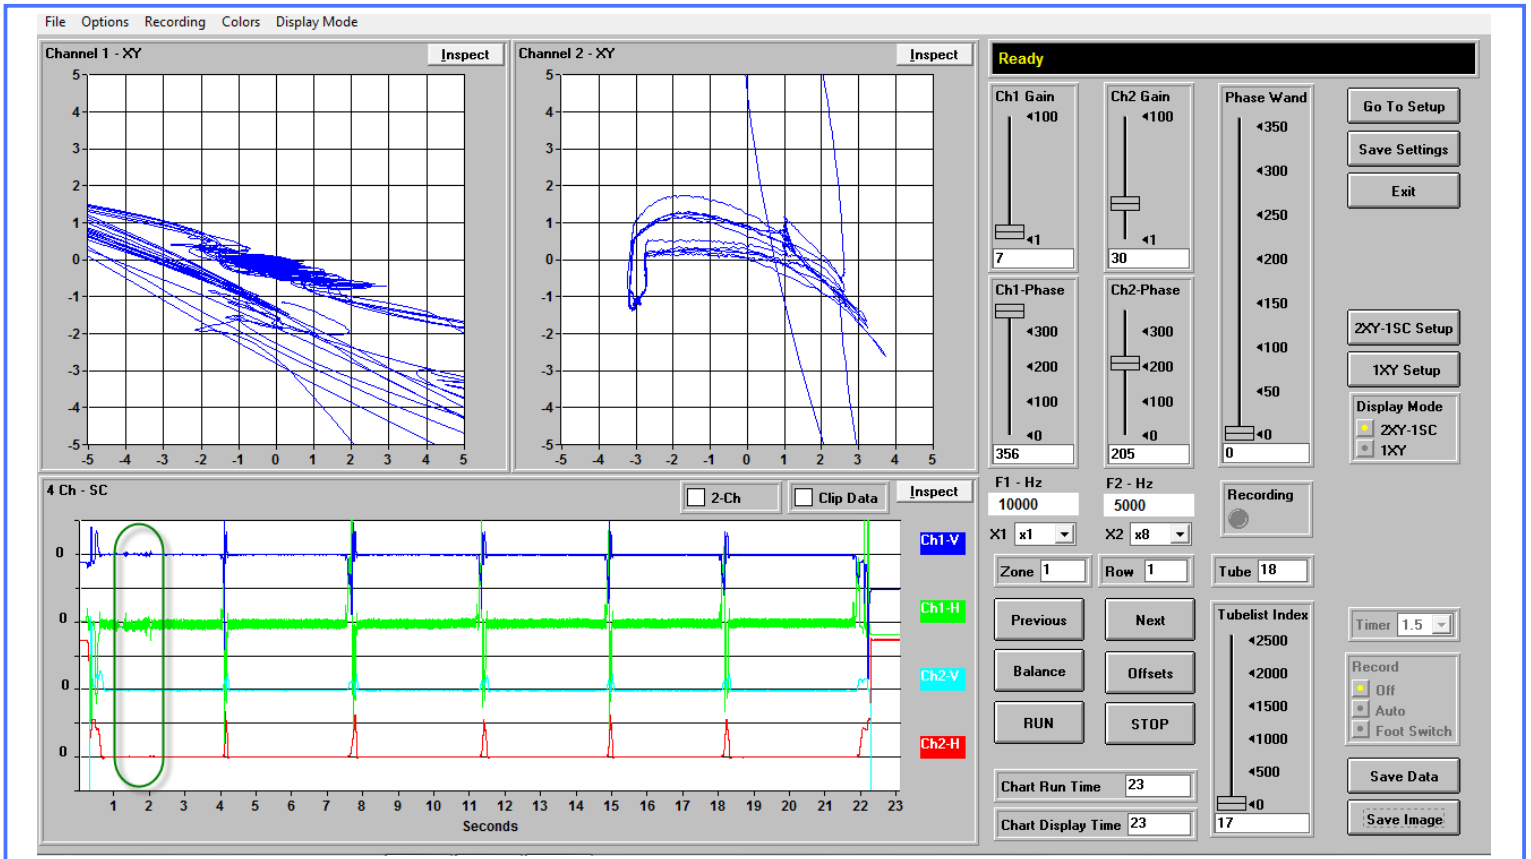
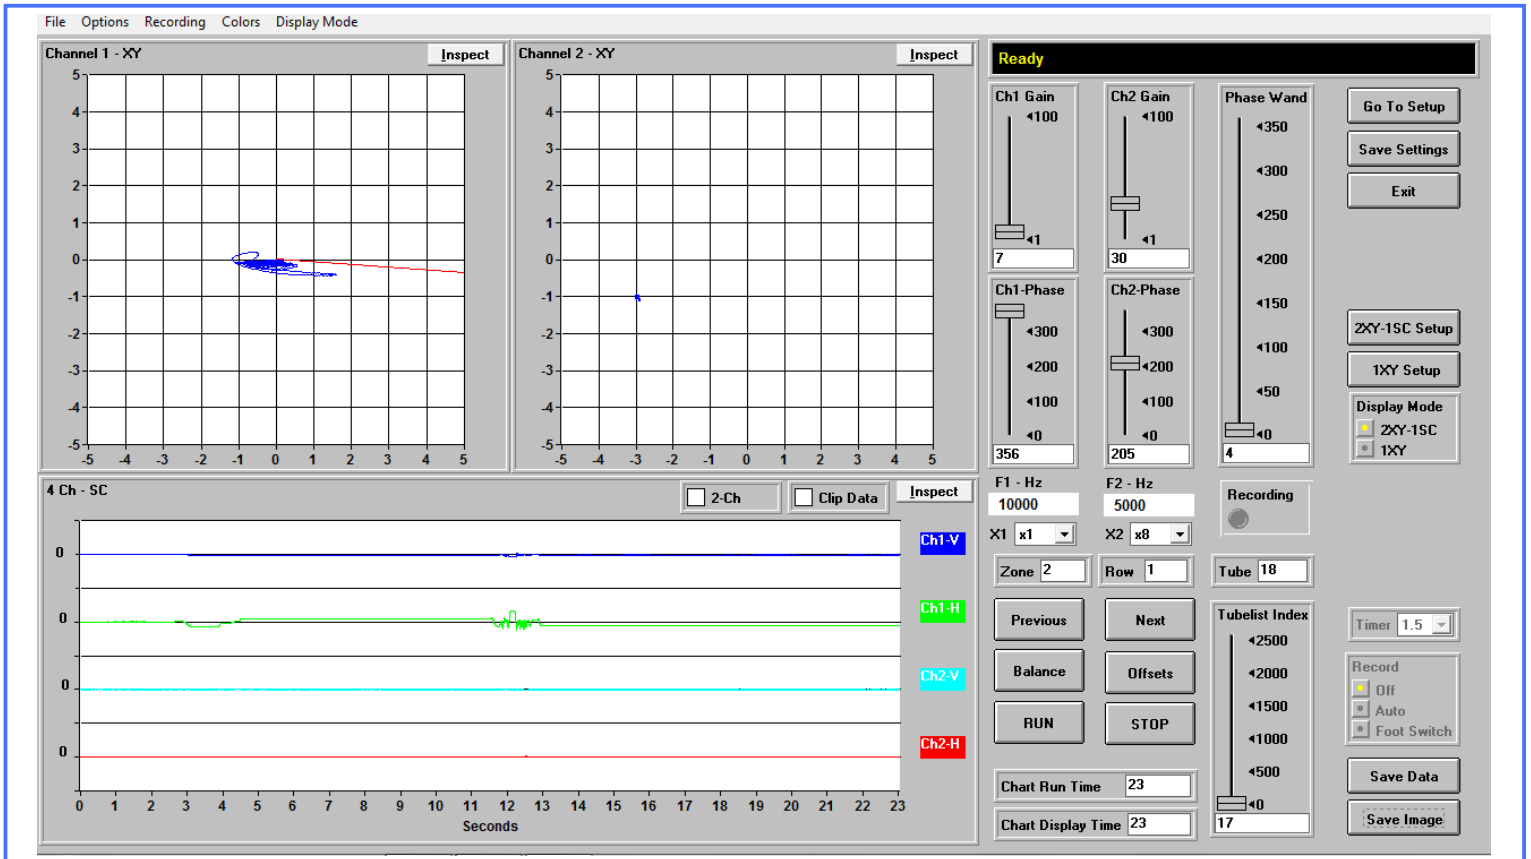
ID PIT 20% - 39% (Row 1 Tube 18)

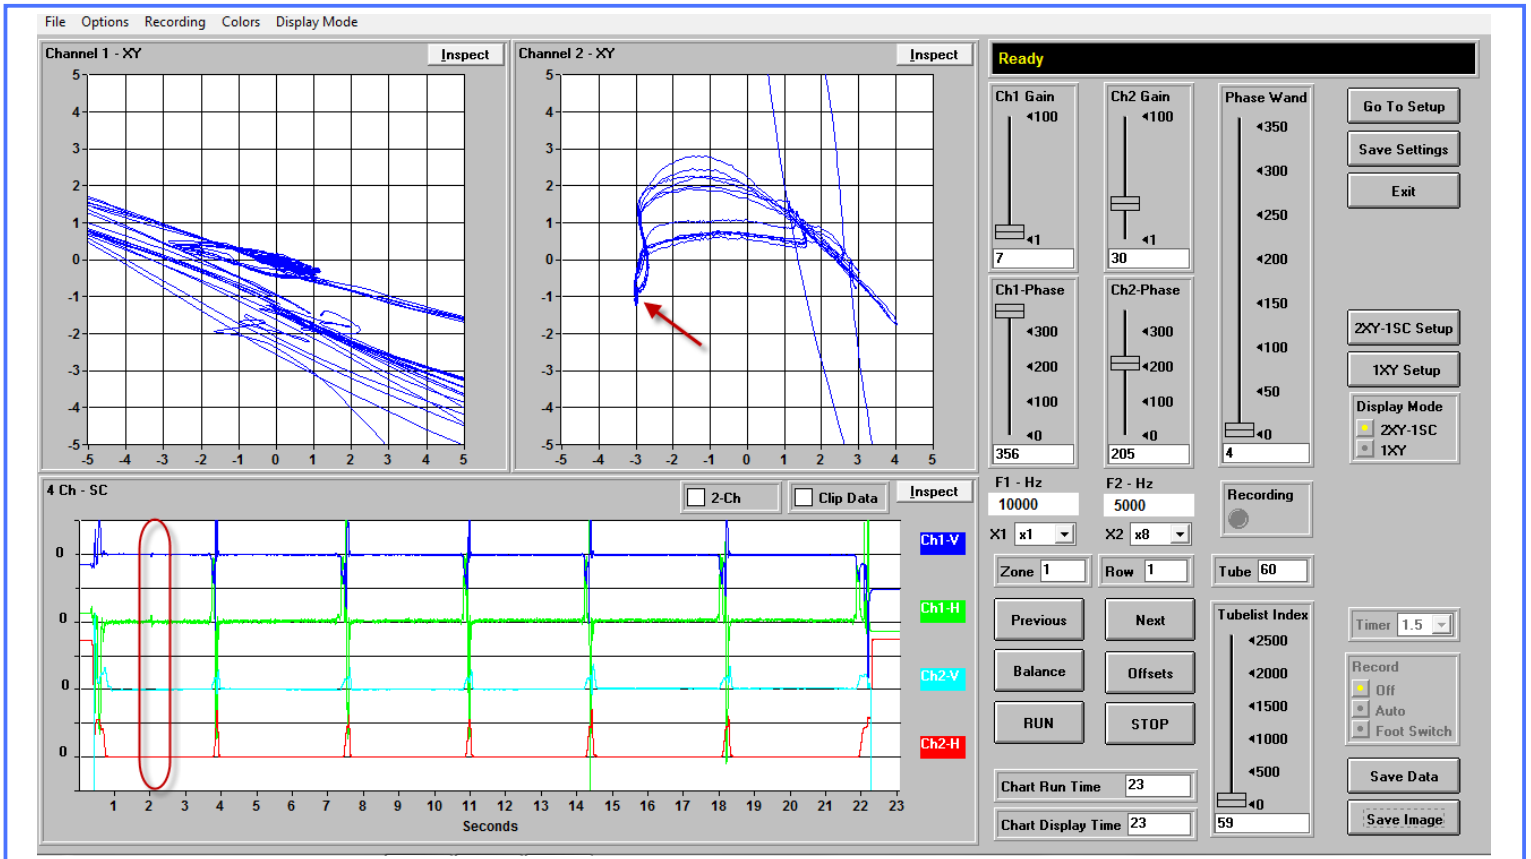
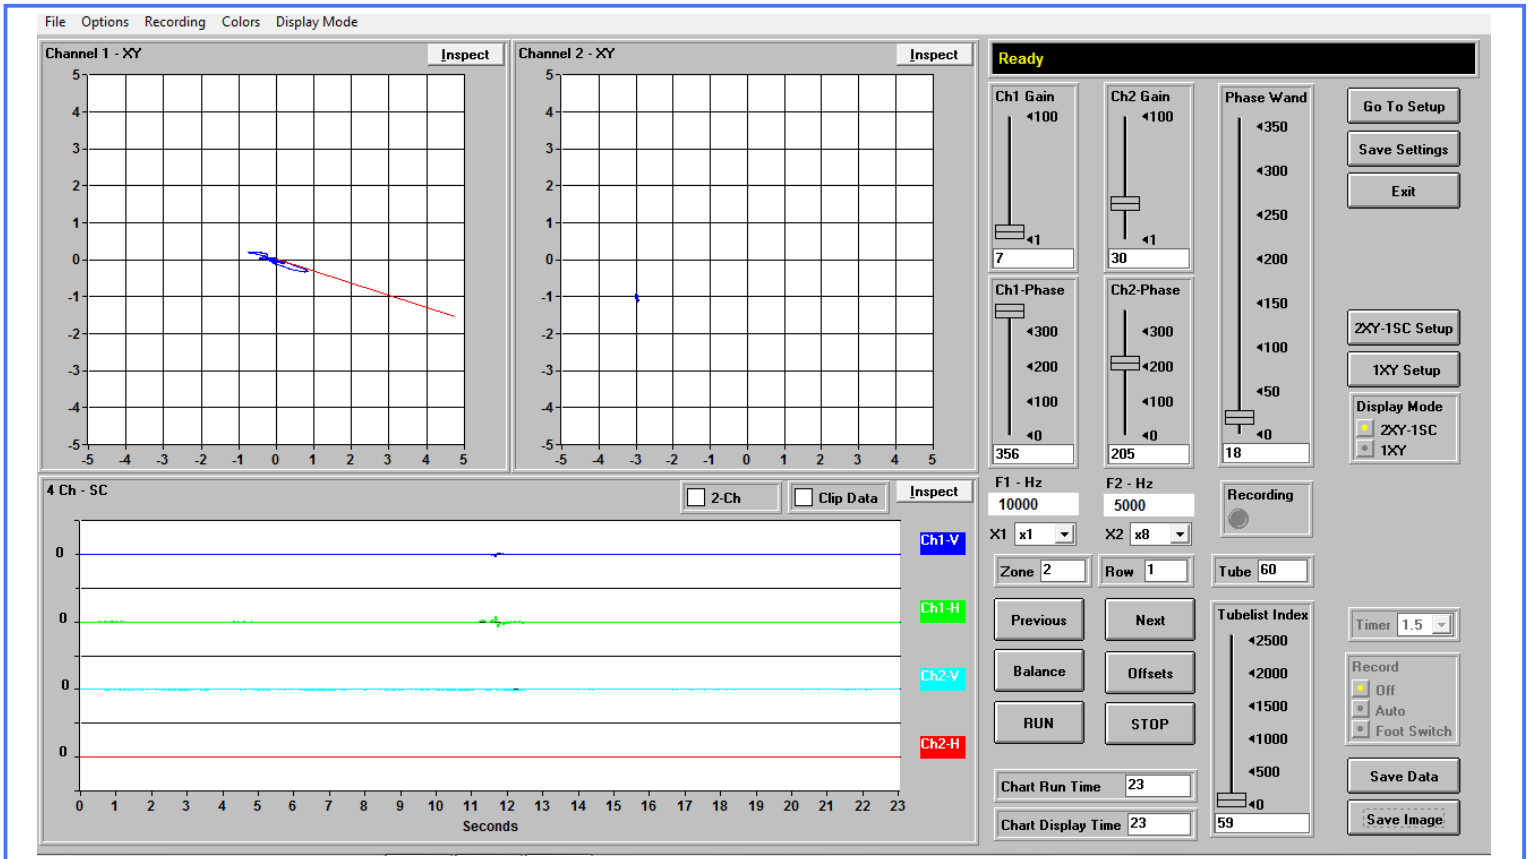
ID PIT 40% - 59% (Row 1 Tube 60)

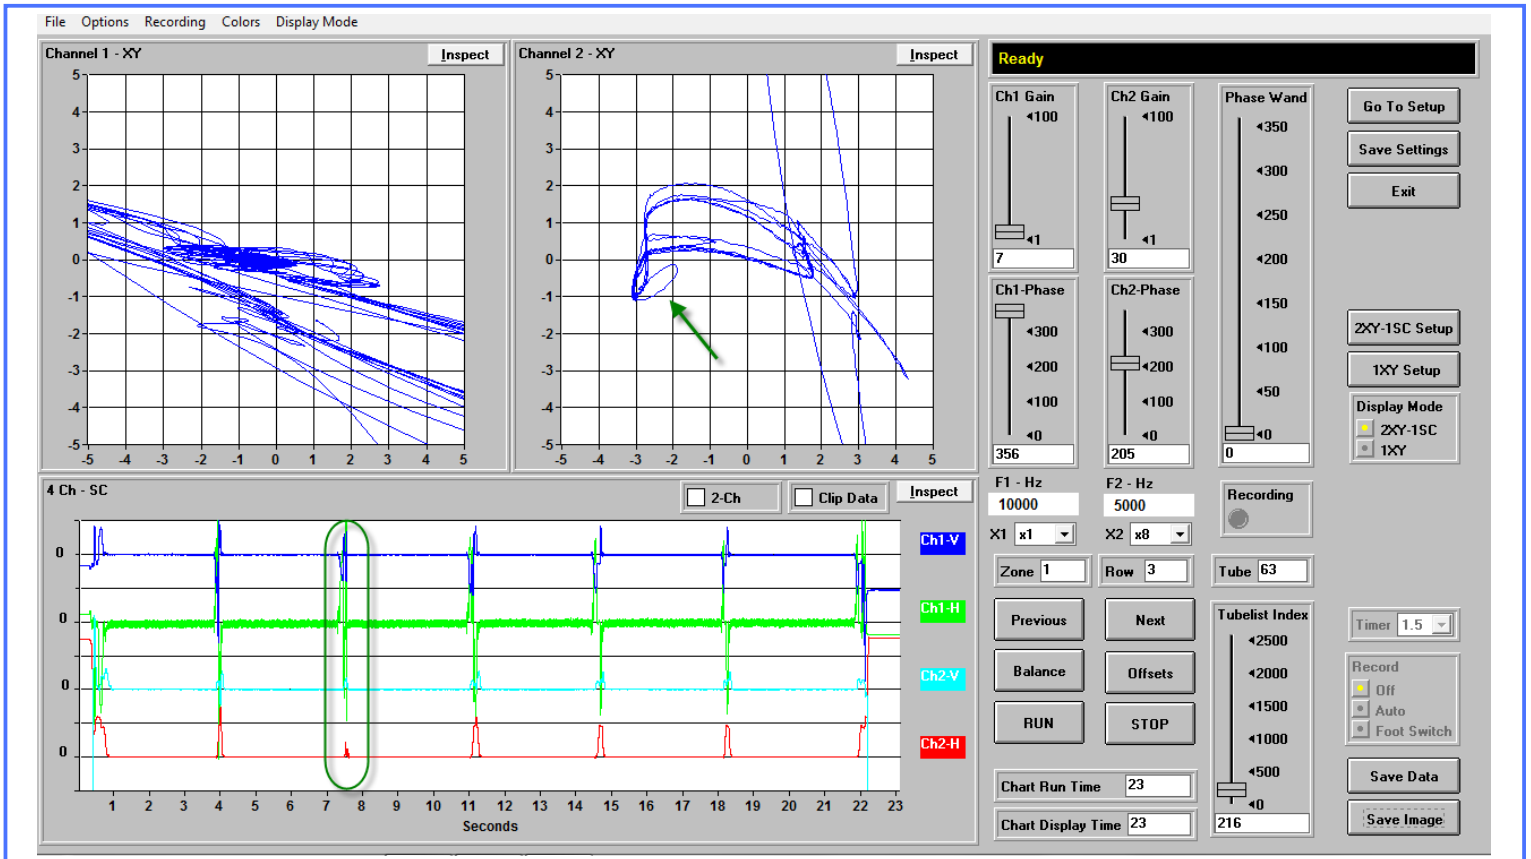
MISSED EXP, NOMINAL (Row 3 Tube 63)

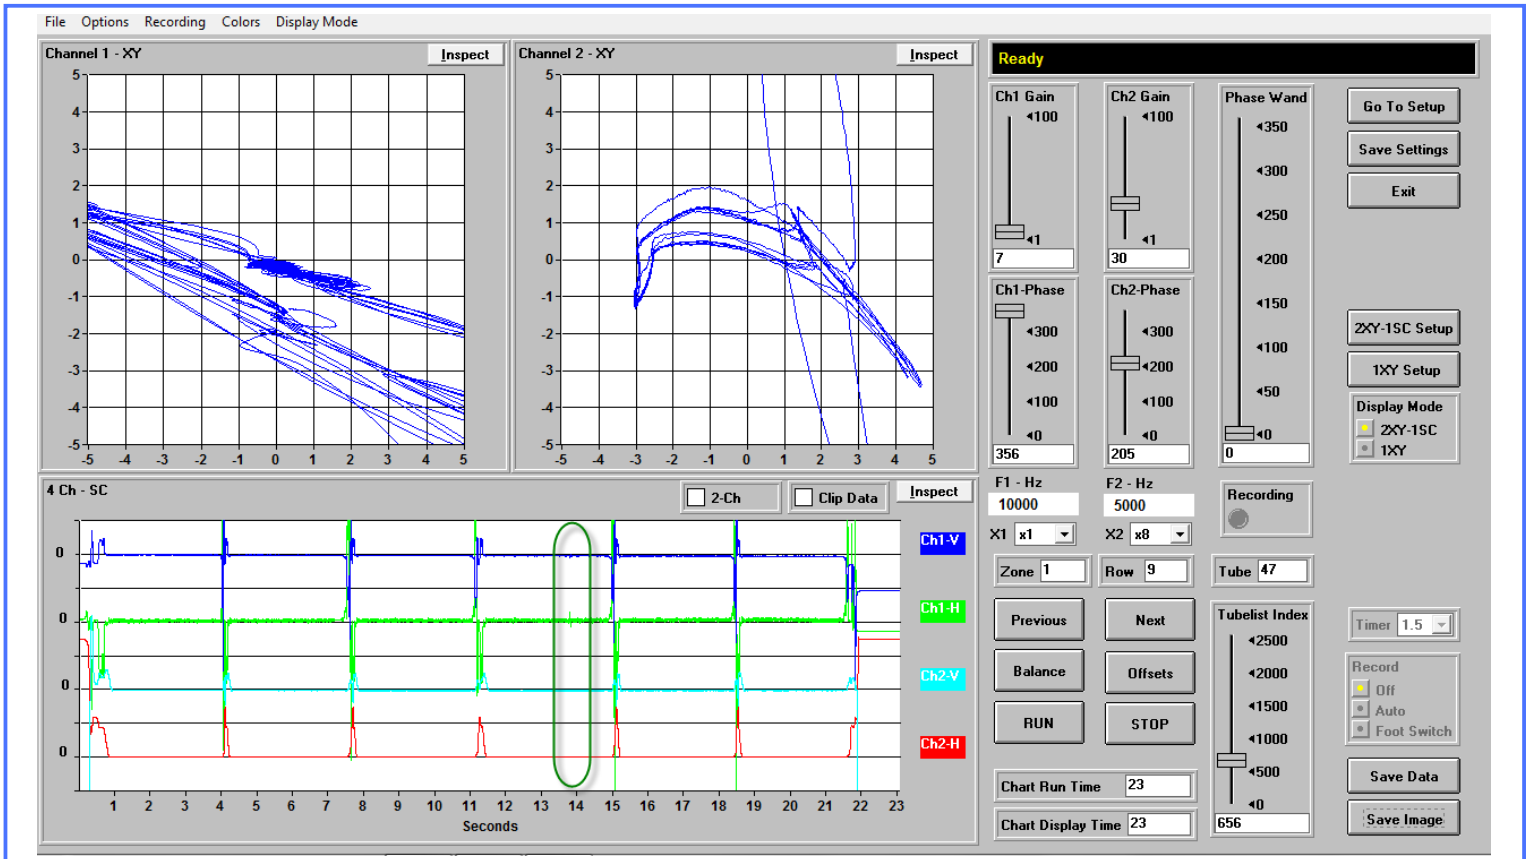
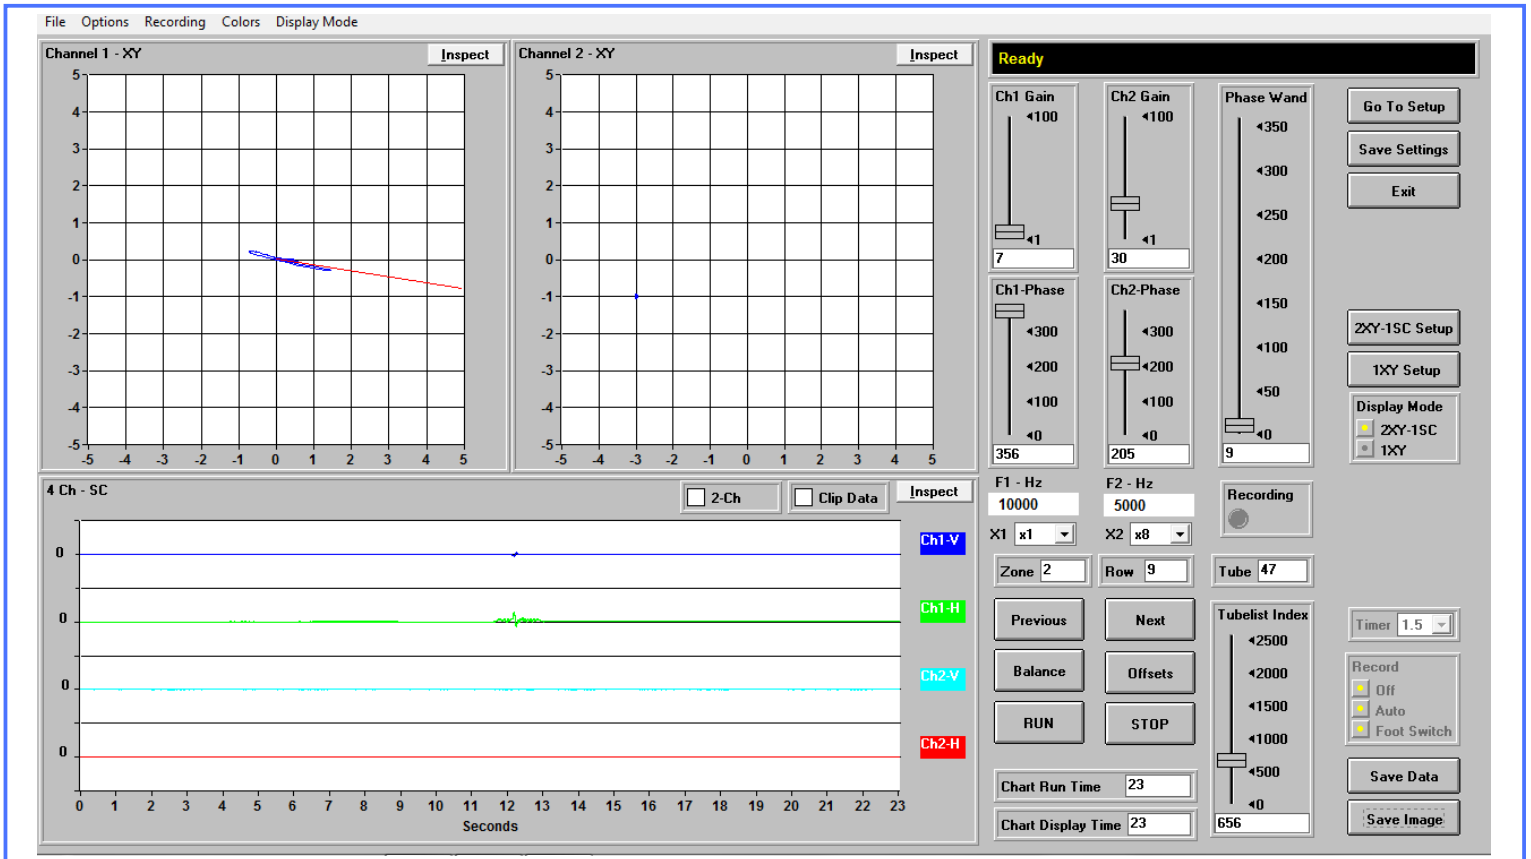
ID PIT 20% - 39% (Row 9 Tube 47)

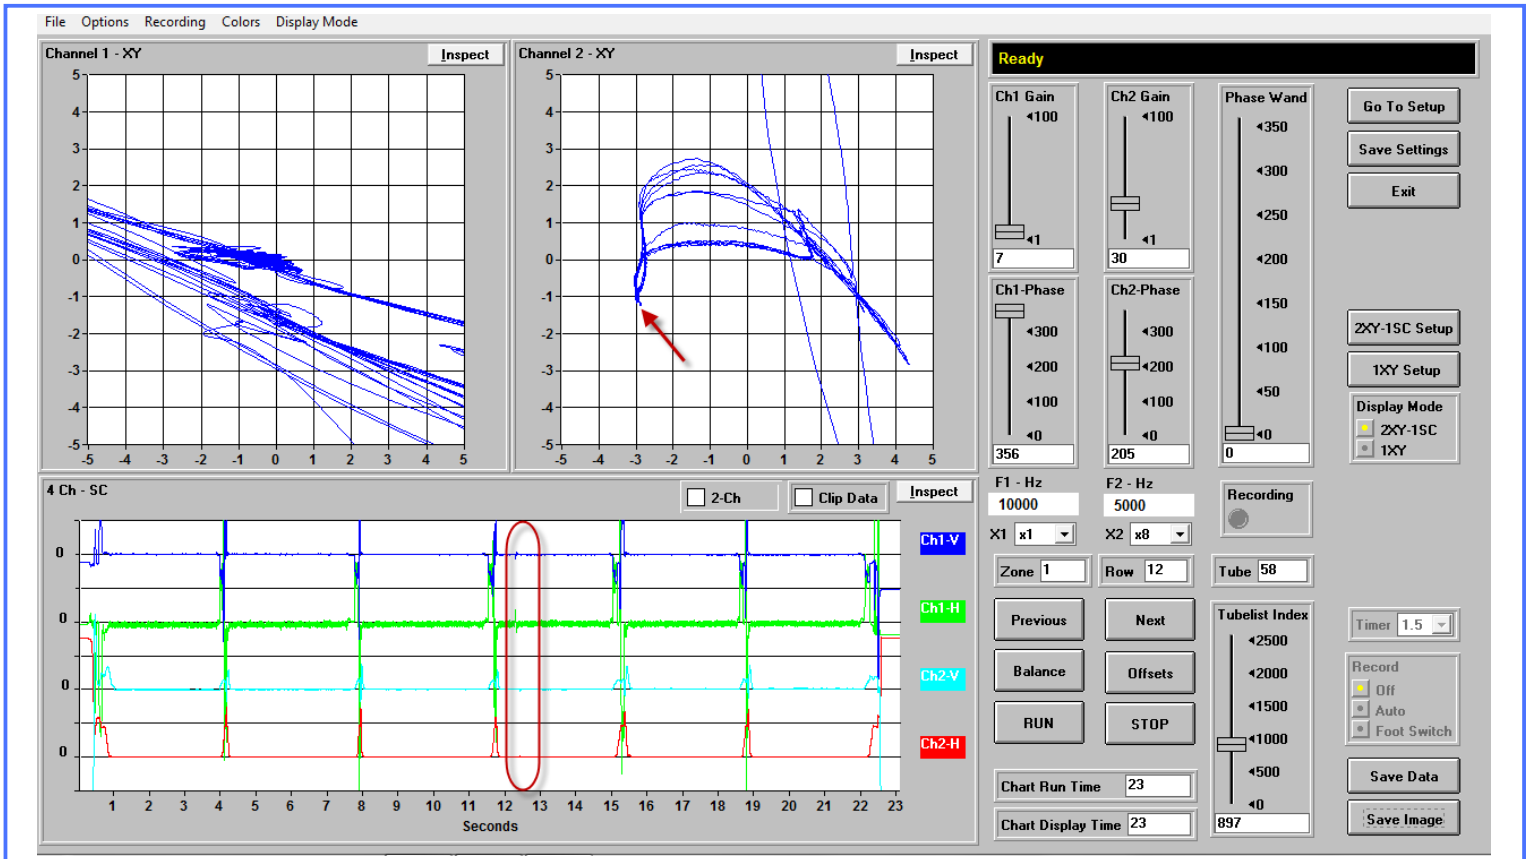
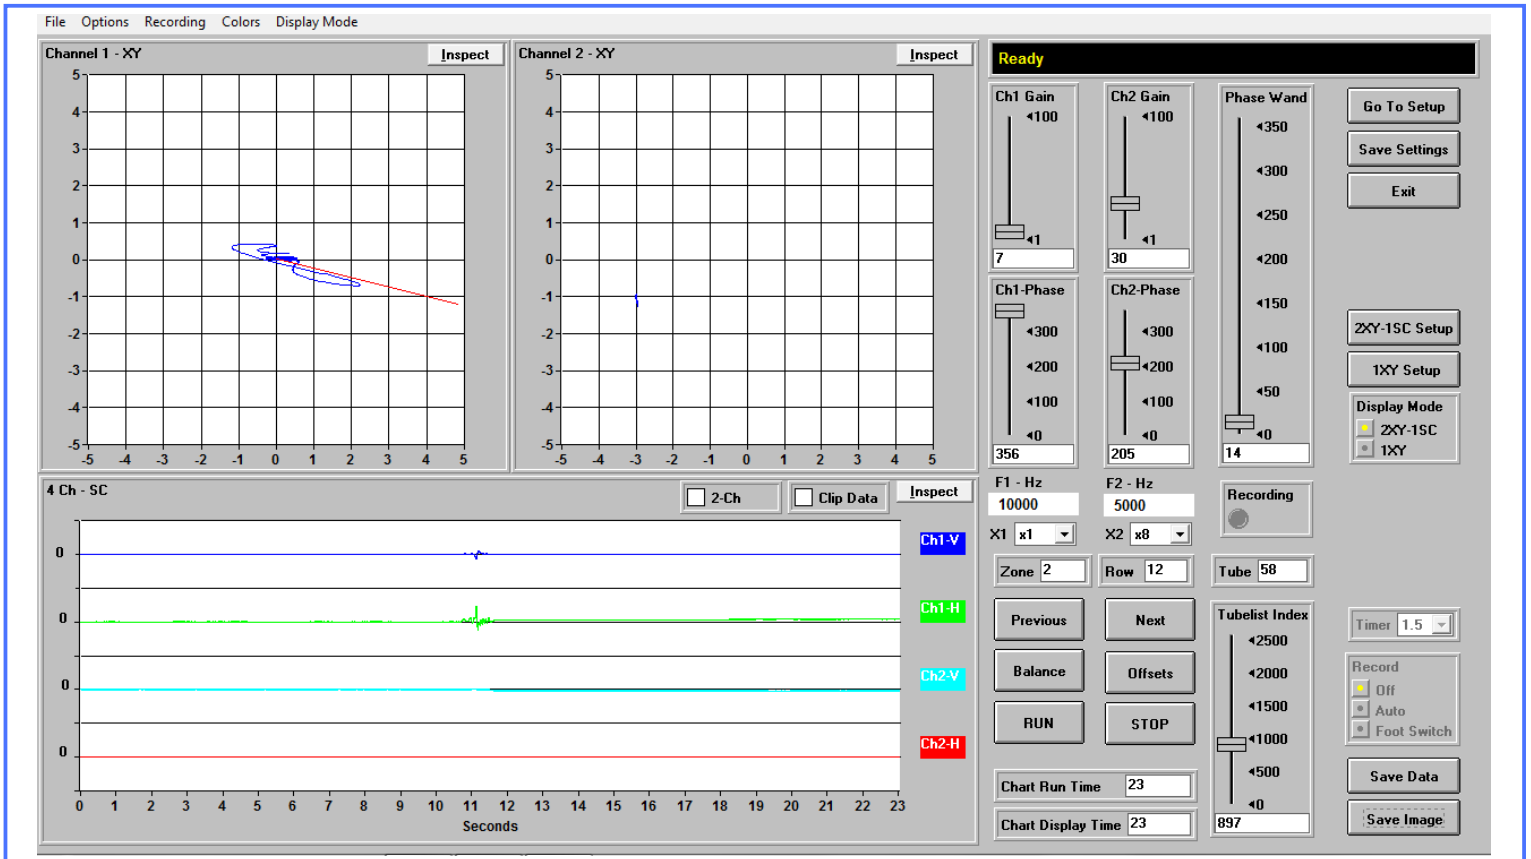
ID PIT 40% - 59% (Row 12 Tube 58)

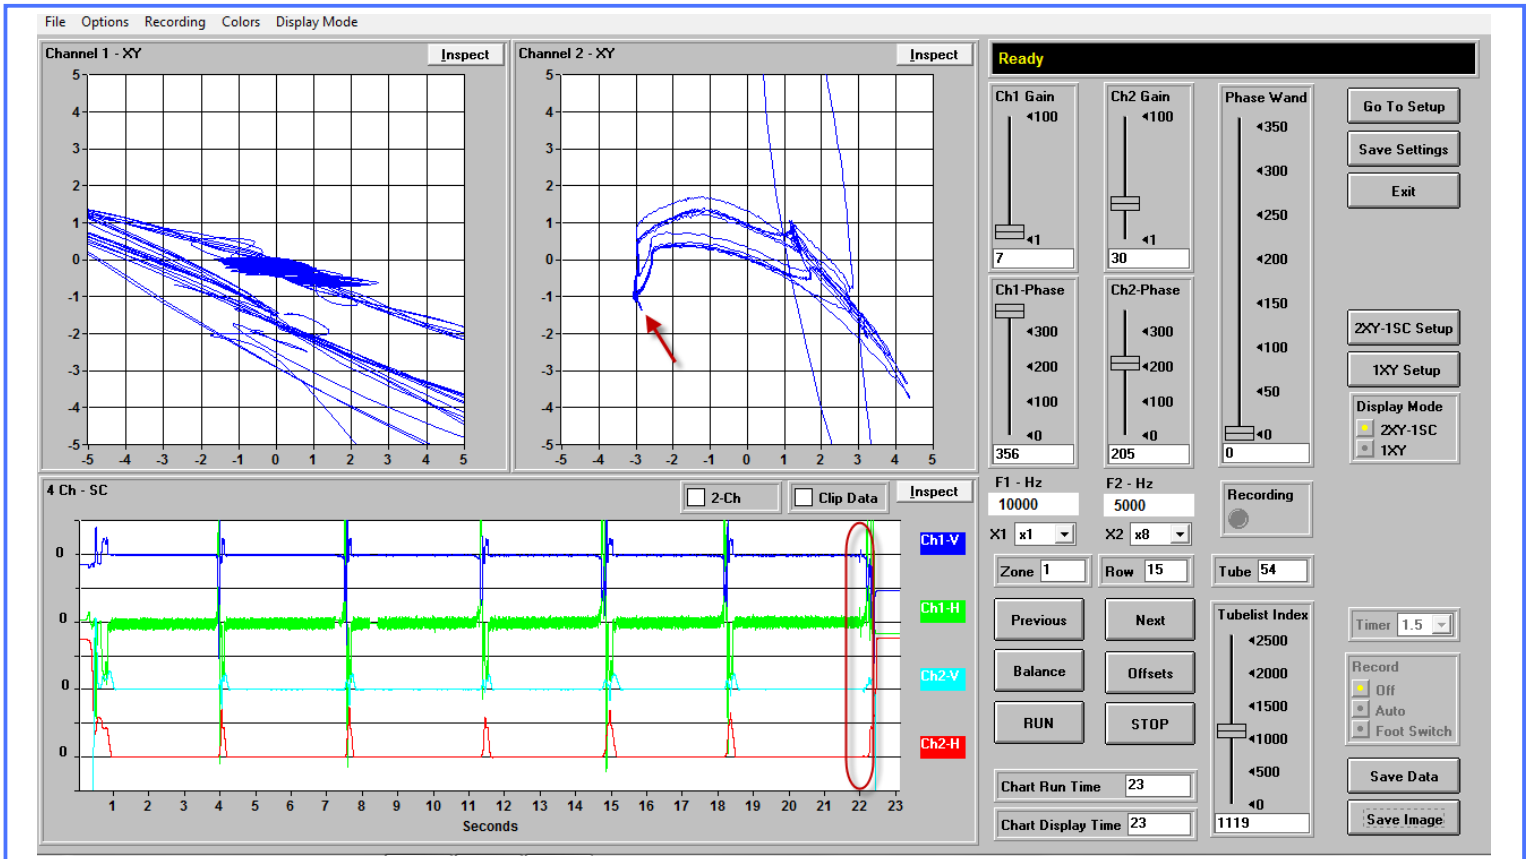
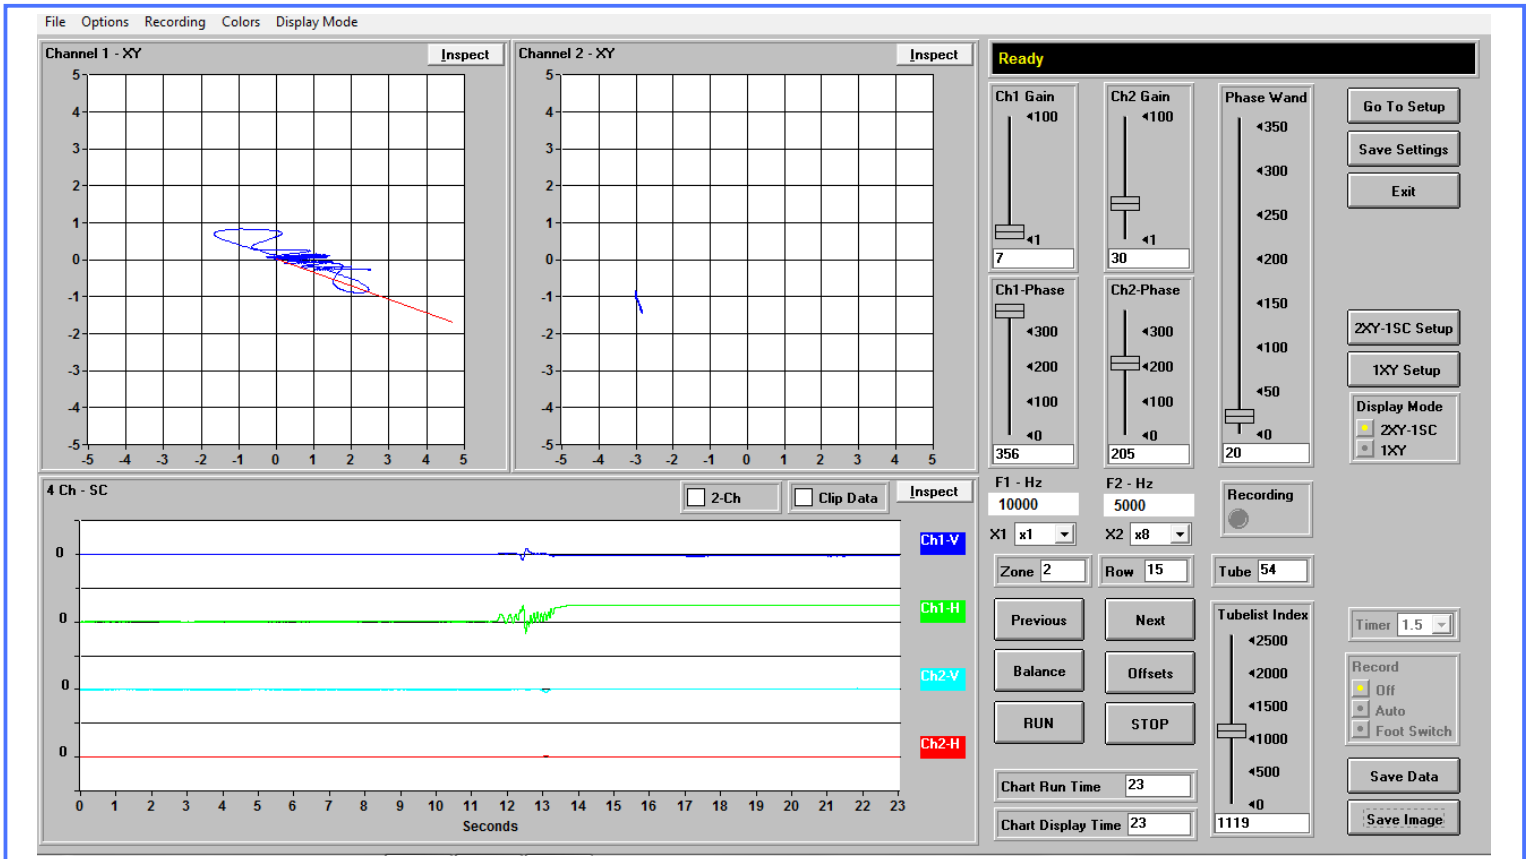
ID PIT 60% - 79% (Row 15 Tube 54)
