## Report of Eddy Current Inspection

Manufacturer: Carrier

Model: 17DA743

Location: DUPONT EXPERIMENTAL STATION  
200 POWER MILL ROAD  
BUILDING 315  
WILMINGTON, DE 19803

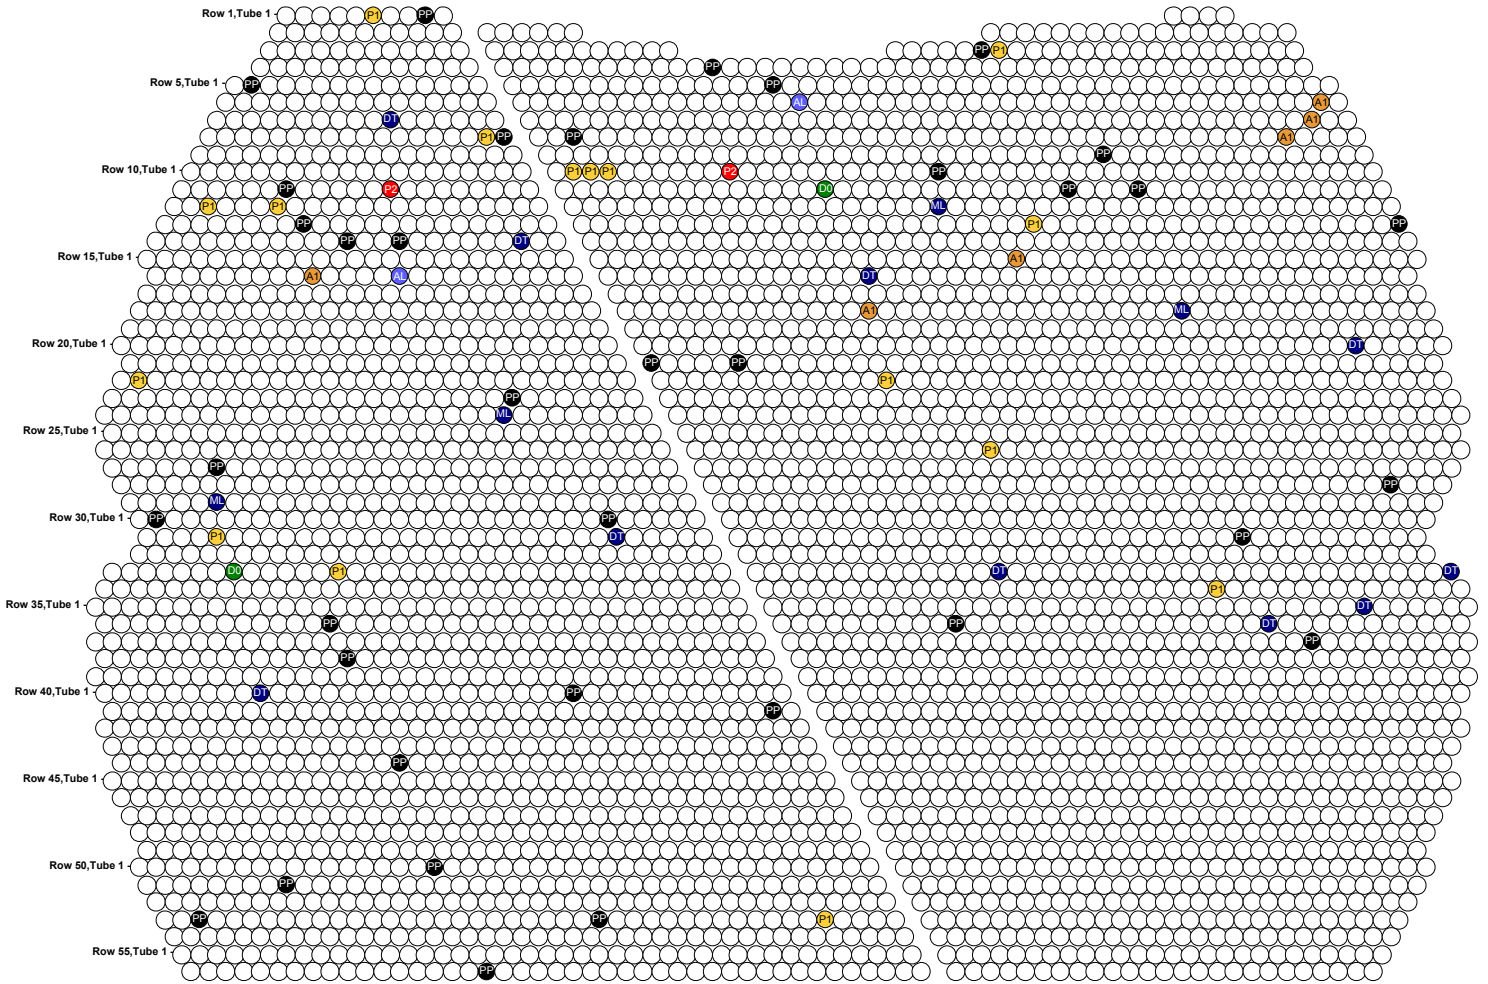
# Condenser Section

● = ID PIT 40% - 59% **REQUIRES ACTION**

Tubes indicating ID Pits of 40% or more should be isolated from the system at this time. ID Pits of less than 40% require no immediate corrective action. However, this type damage is usually progressive and should be monitored.

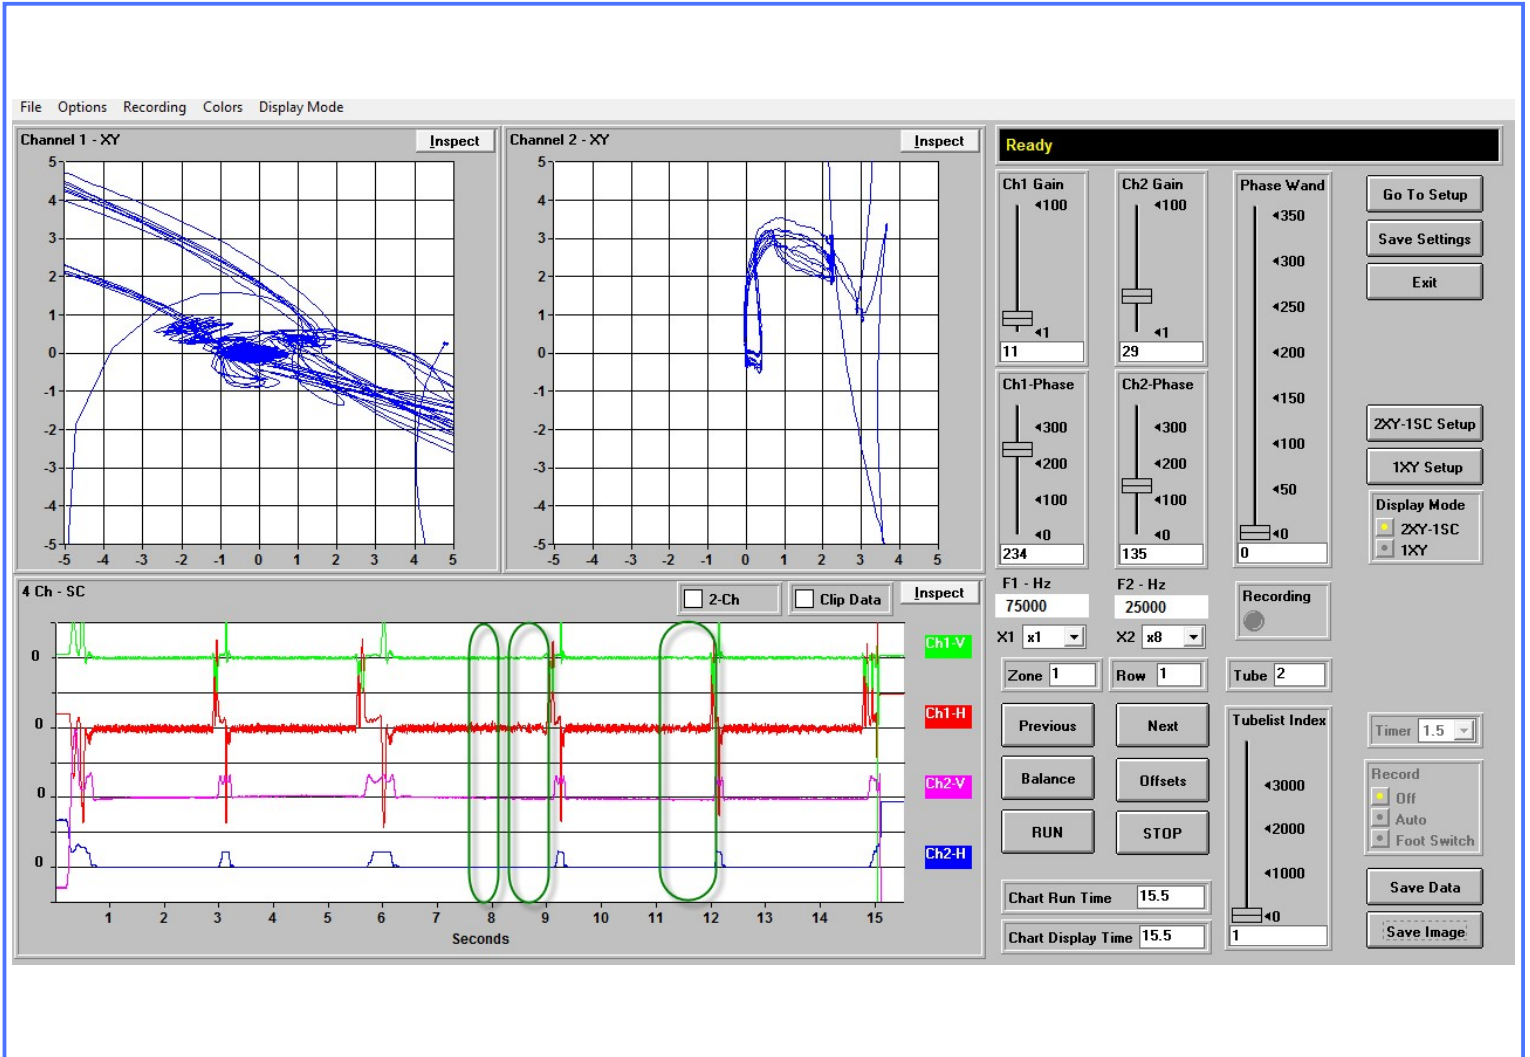
NOTE: Although not marked, the majority of tubes gave indications of minor generalized ID Corrosion and Pitting. Only those tubes giving indications greater than 20% or more were marked in order to keep the tube chart neat and legible and to better illustrate more critical damage.

NOTED ID DAMAGE (Row 1 Tube 2)

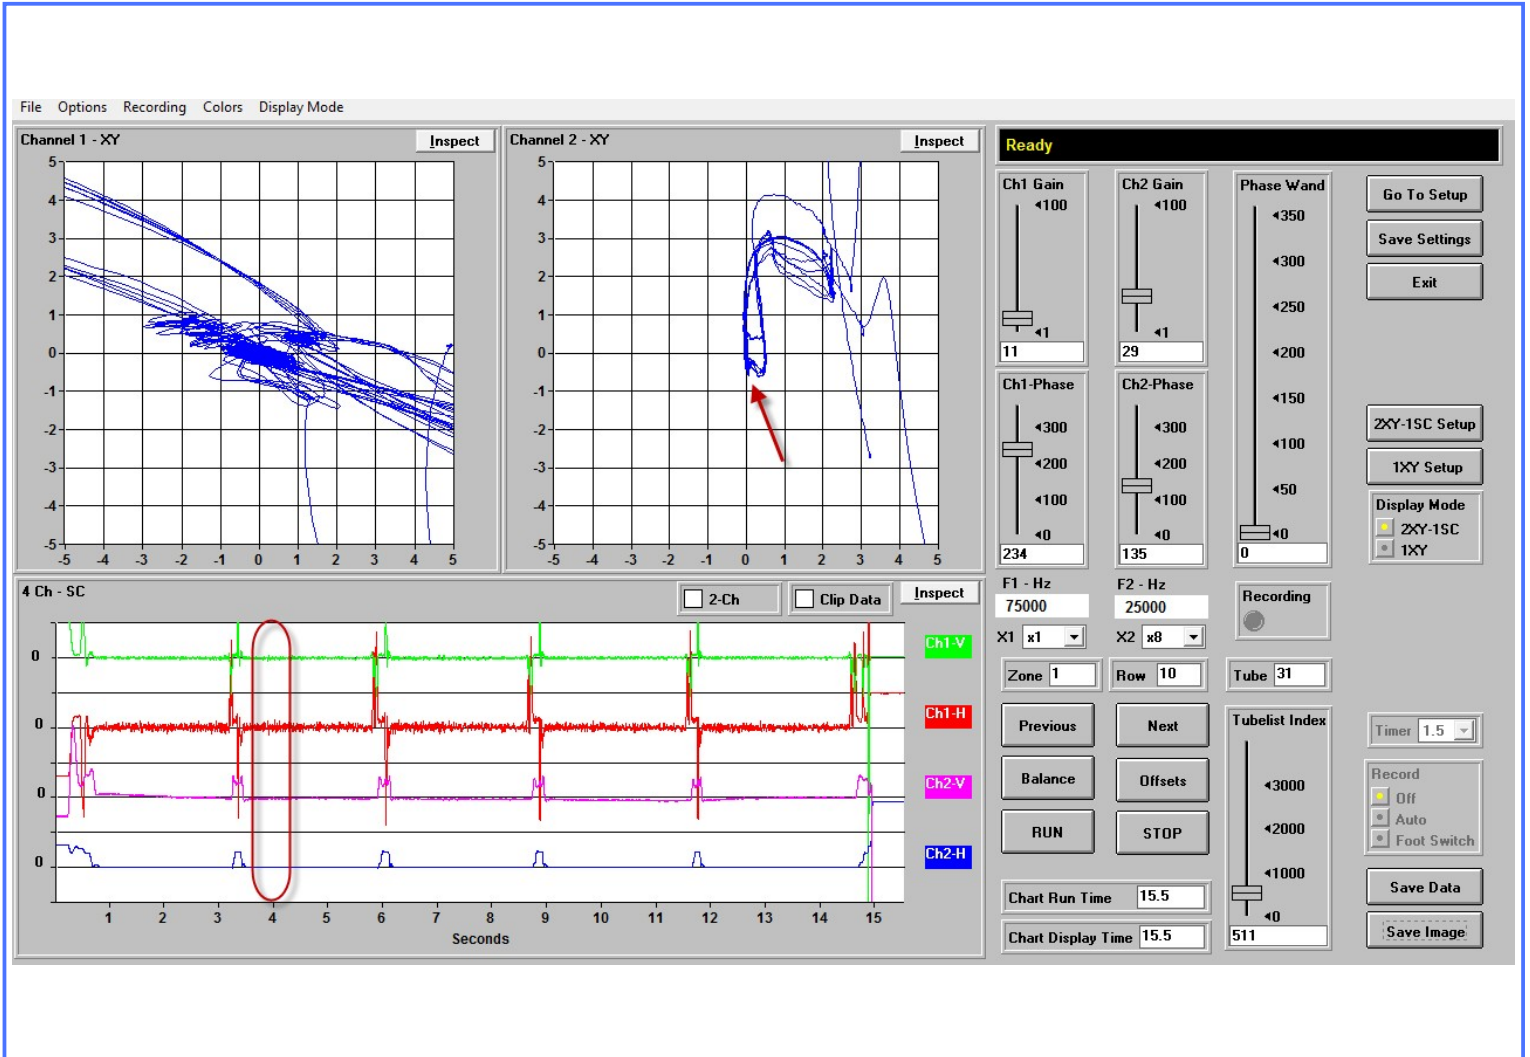
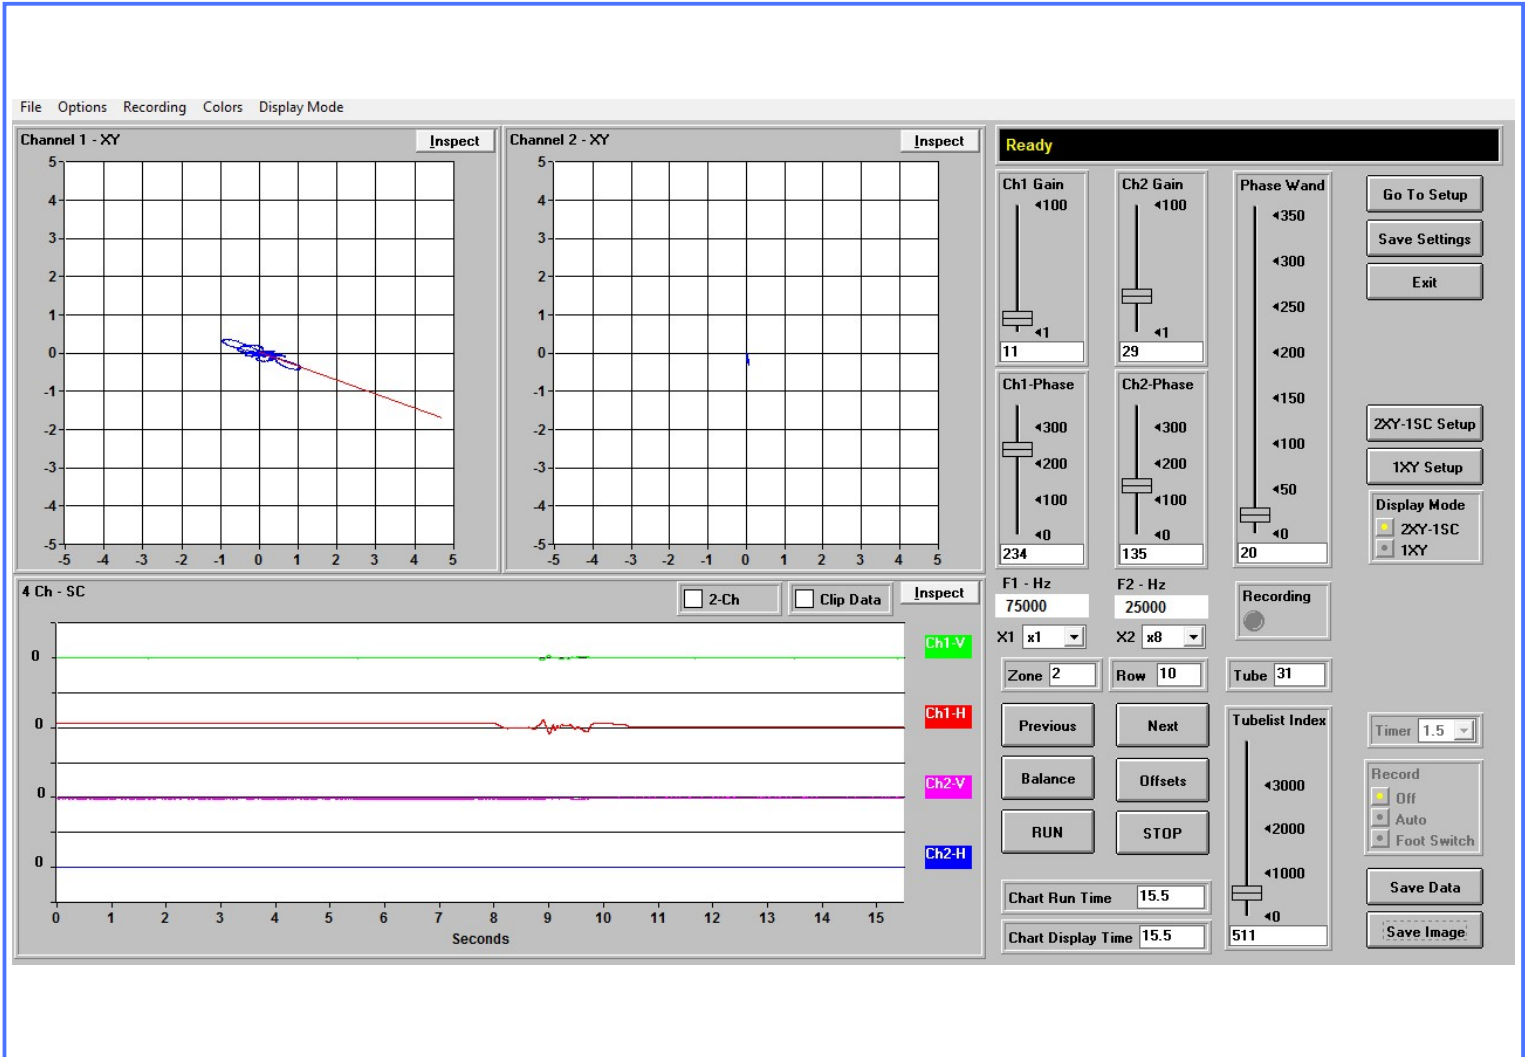
ID PIT 40% - 59% (Row 10 Tube 31)

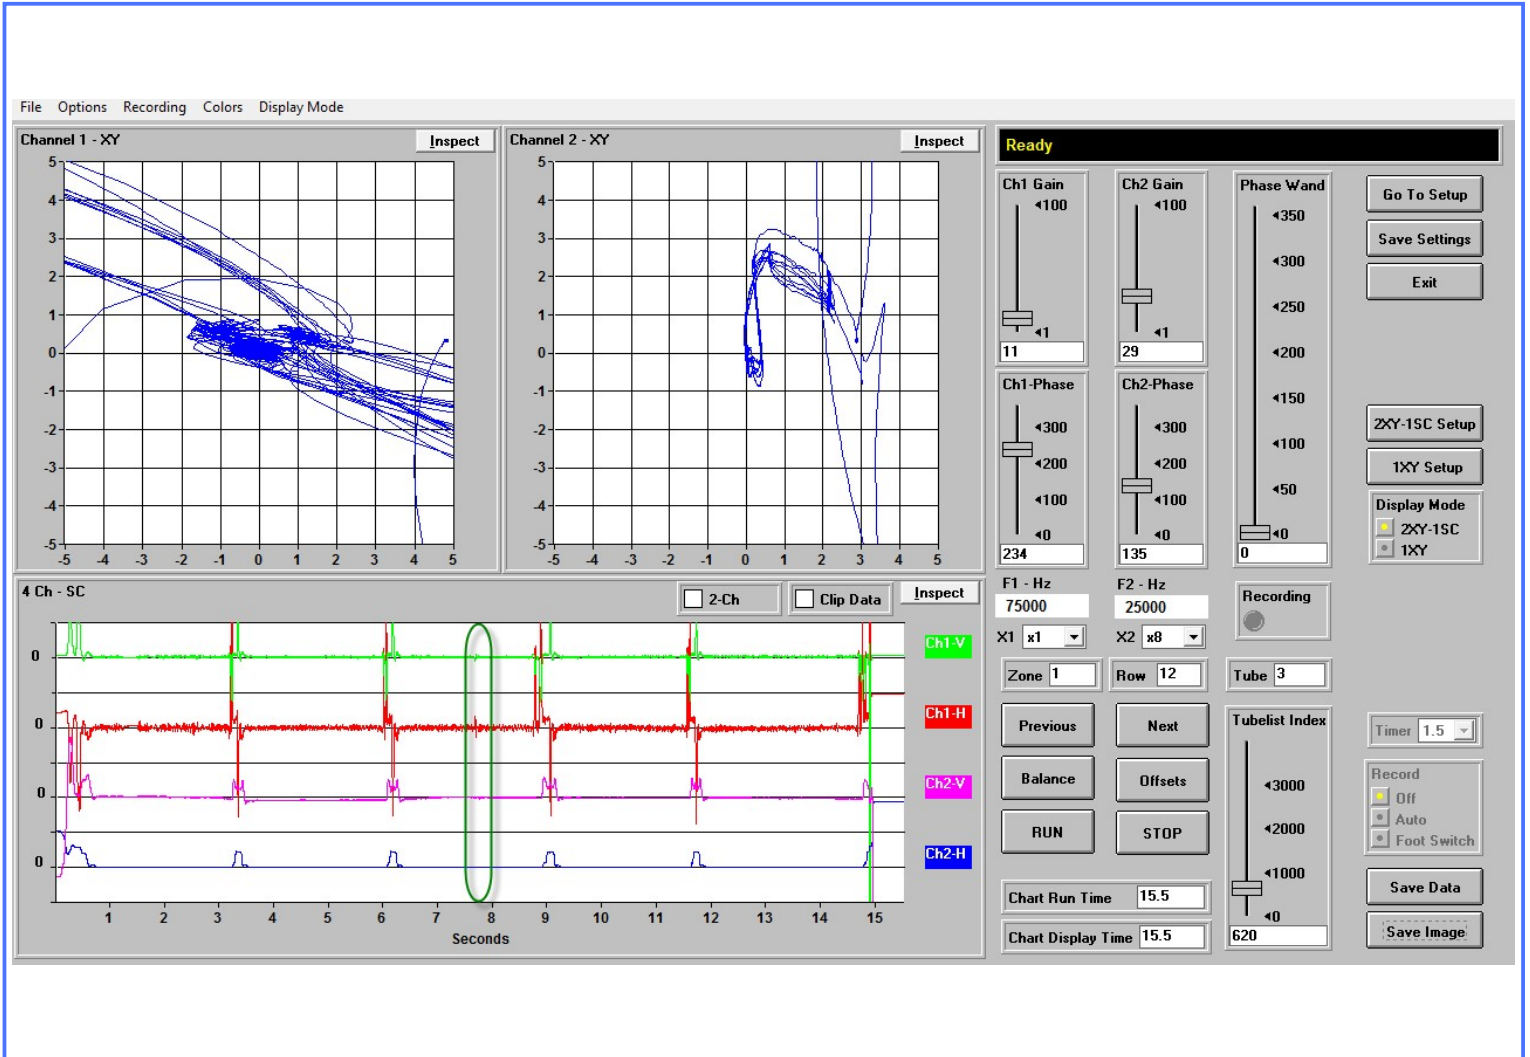
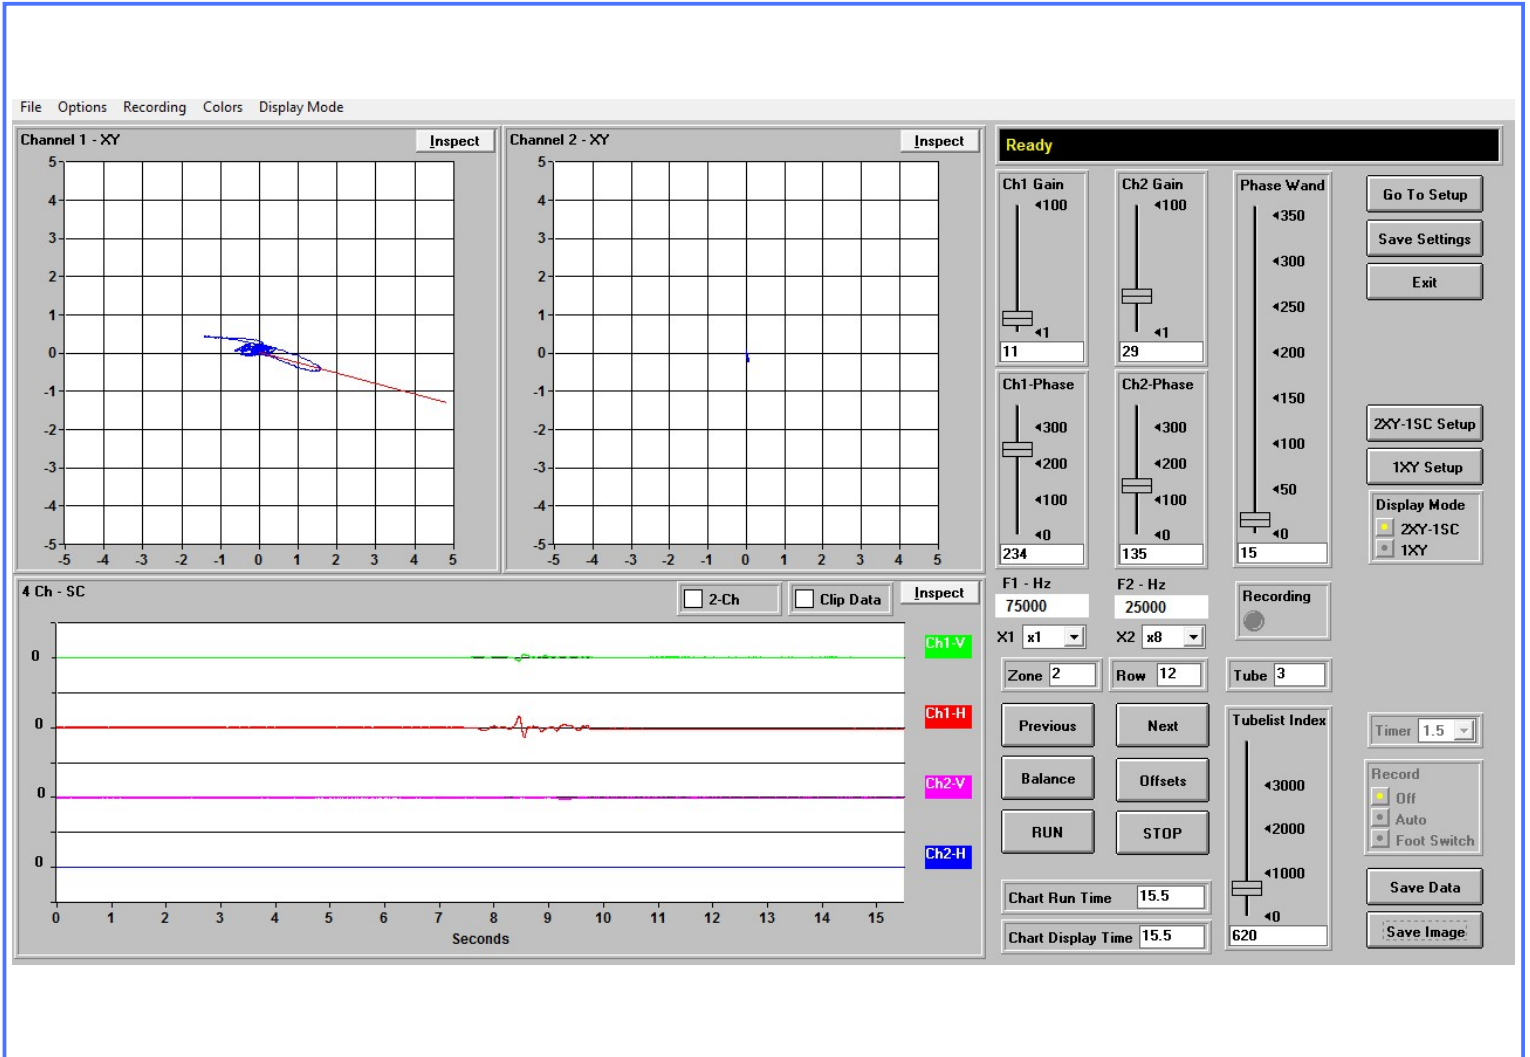
ID PIT 20% - 39% (Row 12 Tube 3)

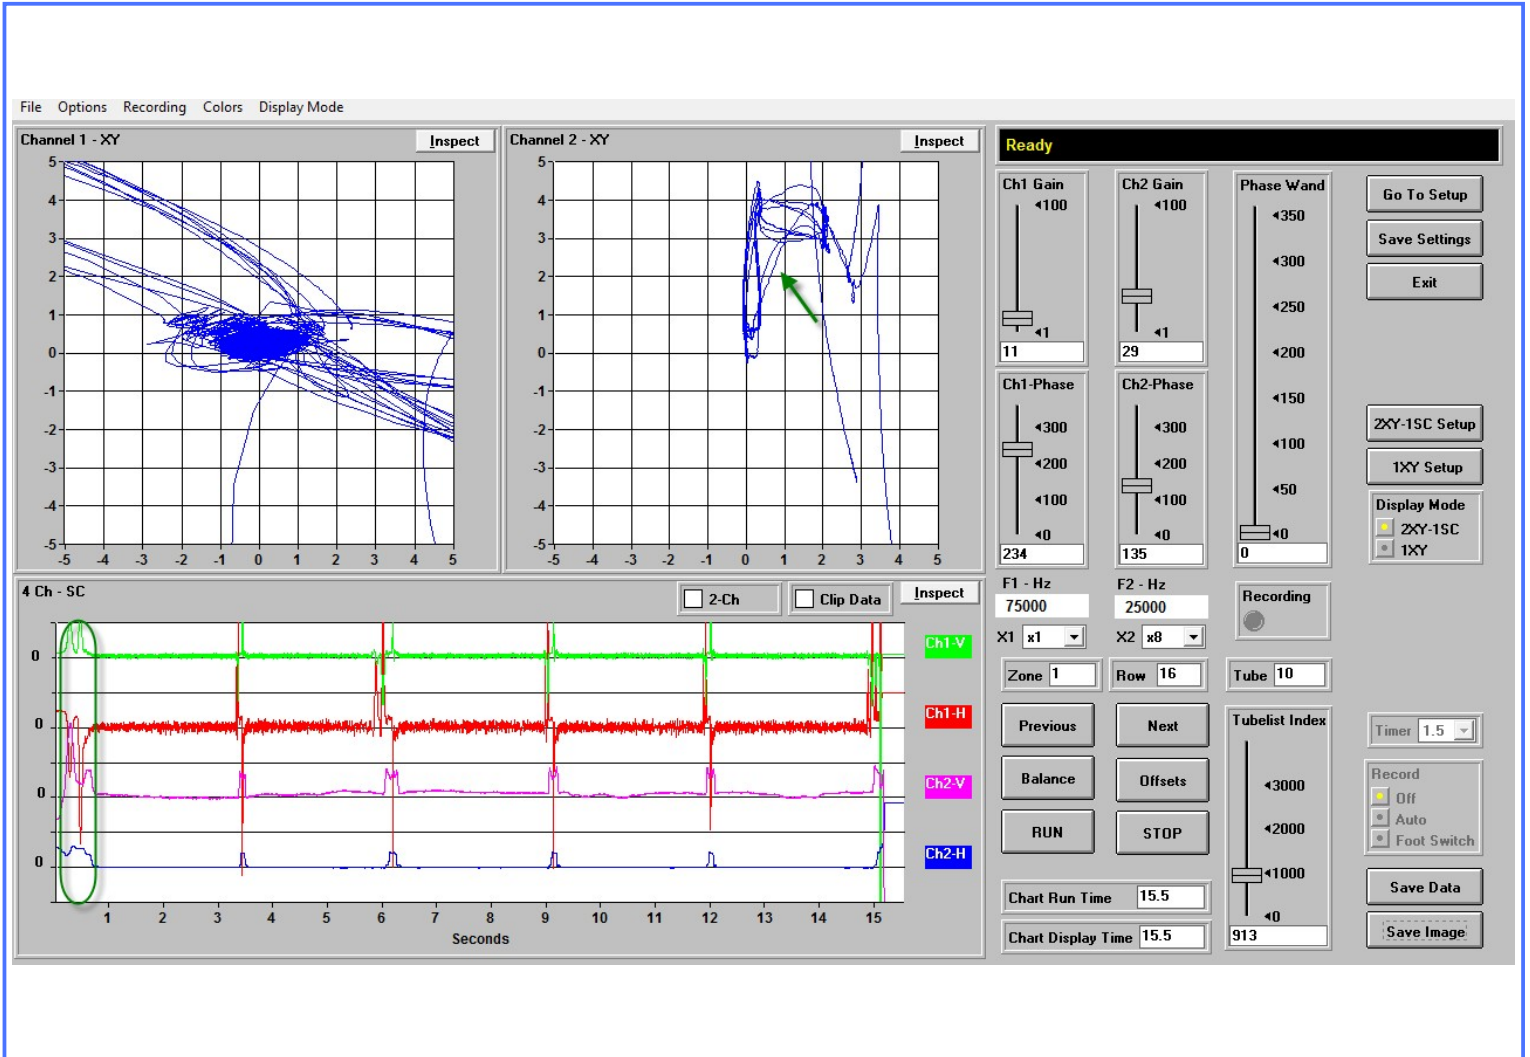
Tubes indicating Abnormal Bell End Indications require no corrective action at this time. The indications are that of minor thinning at the Bell End. The exact cause and description of the anomaly is unknown.

ABN. NOMINAL BELL END (Row 16 Tube 10)

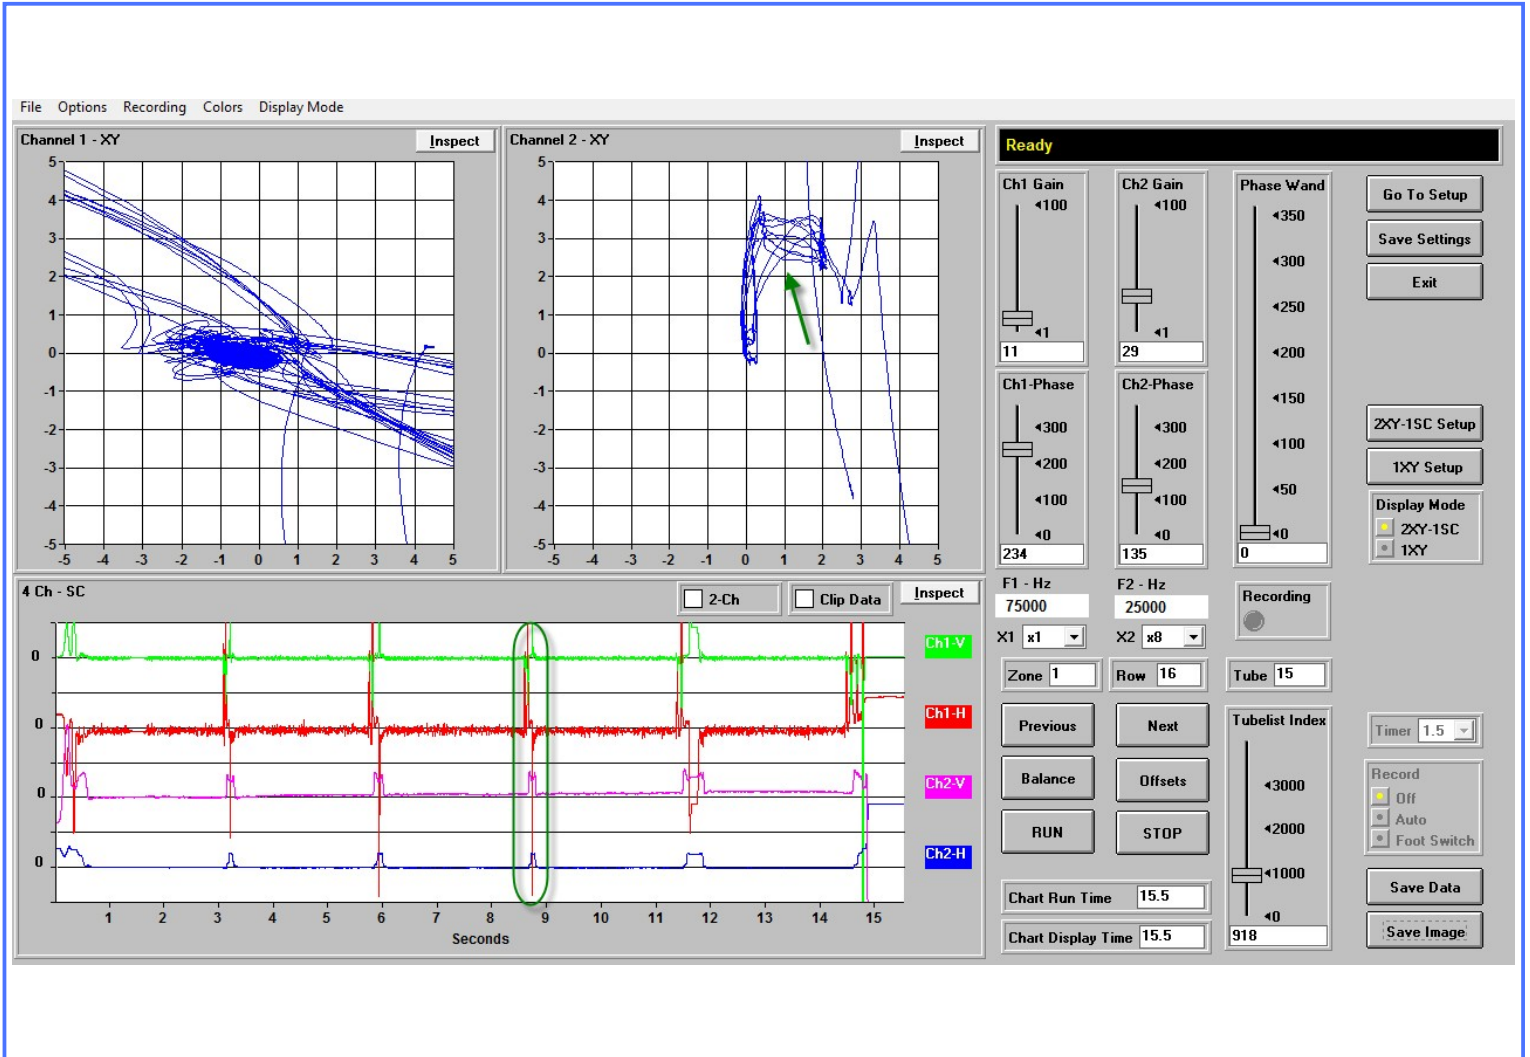
Tubes indicating Abnormal Support Landings require no corrective action at this time. These tubes showed a distorted transition zone at the indicated support. The exact cause of the indication is unknown, but is believed to be the result of manufacturing.

ABNORMAL LAND (Row 16 Tube 15)

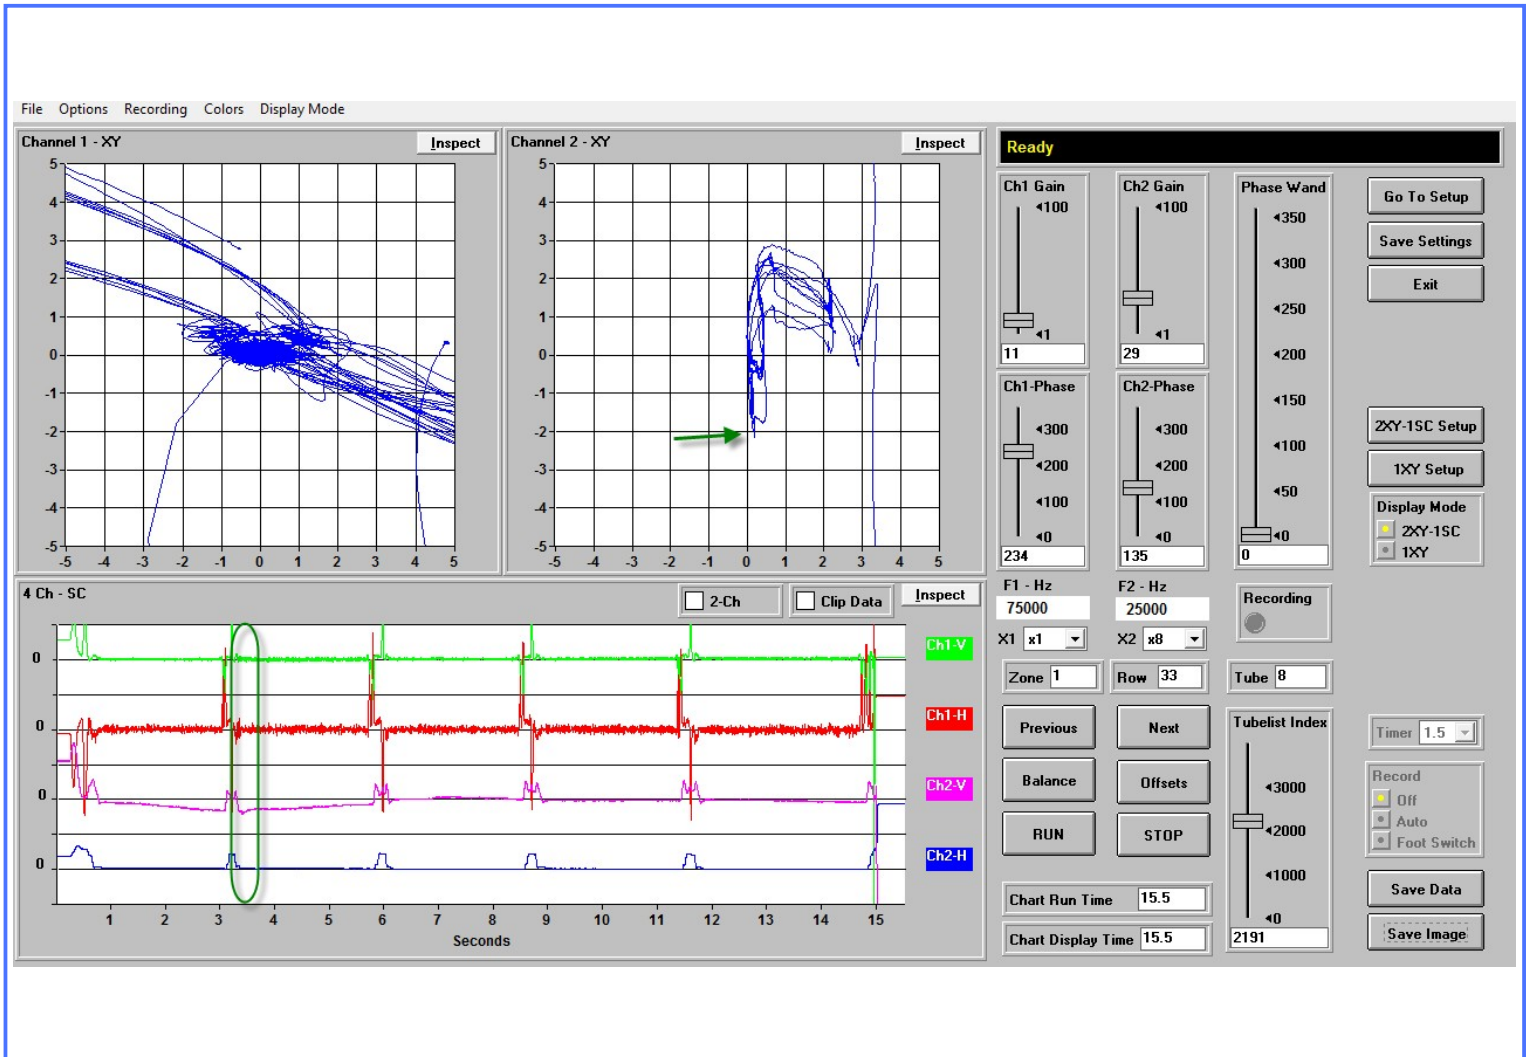
OD DEFECT < 20% (Row 33 Tube 8)

The tubes marked for OD Defects require no corrective action at this time.

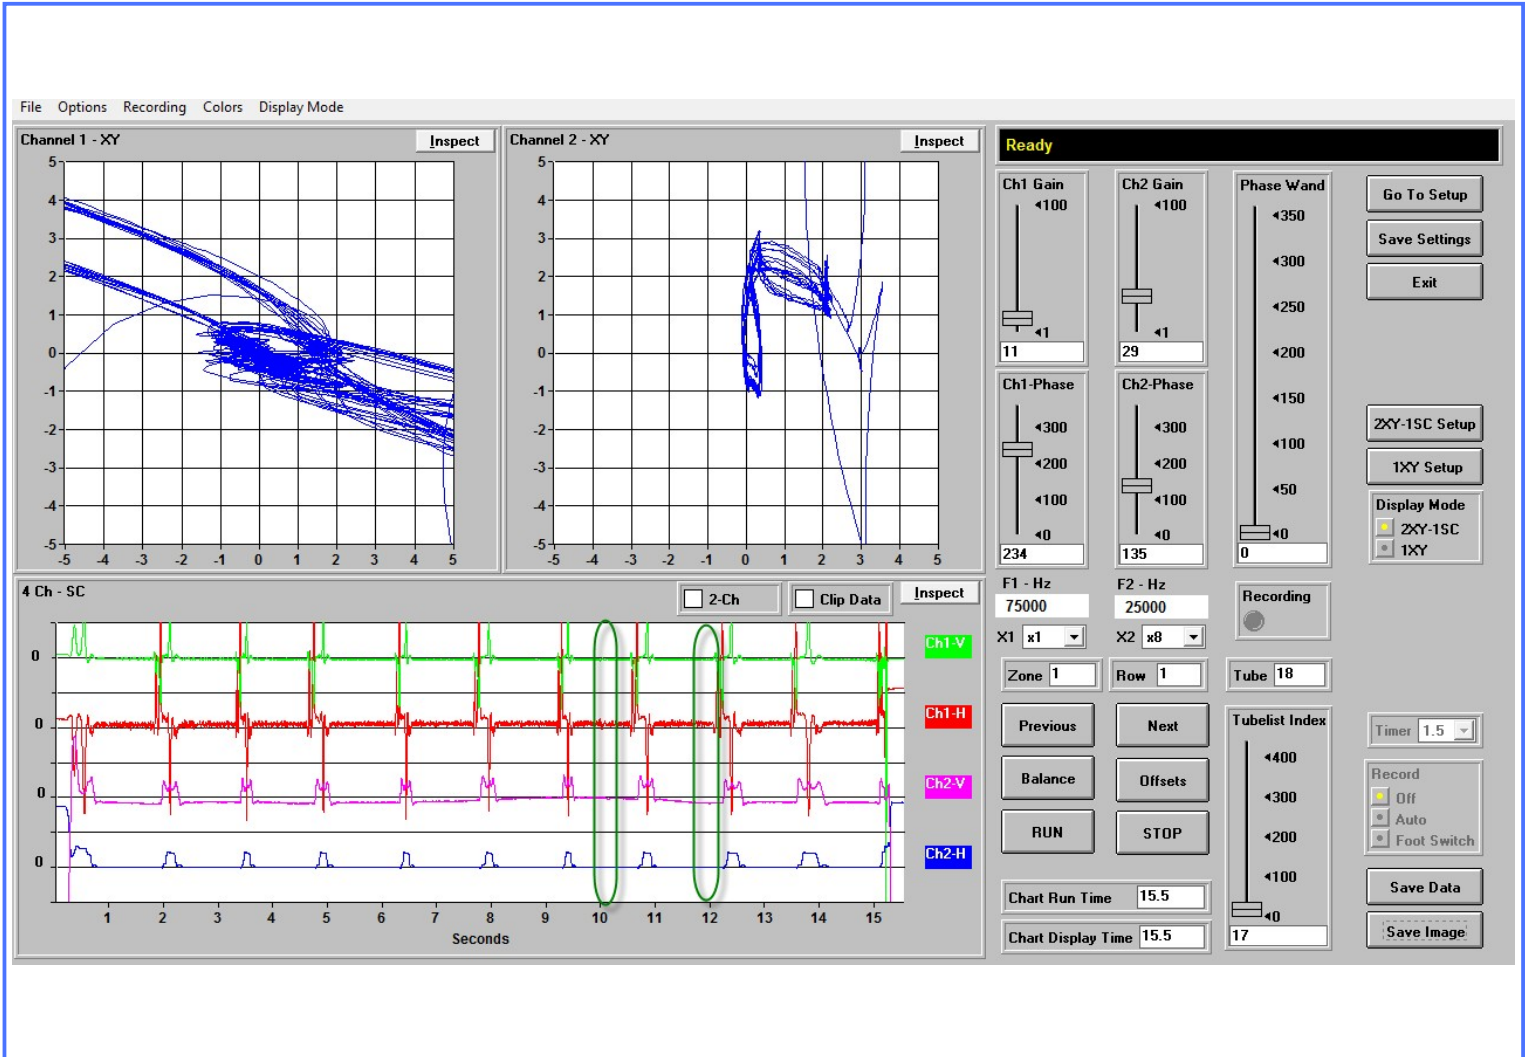
NOTE: Although not marked, all the tubes in this bundle gave indications of minor generalized ID Corrosion and ID Pitting. No individual tubes gave indications of significant damage, and therefore none were marked.

NOTED ID DAMAGE (Row 1 Tube 18)

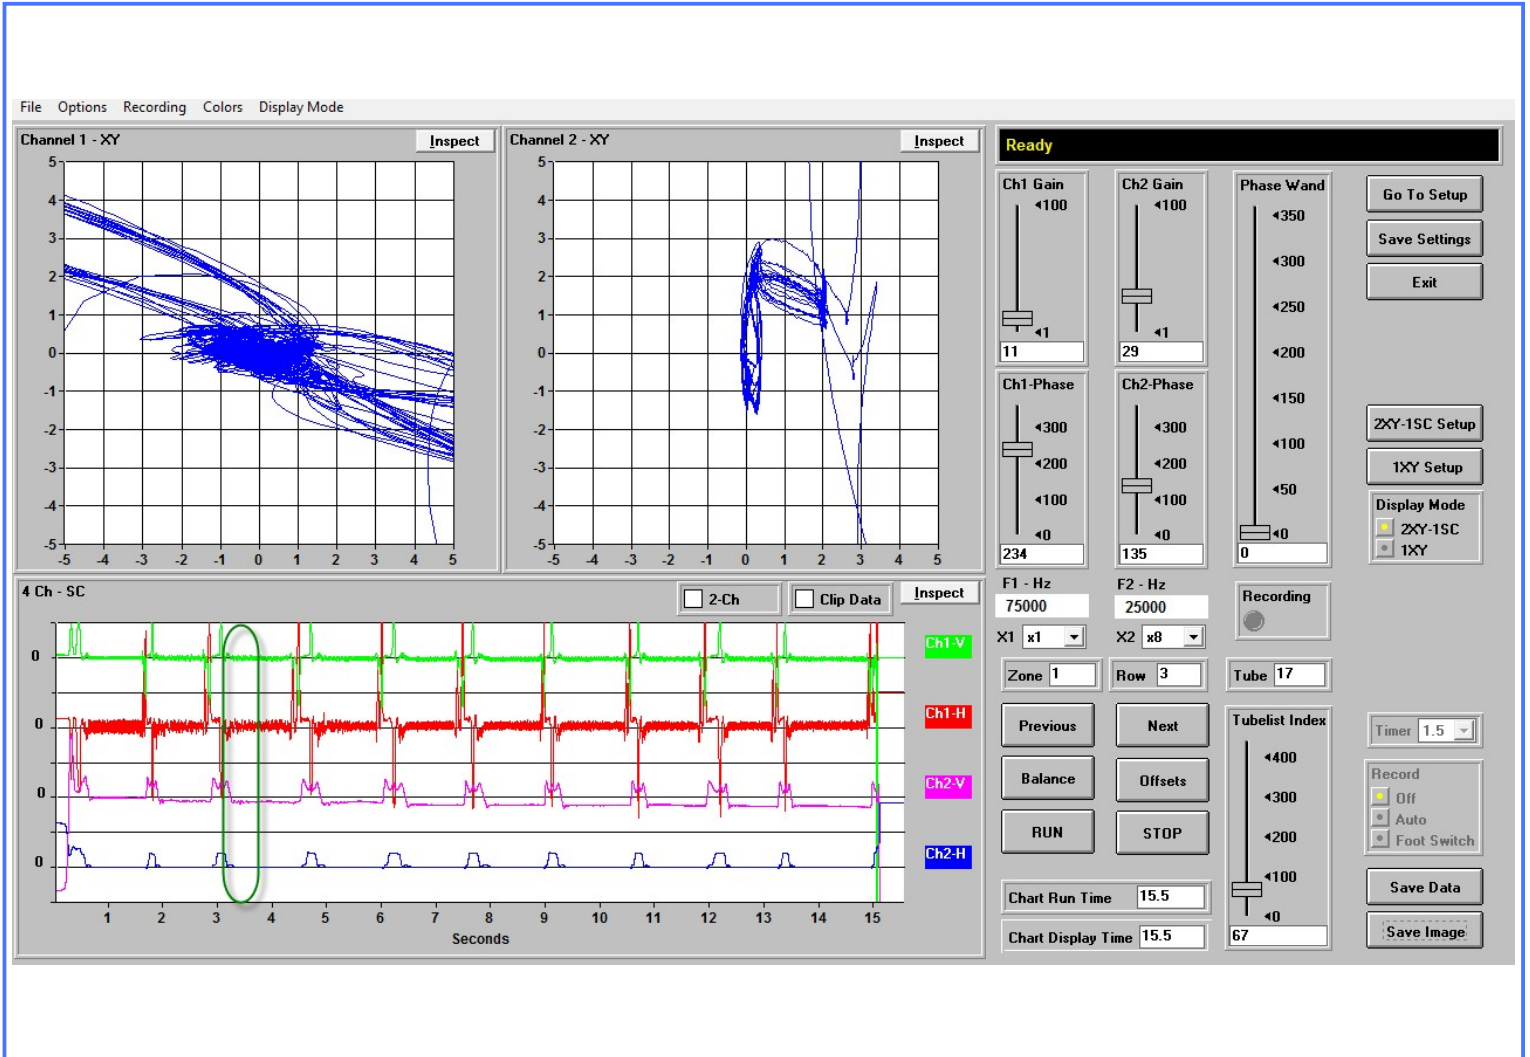
OD DEFECT < 20% (Row 3 Tube 17)

The tubes marked for OD Defects require no corrective action at this time.

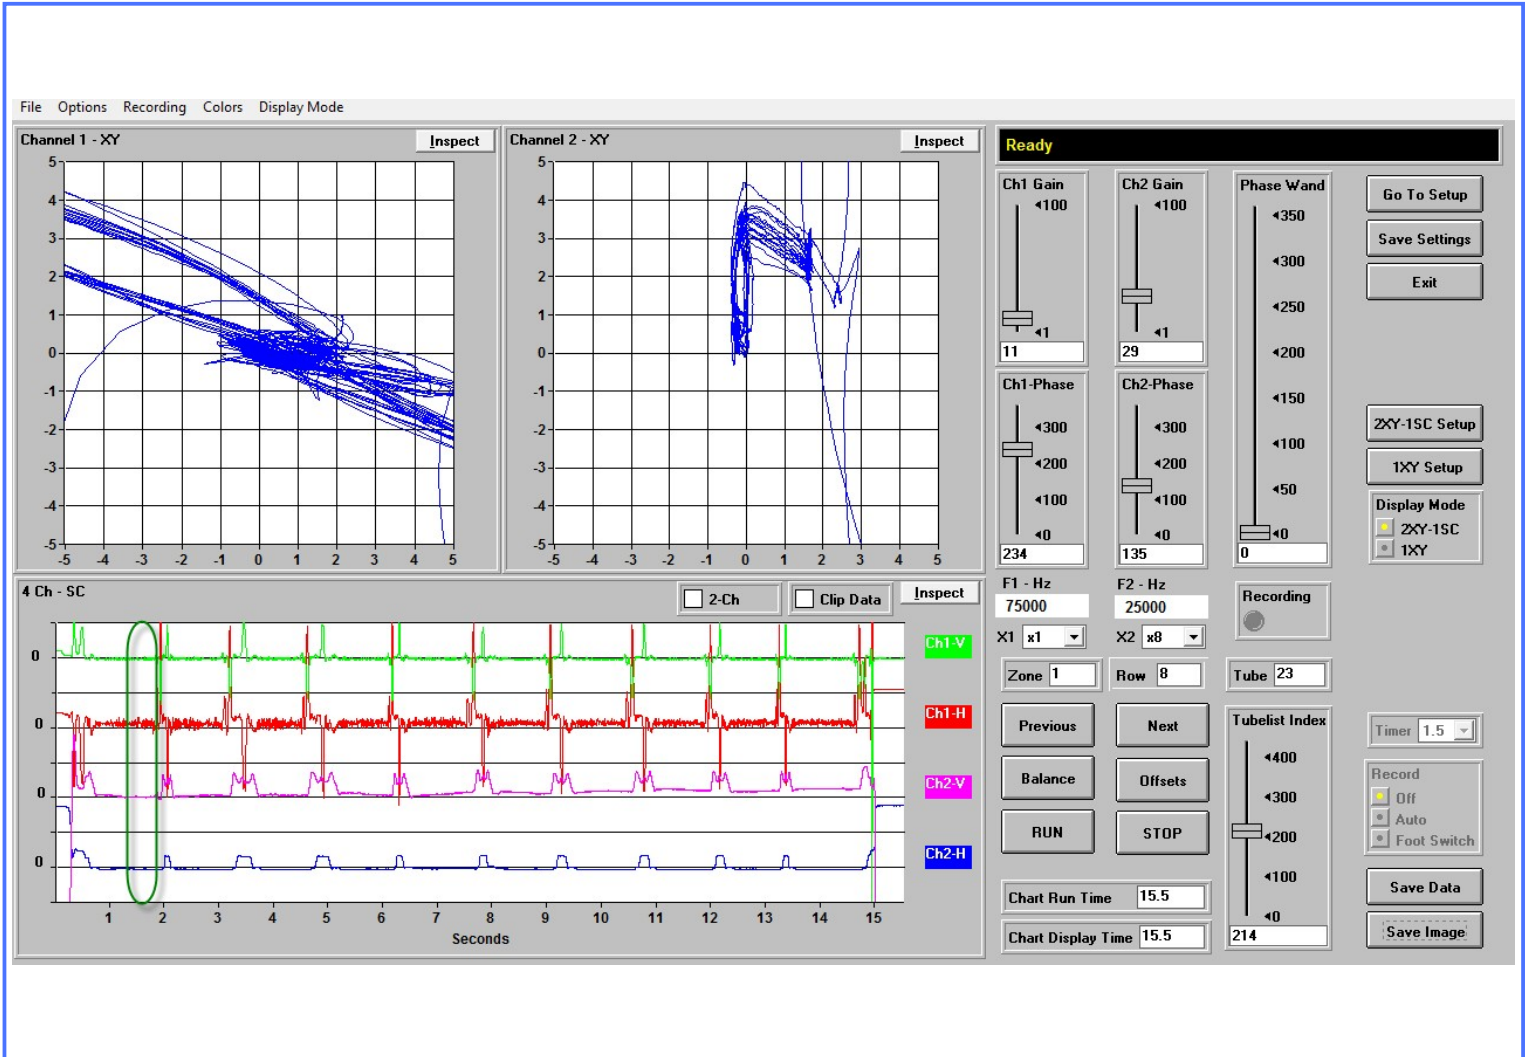
OD DEFECT < 20% (Row 8 Tube 23)

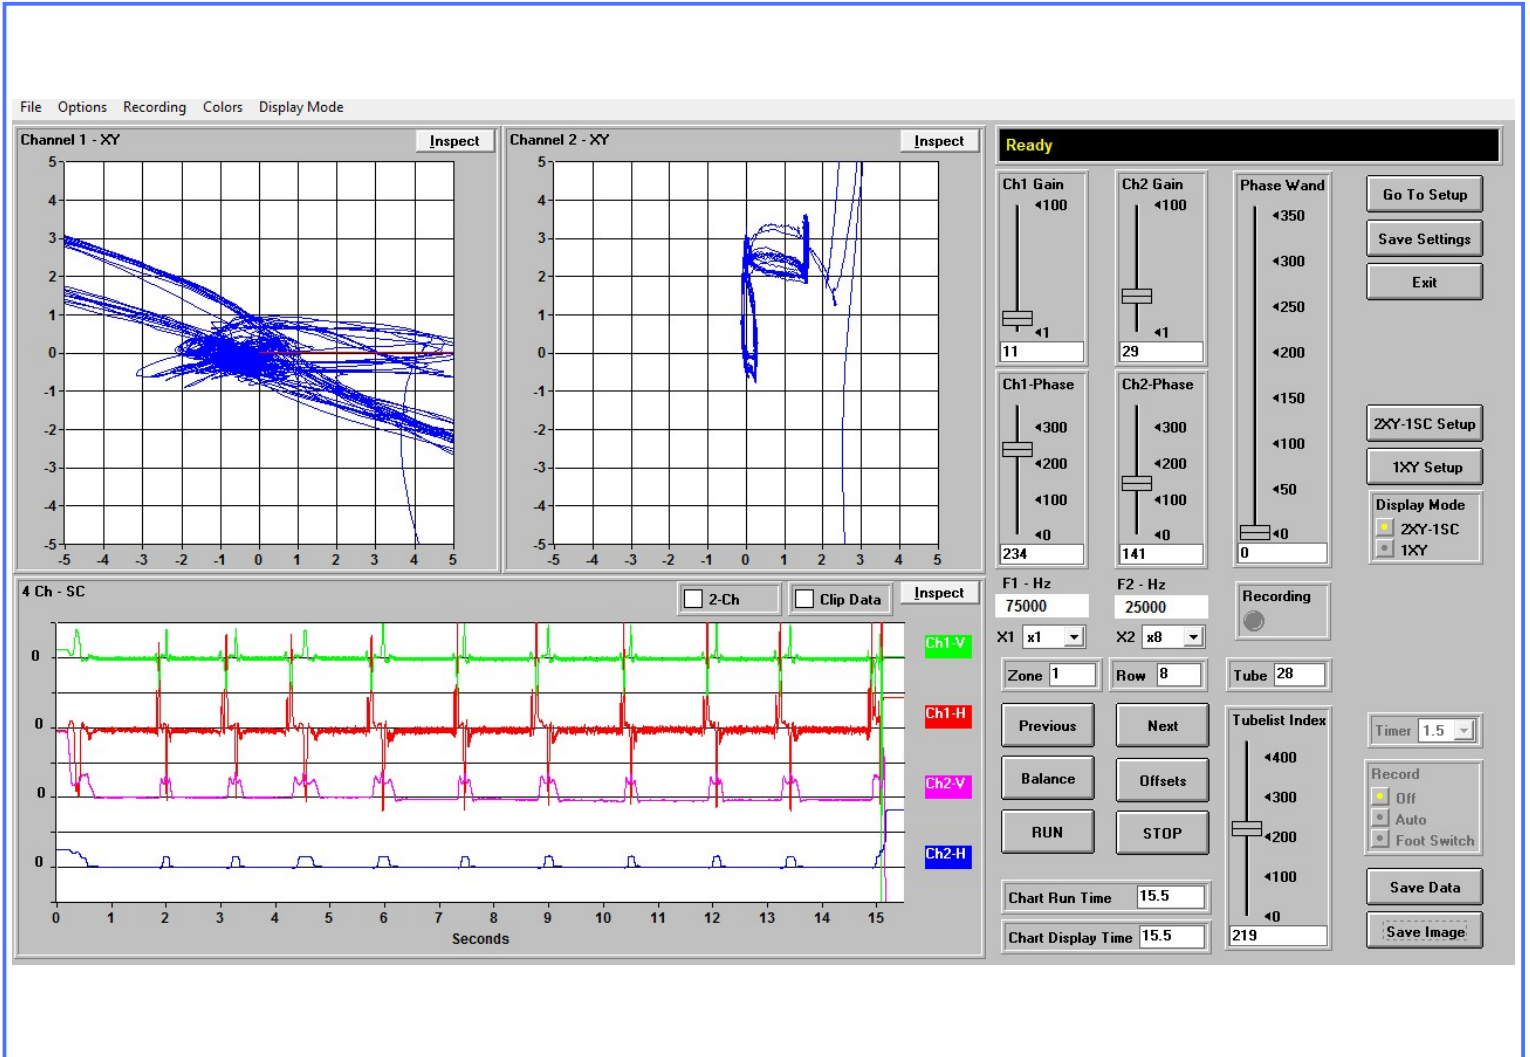
The tube(s) marked as "Different Tube Type" were .750/.042/.028 CuNi tubes. The test instrument was calibrated, and standard procedures were followed for this tube type and alloy. These tubes showed no measurable indications of tube damage and were marked for information purposes only.

DIFFERENT TUBE TYPE (Row 8 Tube 28)

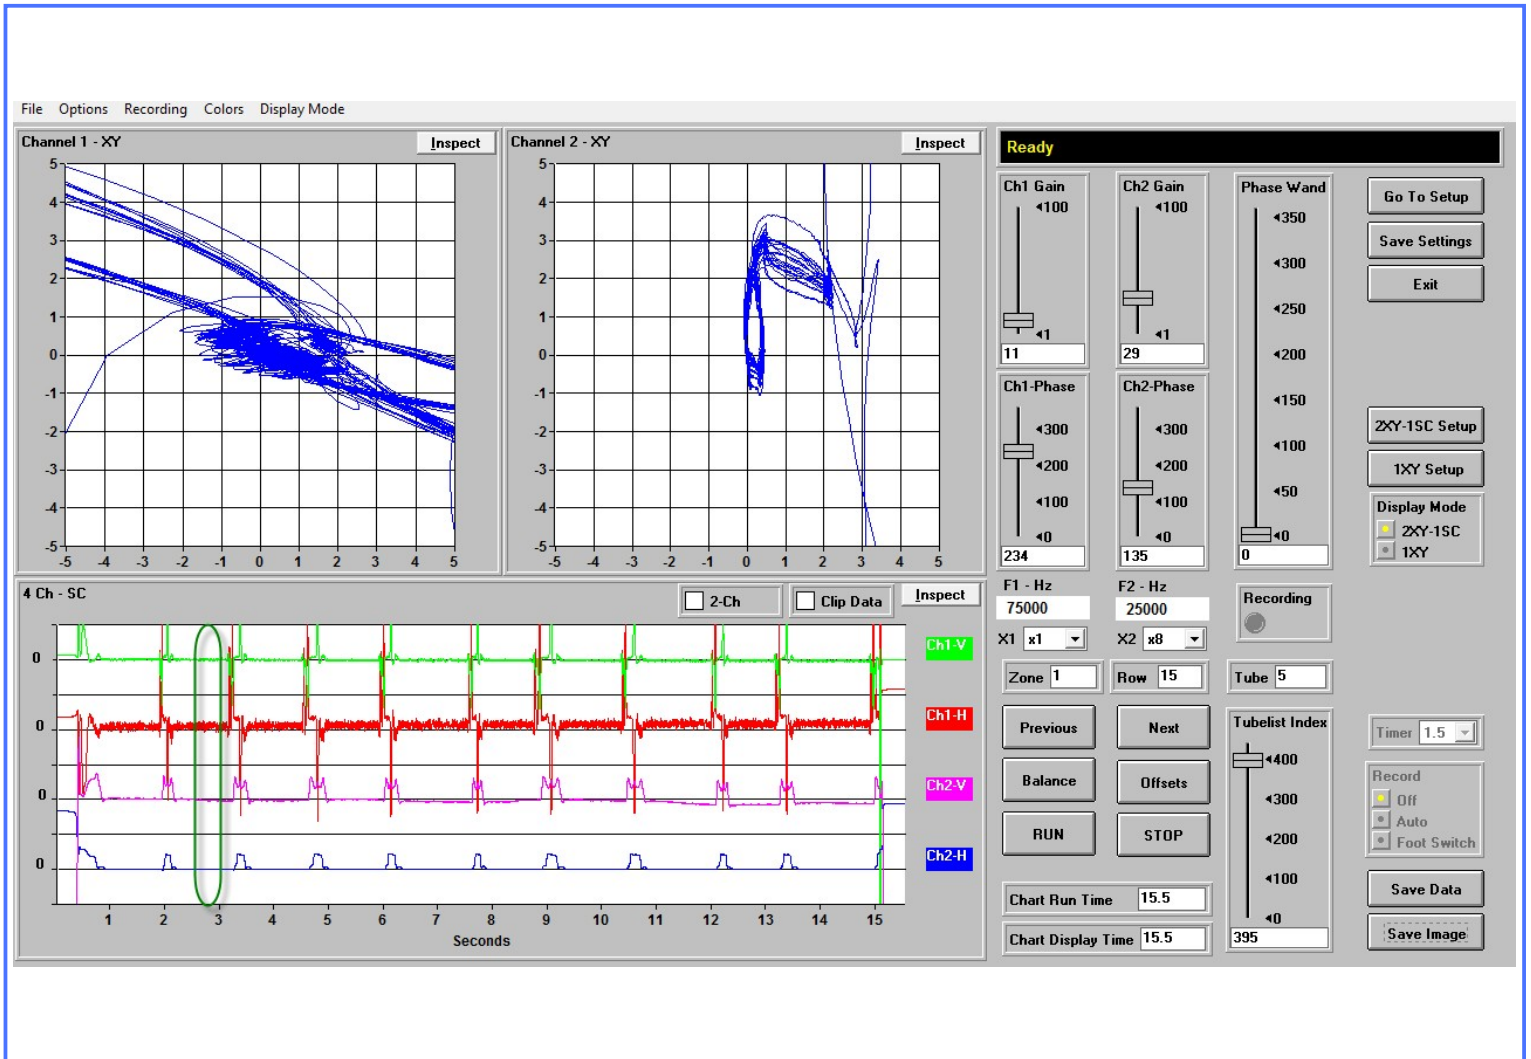
OD DEFECT < 20% (Row 15 Tube 5)
