Report of Eddy Current Inspection

Manufacturer: Carrier

Model: 17DA743

Location: DUPONT EXPERIMENTAL STATION
200 POWER MILL ROAD
BUILDING 315
WILMINGTON, DE 19803

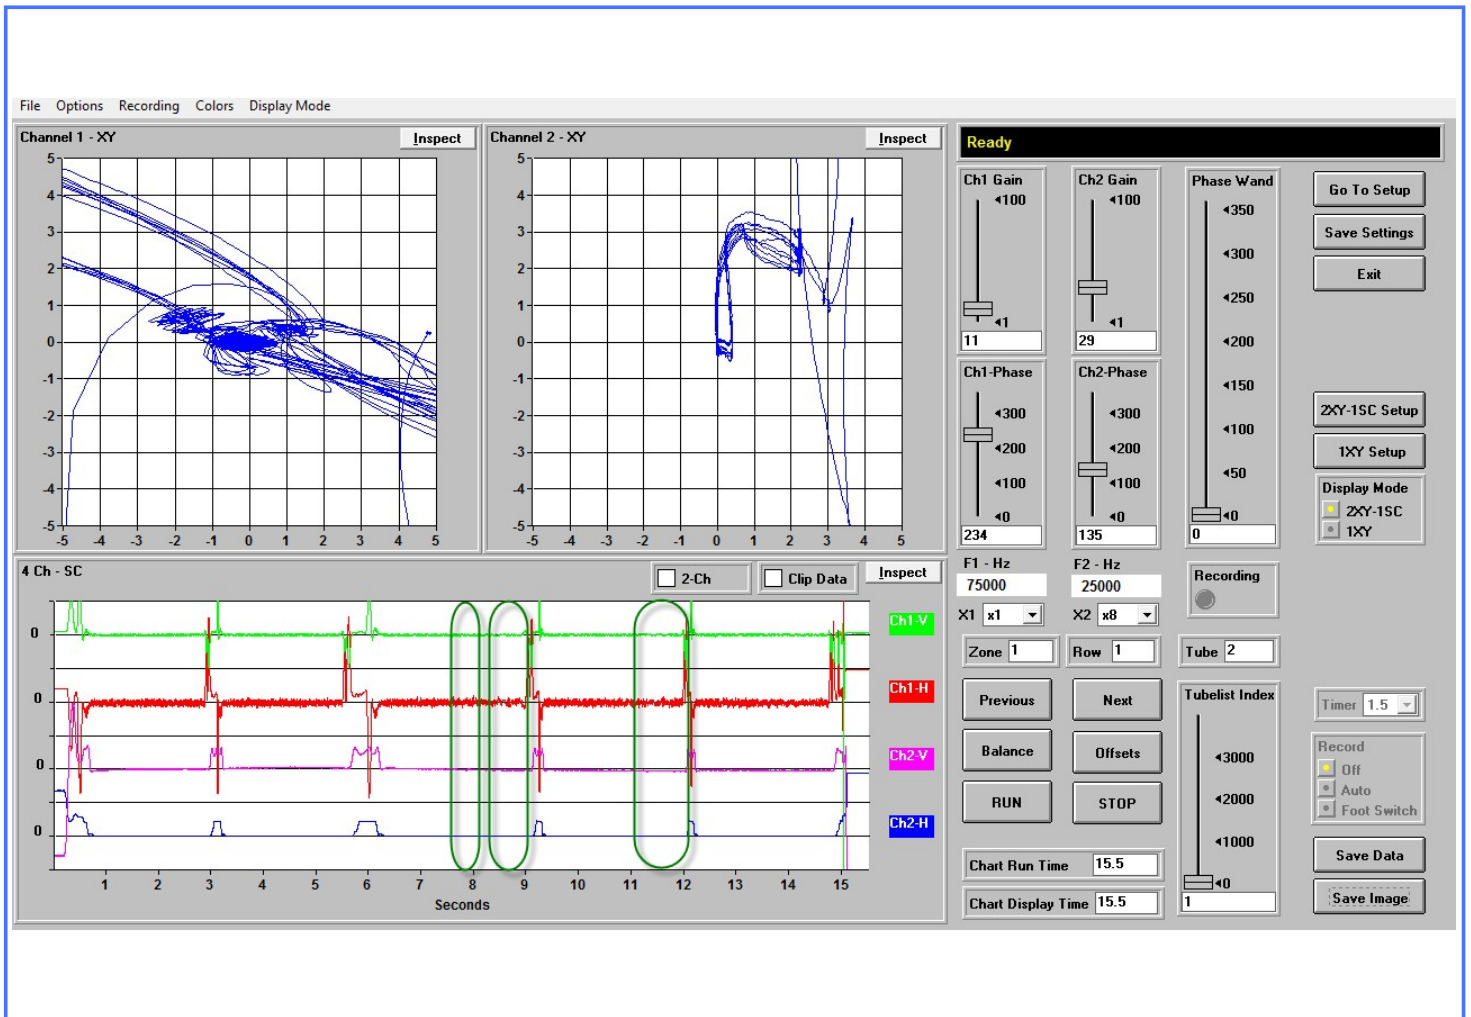
NOTE: Although not marked, the majority of tubes gave indications of minor generalized ID Corrosion and Pitting. Only those tubes giving indications greater than 20% or more were marked in order to keep the tube chart neat and legible and to better illustrate more critical damage.

NOTED ID DAMAGE (Row 1 Tube 2)

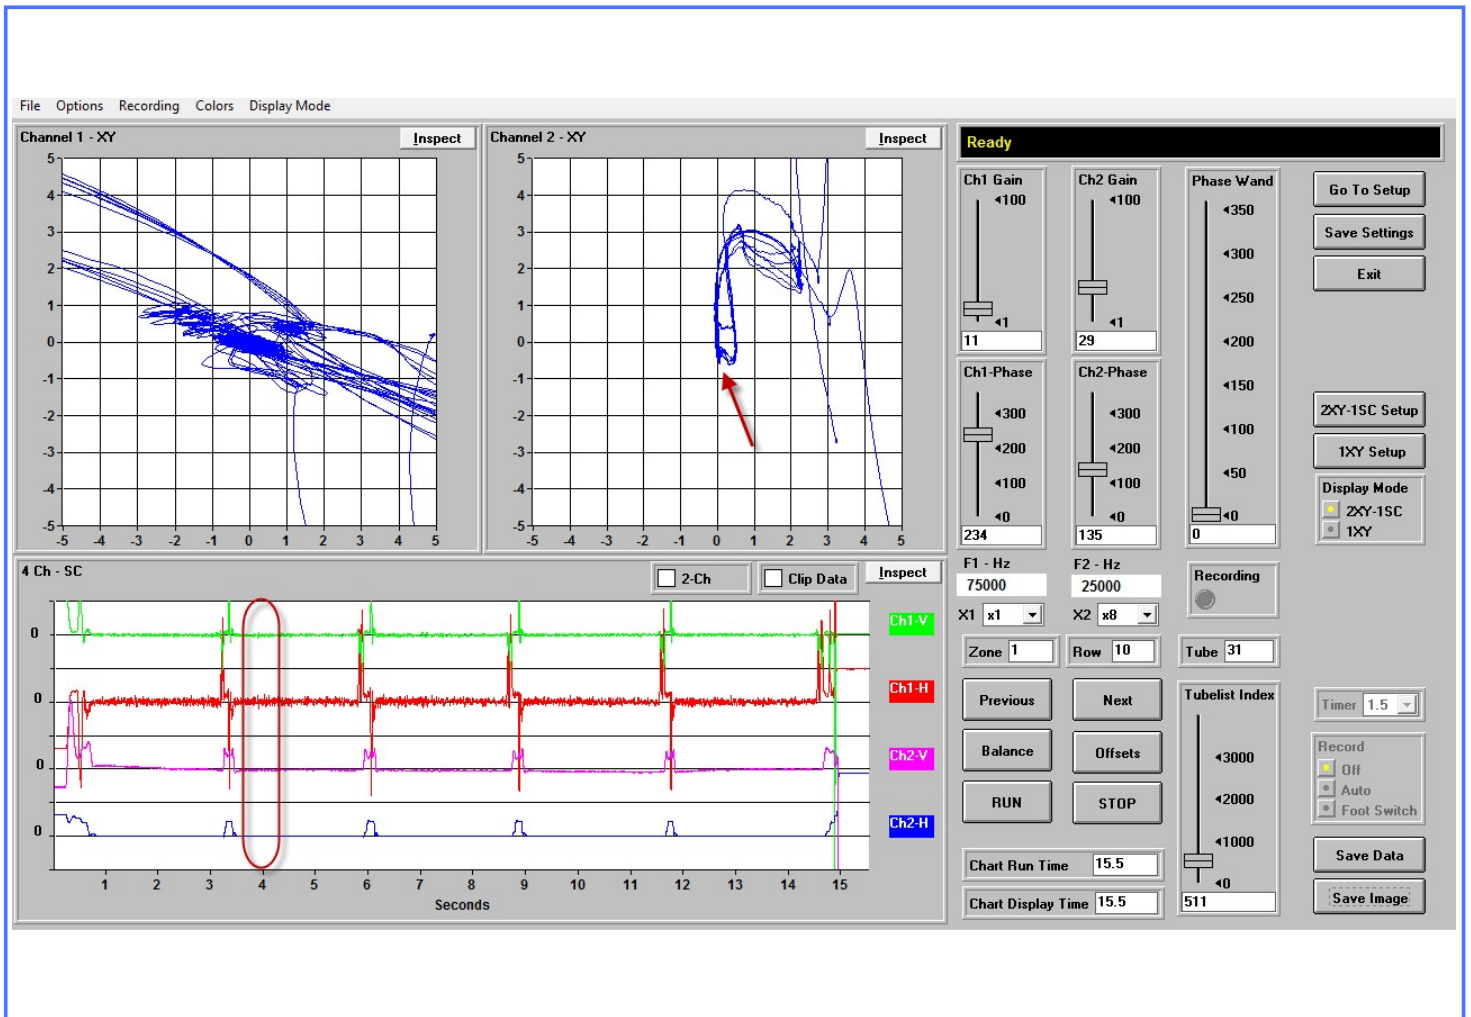
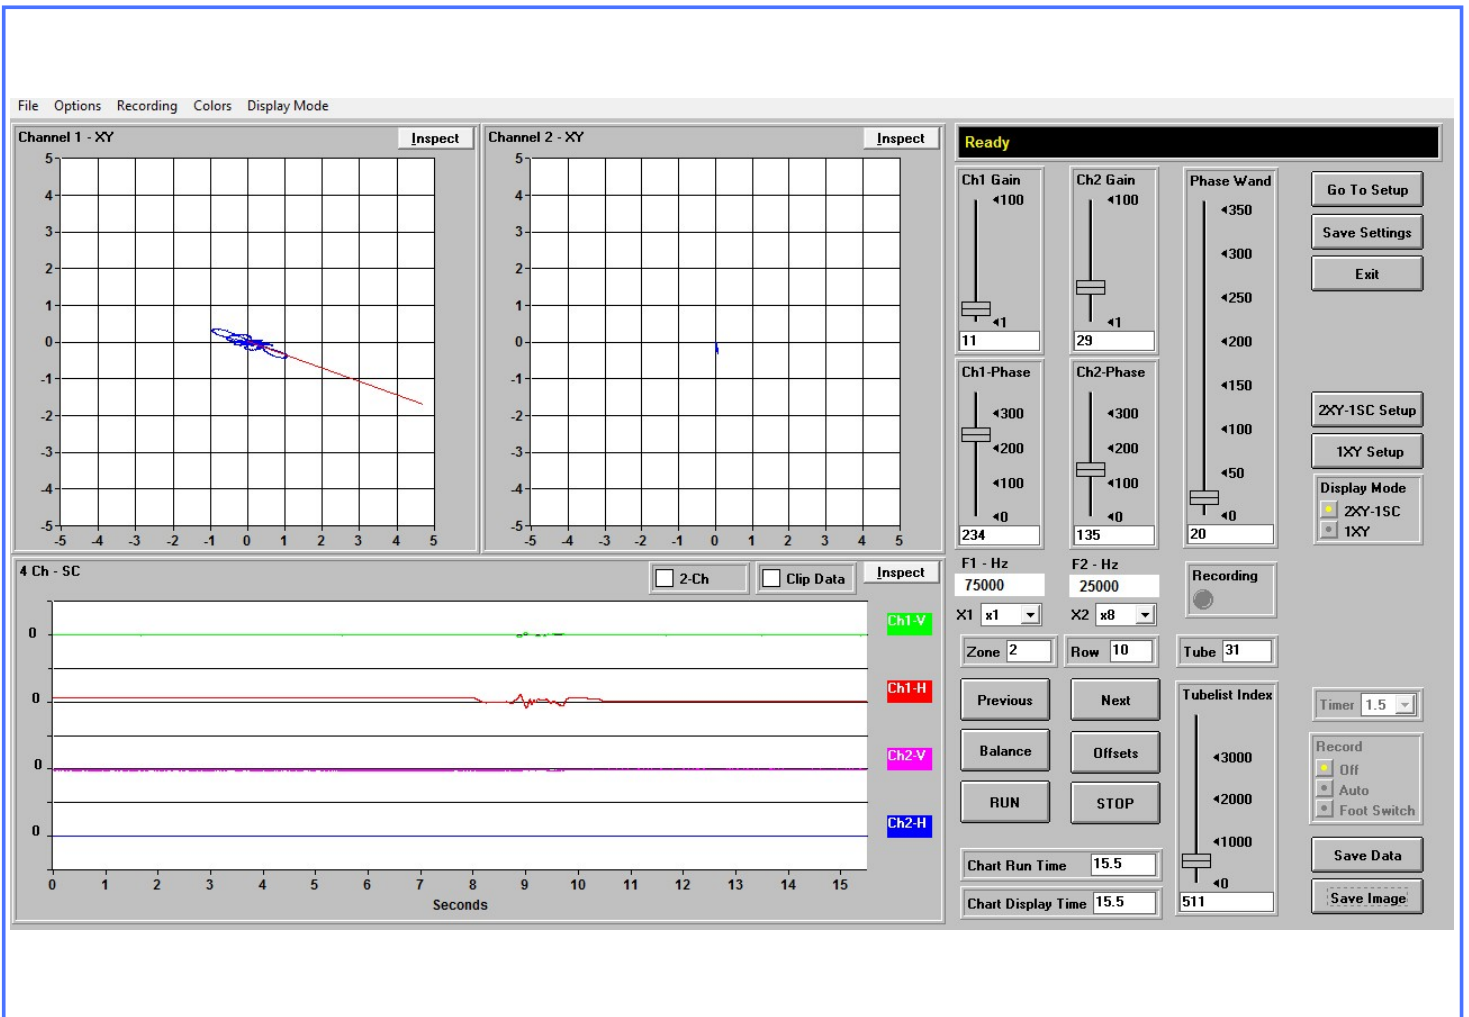
ID PIT 40% - 59% (Row 10 Tube 31)

Tubes indicating ID Pits of 40% or more should be isolated from the system at this time. ID Pits of less than 40% require no immediate corrective action. However, this type damage is usually progressive and should be monitored.

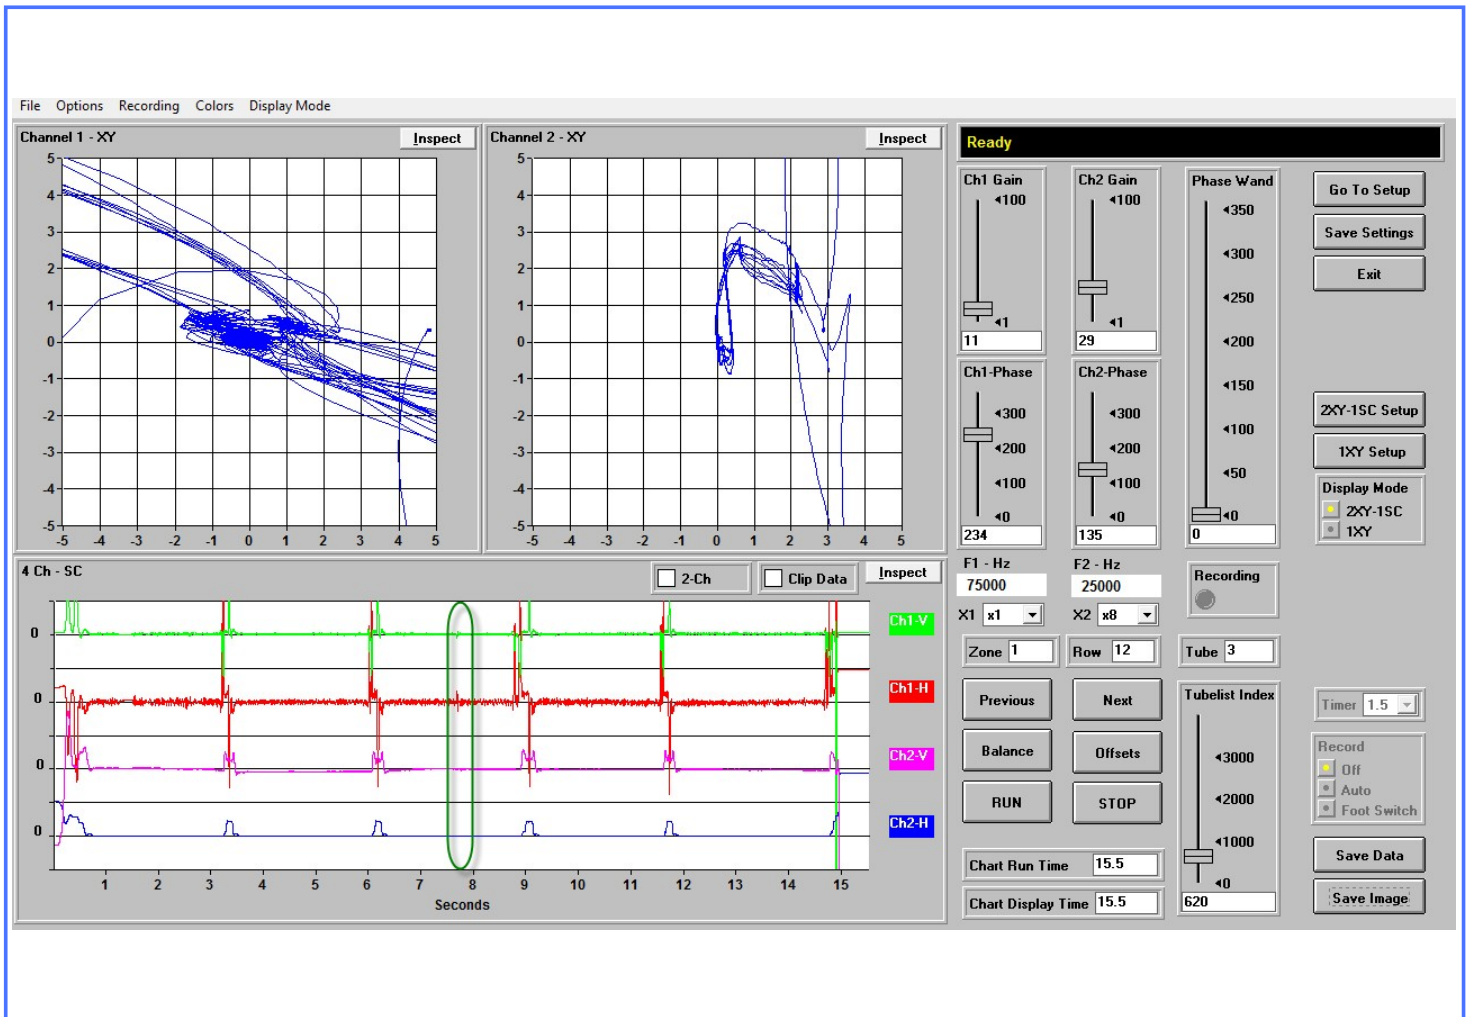
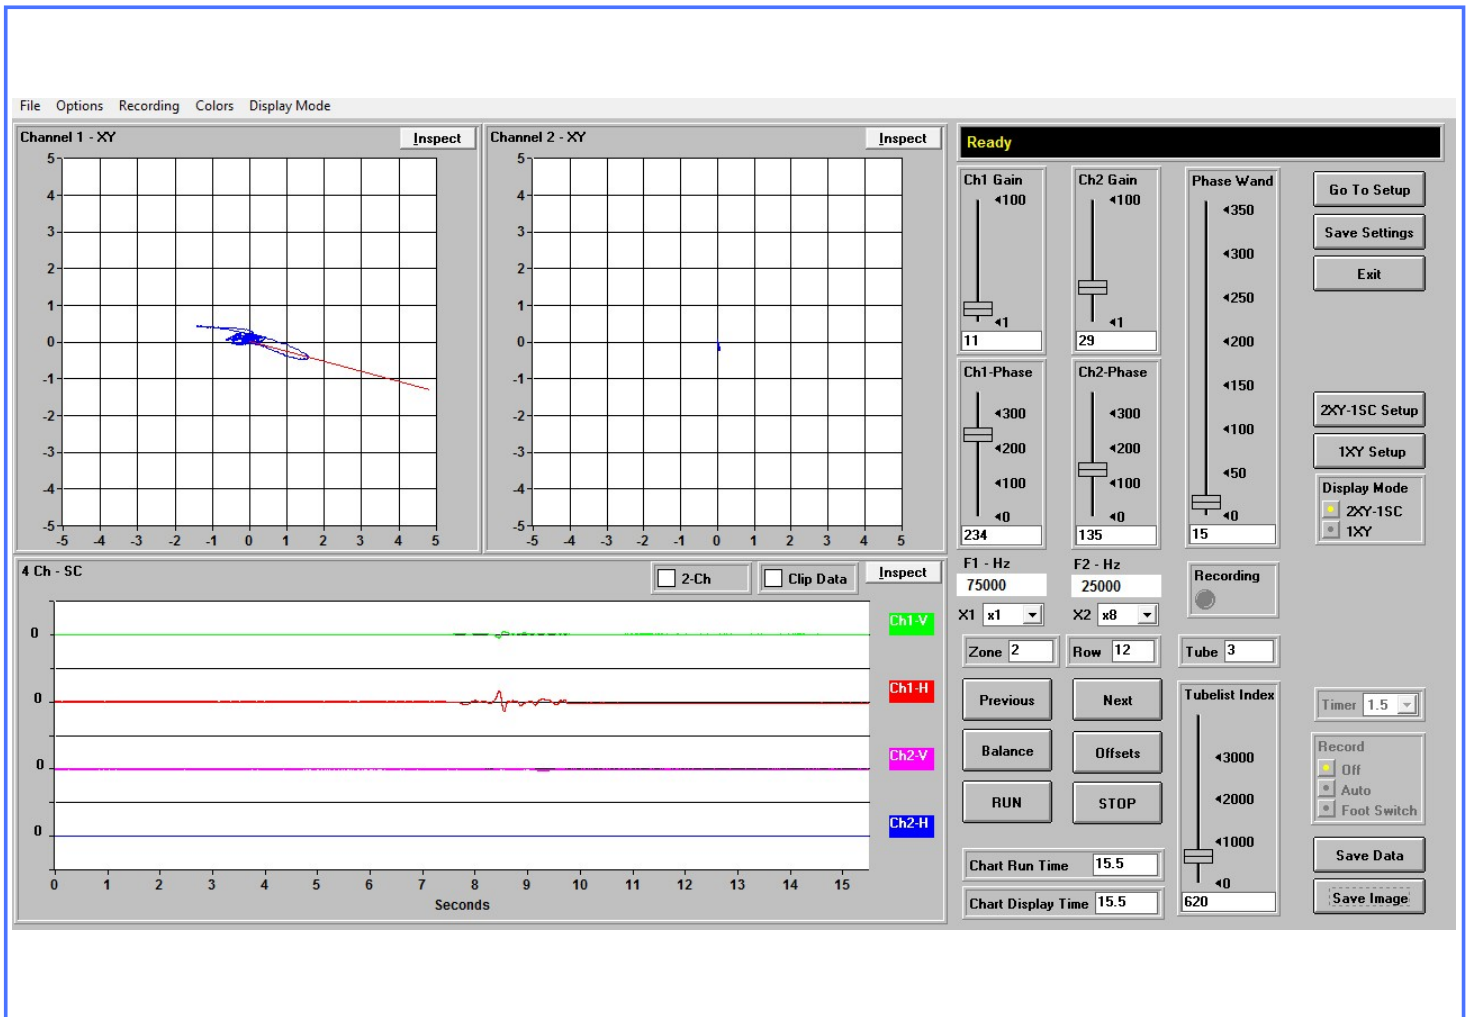
ID PIT 20% - 39% (Row 12 Tube 3)

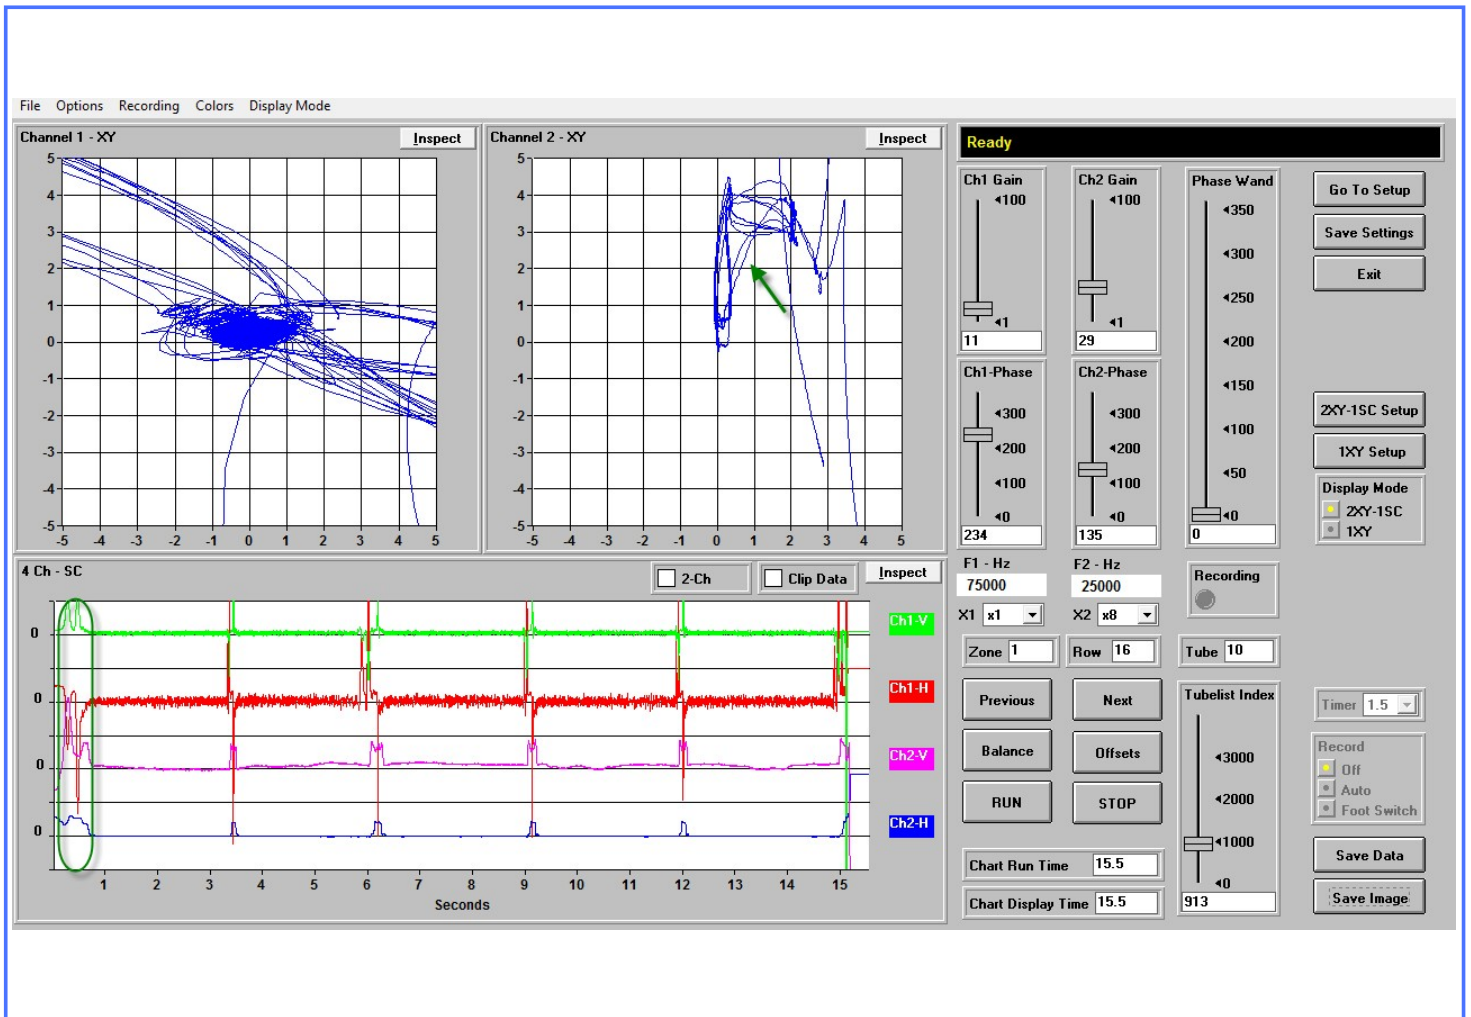
Tubes indicating Abnormal Bell End Indications require no corrective action at this time. The indications are that of minor thinning at the Bell End. The exact cause and description of the anomaly is unknown.

ABN. NOMINAL BELL END (Row 16 Tube 10)

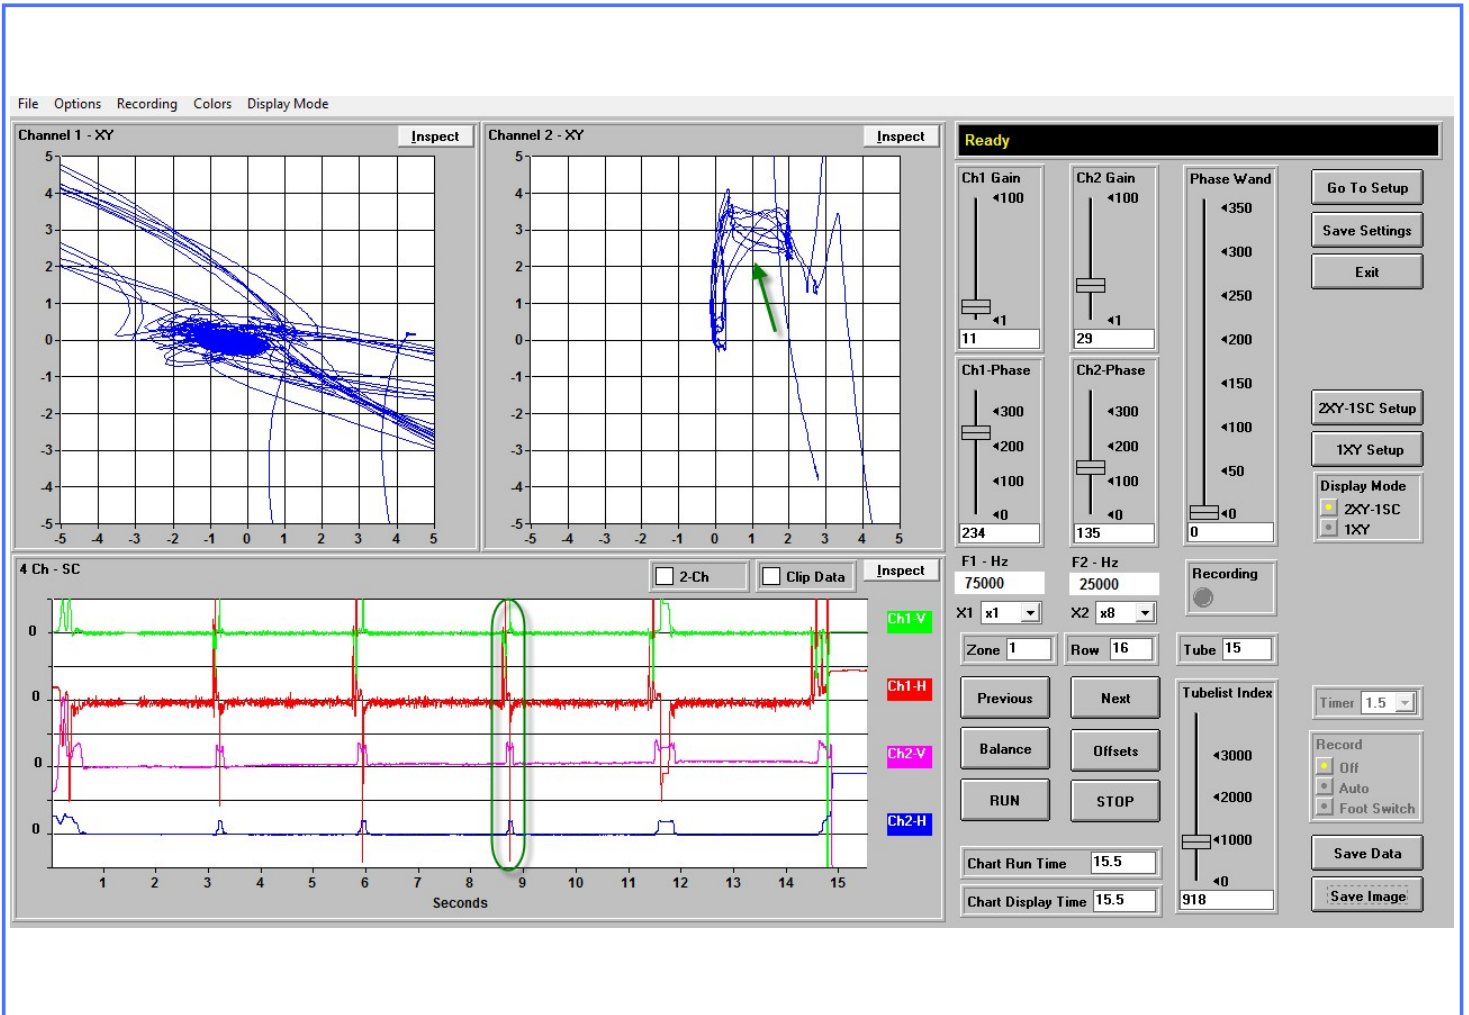
Tubes indicating Abnormal Support Landings require no corrective action at this time. These tubes showed a distorted transition zone at the indicated support. The exact cause of the indication is unknown, but is believed to be the result of manufacturing.

ABNORMAL LAND (Row 16 Tube 15)

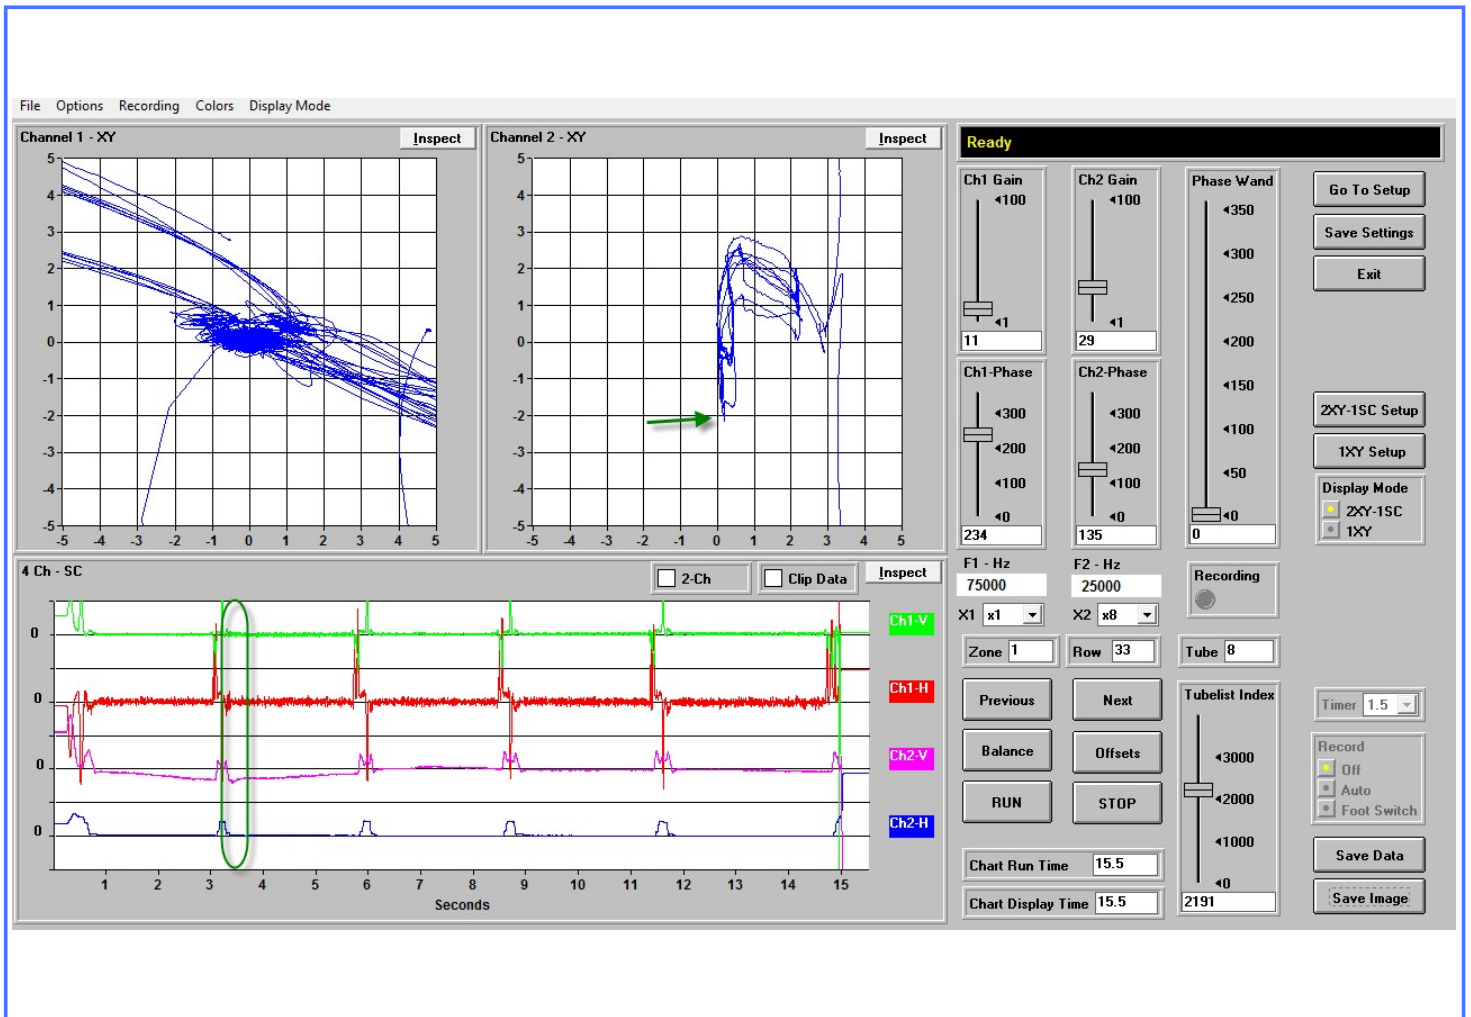
The tubes marked for OD Defects require no corrective action at this time.

OD DEFECT < 20% (Row 33 Tube 8)

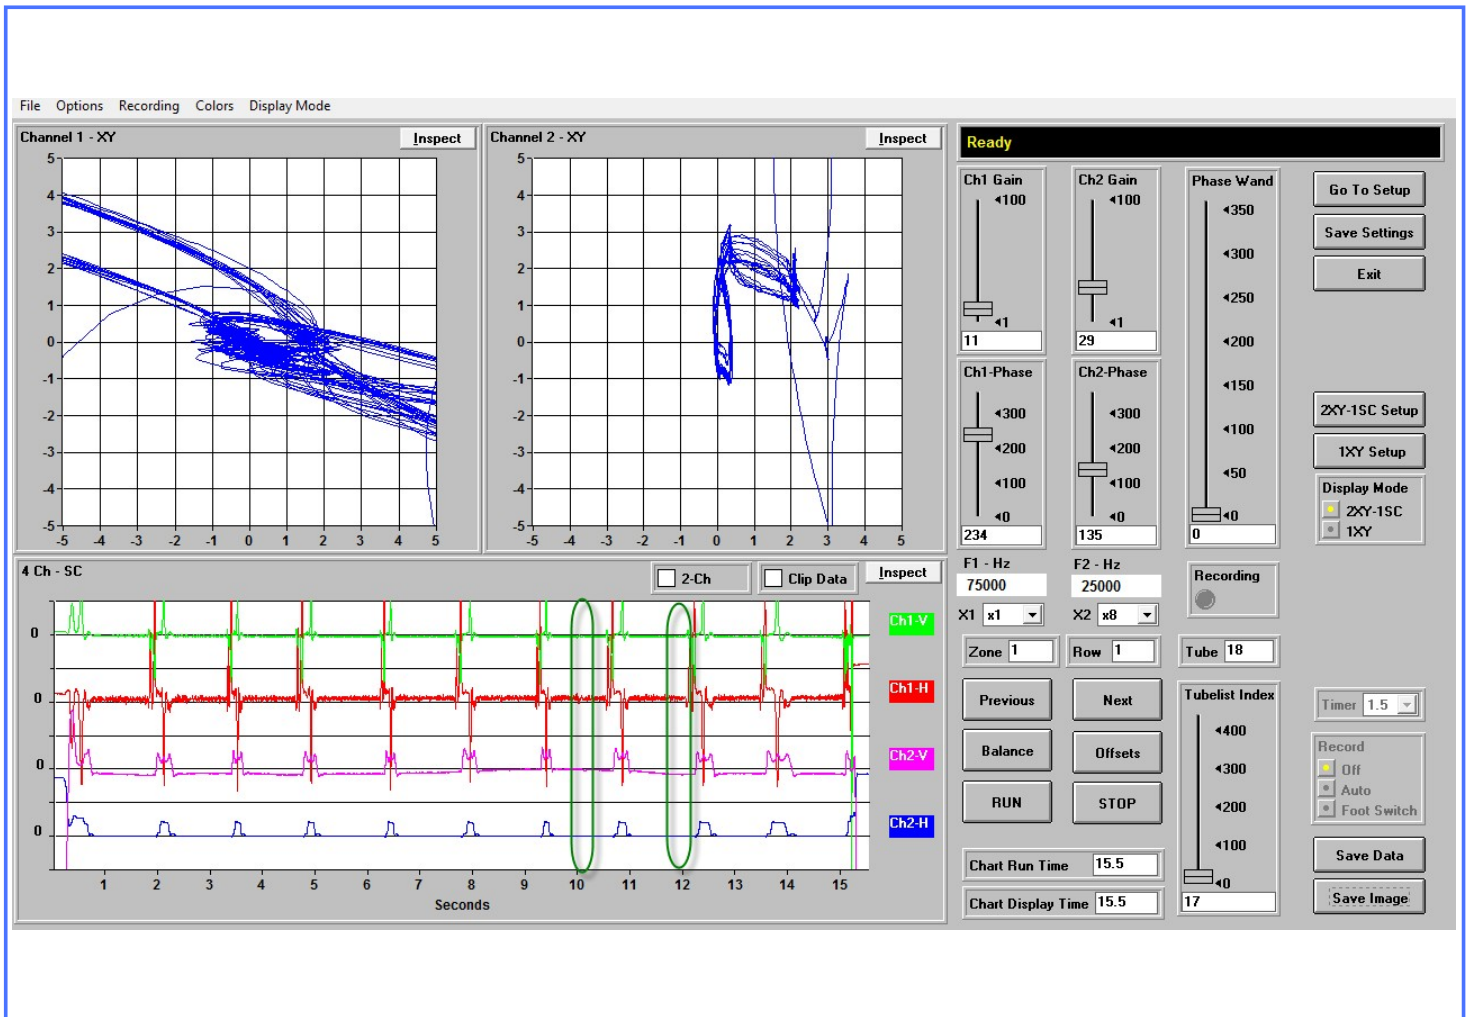
NOTE: Although not marked, all the tubes in this bundle gave indications of minor generalized ID Corrosion and ID Pitting. No individual tubes gave indications of significant damage, and therefore none were marked.

NOTED ID DAMAGE (Row 1 Tube 18)

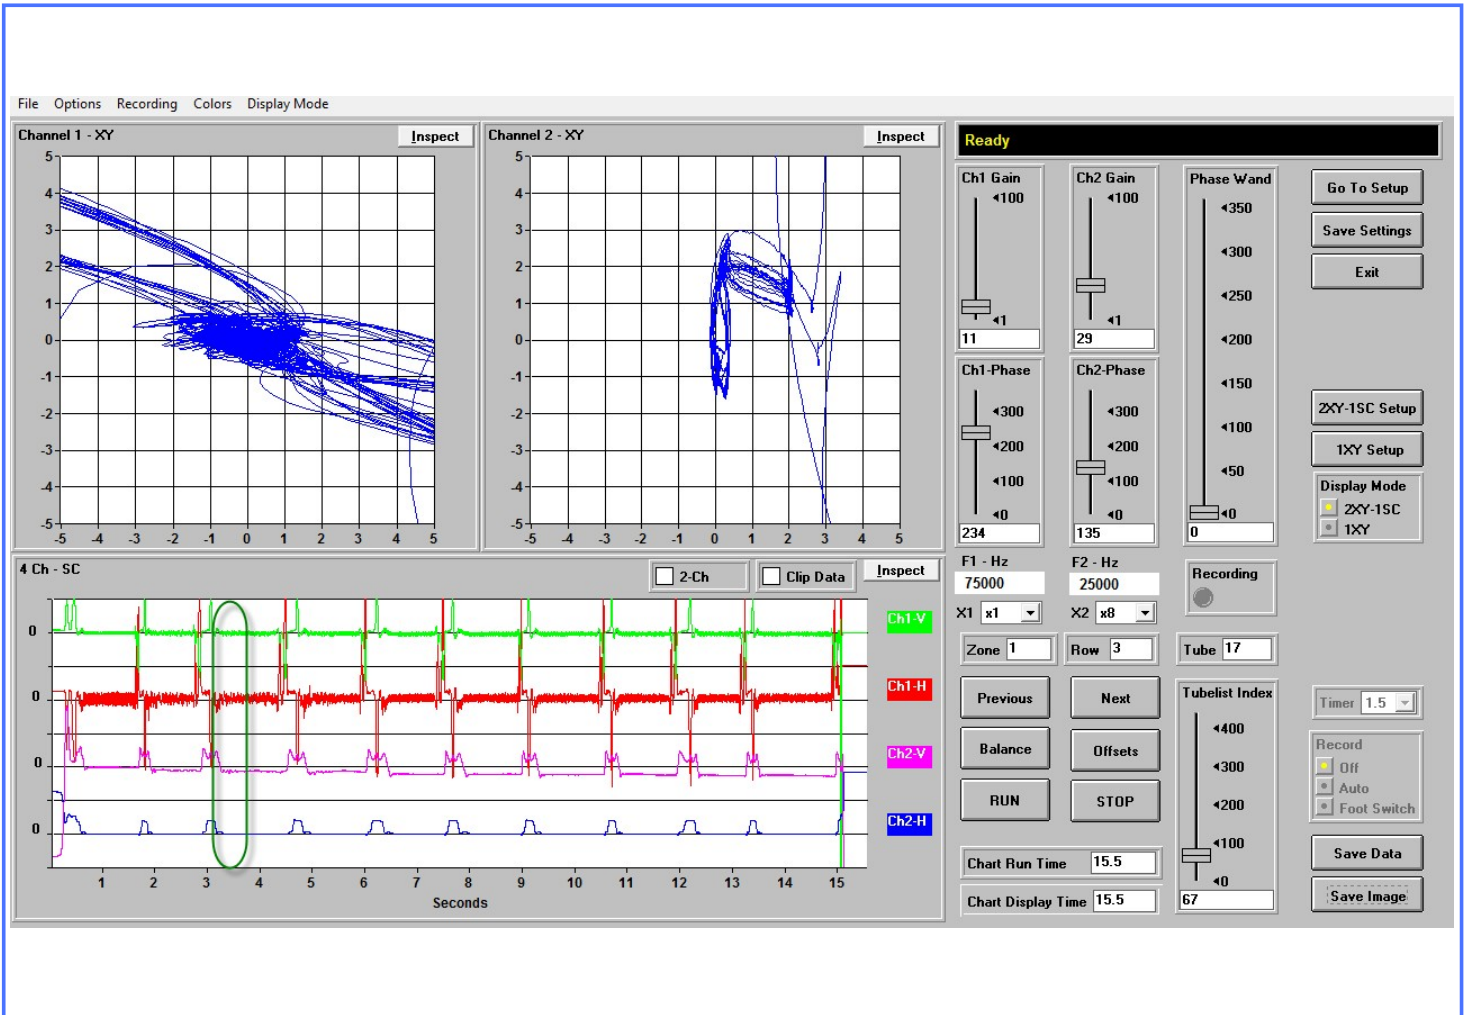
The tubes marked for OD Defects require no corrective action at this time.

OD DEFECT < 20% (Row 3 Tube 17)

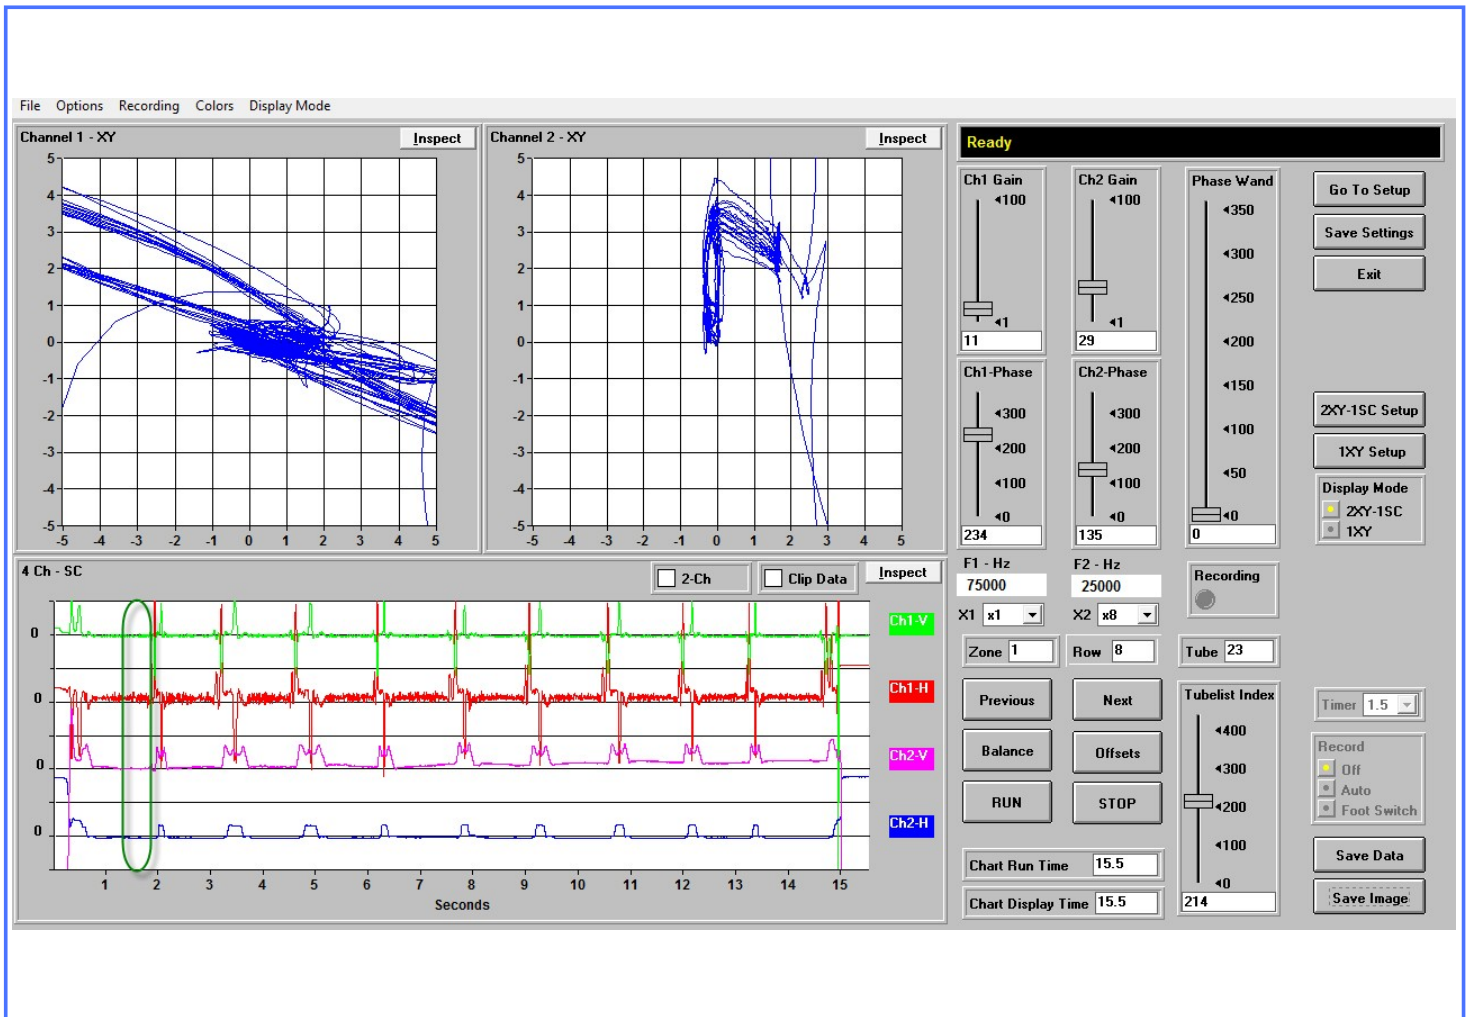
OD DEFECT < 20% (Row 8 Tube 23)

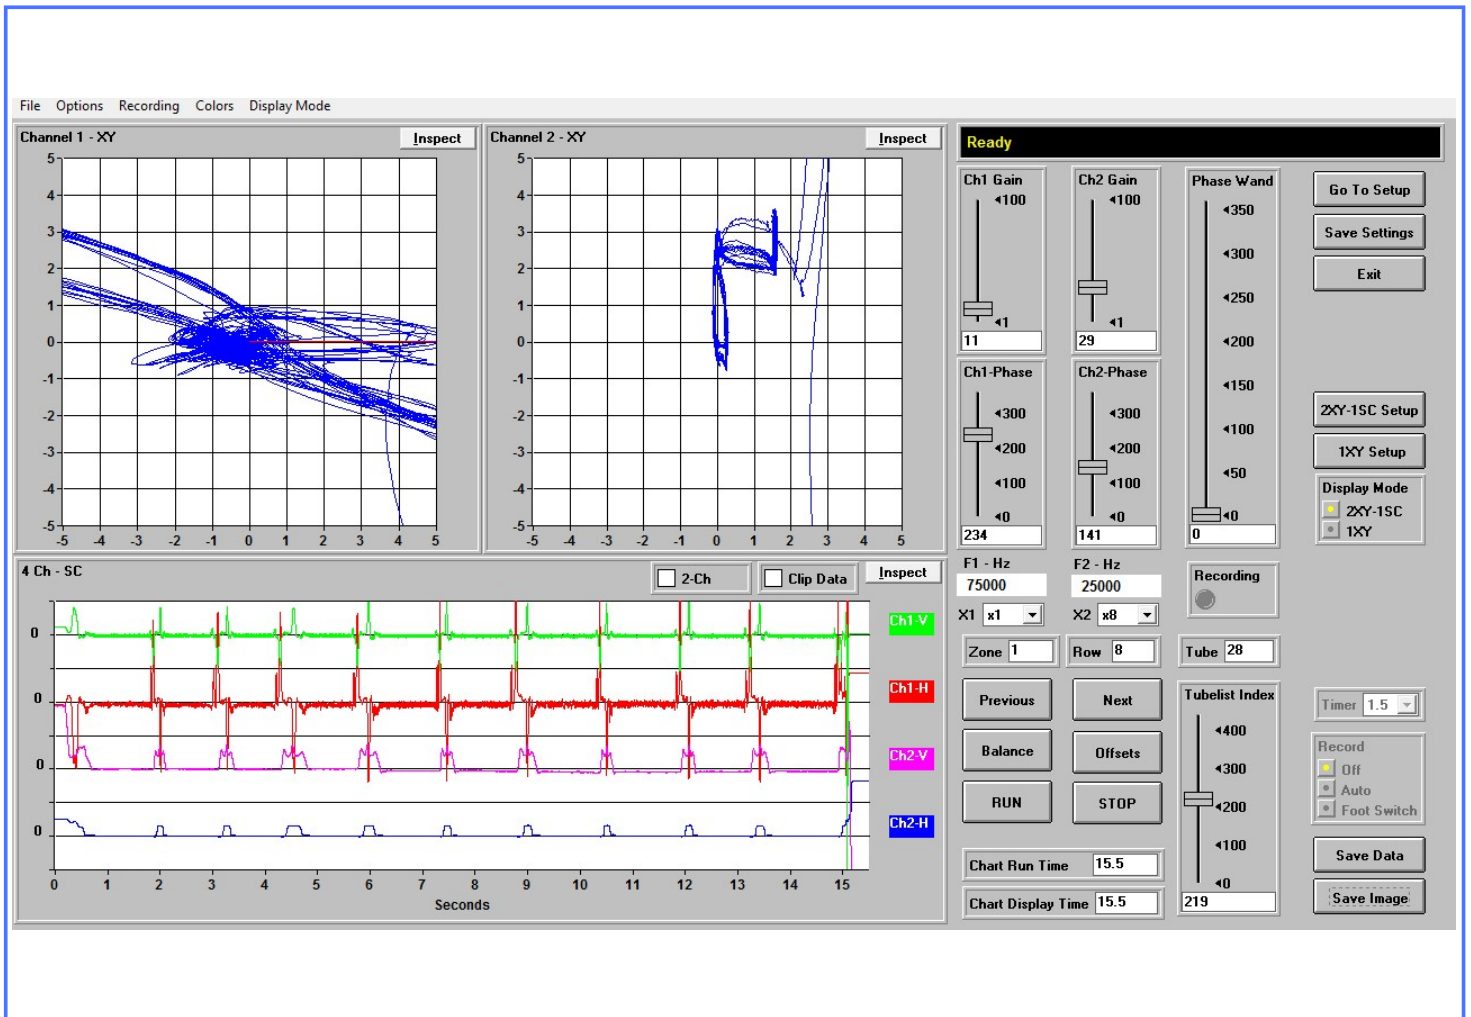
The tube(s) marked as "Different Tube Type" were .750/.042/.028 CuNi tubes. The test instrument was calibrated, and standard procedures were followed for this tube type and alloy. These tubes showed no measurable indications of tube damage and were marked for information purposes only.

DIFFERENT TUBE TYPE (Row 8 Tube 28)

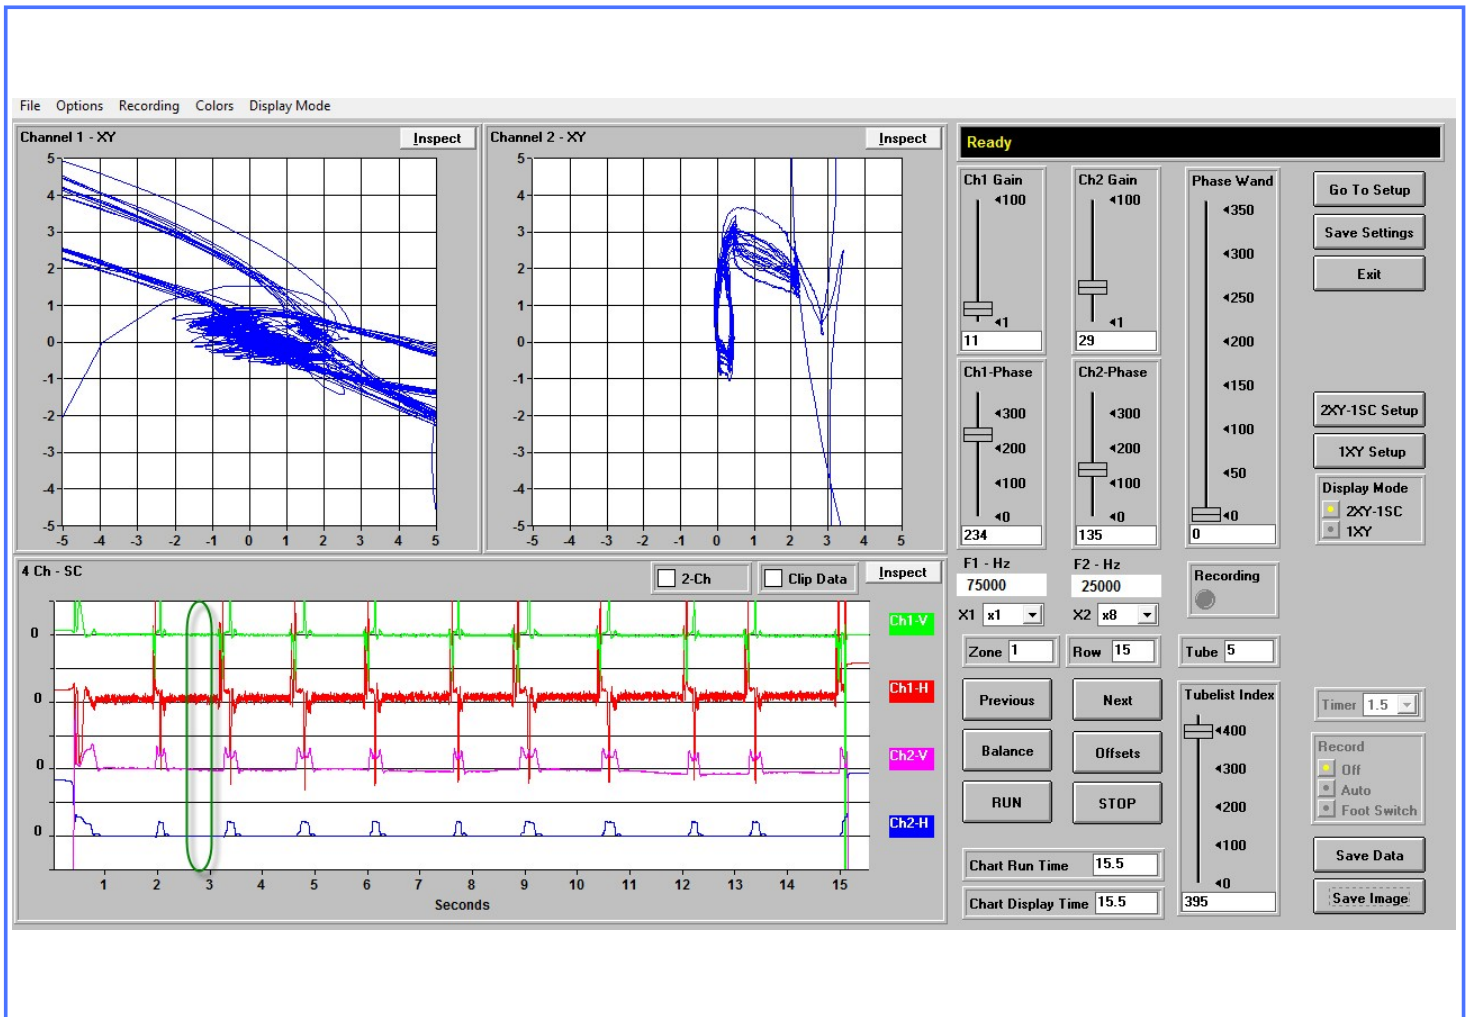
OD DEFECT < 20% (Row 15 Tube 5)
