## Report of Eddy Current Inspection

Manufacturer: York

Model: OM3000

Location: DUPONT EXPERIMENTAL STATION  
RT. 141 BETWEEN 52 & 202  
WILMINGTON, DE 19735

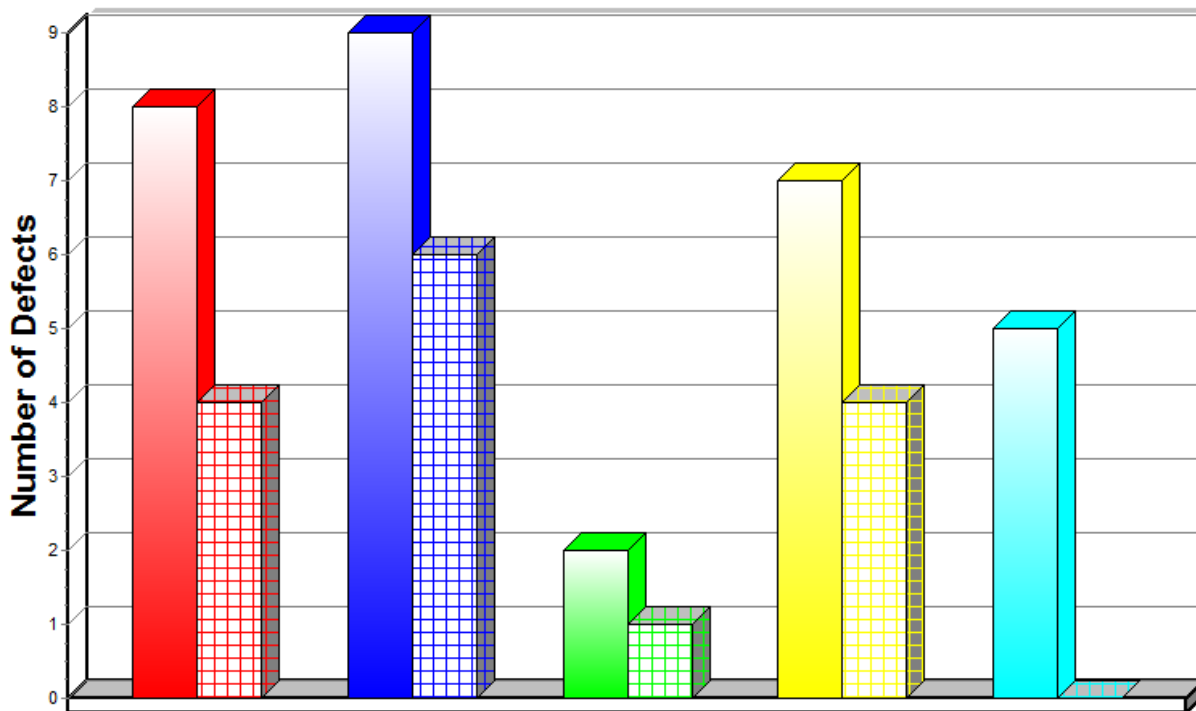
### B/H Condenser Defects

- ID CORROSION < 20%
- ID CORROSION 20% - 39%
- ID PIT < 20%
- ID PIT 20% - 39%
- TESTED, DEBRIS
- 12/22/2010

B/H Condenser: 1326 Tubes		
Significant/Measurable Indications	Number of Tubes Marked	Percent of Bundle
ID CORROSION < 20%	8	.60
ID CORROSION 20% - 39%	9	.68
ID PIT < 20%	2	.15
ID PIT 20% - 39%	7	.53
TESTED, DEBRIS	5	.38
<b>Totals</b>	<b>31</b>	<b>2.34</b>

The ID Corrosion detected appears minor and requires no corrective action at this time. ID Corrosion is the deterioration of the tube's inner surface due to a biological or chemical attack and is usually progressive.

The ID Pits marked require no immediate corrective action. However, this type damage is usually progressive and should be monitored.

The tubes marked as Tested Debris require no corrective action at this time. These tubes contain ID deposits and/or foreign material. No damage was detected and no corrective action is required at this time.

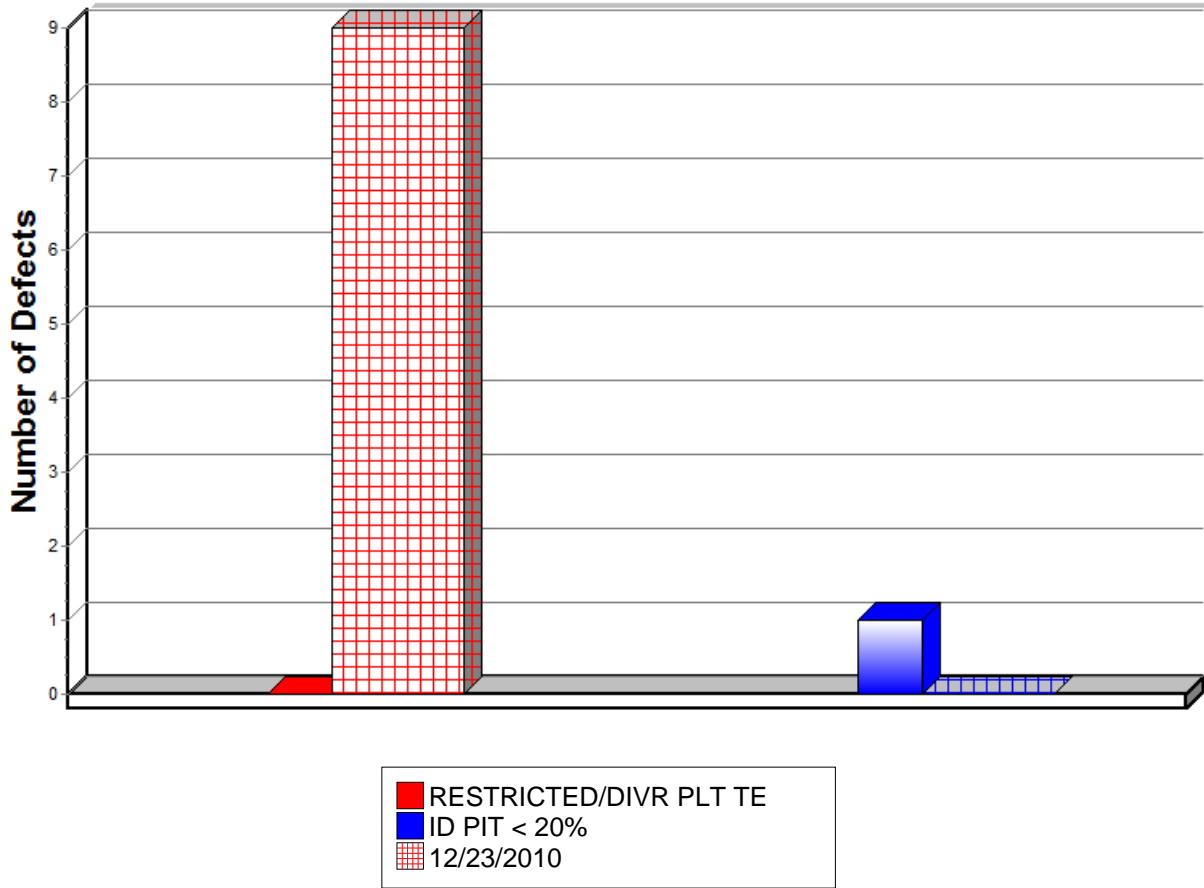
### Evaporator Defects

Evaporator: 1852 Tubes		
Significant/Measurable Indications	Number of Tubes Marked	Percent of Bundle
ID PIT < 20%	1	.05

The ID Pits marked require no immediate corrective action. However, this type damage is usually progressive and should be monitored.

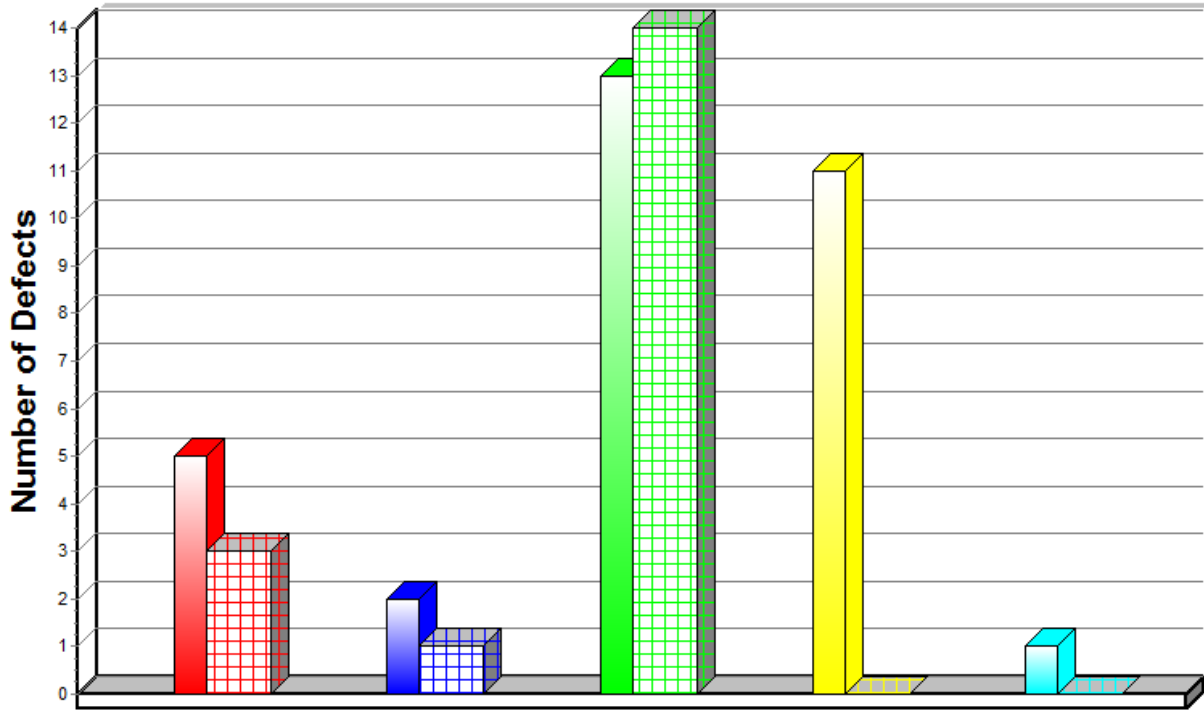
### T/H Condenser Defects

- ID CORROSION < 20%
- ID PIT < 20%
- ID PIT 20% - 39%
- TESTED, DEBRIS
- TESTED, NO DEFECTS
- 12/23/2010

T/H Condenser: 1264 Tubes		
Significant/Measurable Indications	Number of Tubes Marked	Percent of Bundle
ID CORROSION < 20%	5	.40
ID PIT < 20%	2	.16
ID PIT 20% - 39%	13	1.03
TESTED, DEBRIS	11	.87
TESTED, NO DEFECTS	1	.08
<b>Totals</b>	<b>32</b>	<b>2.54</b>

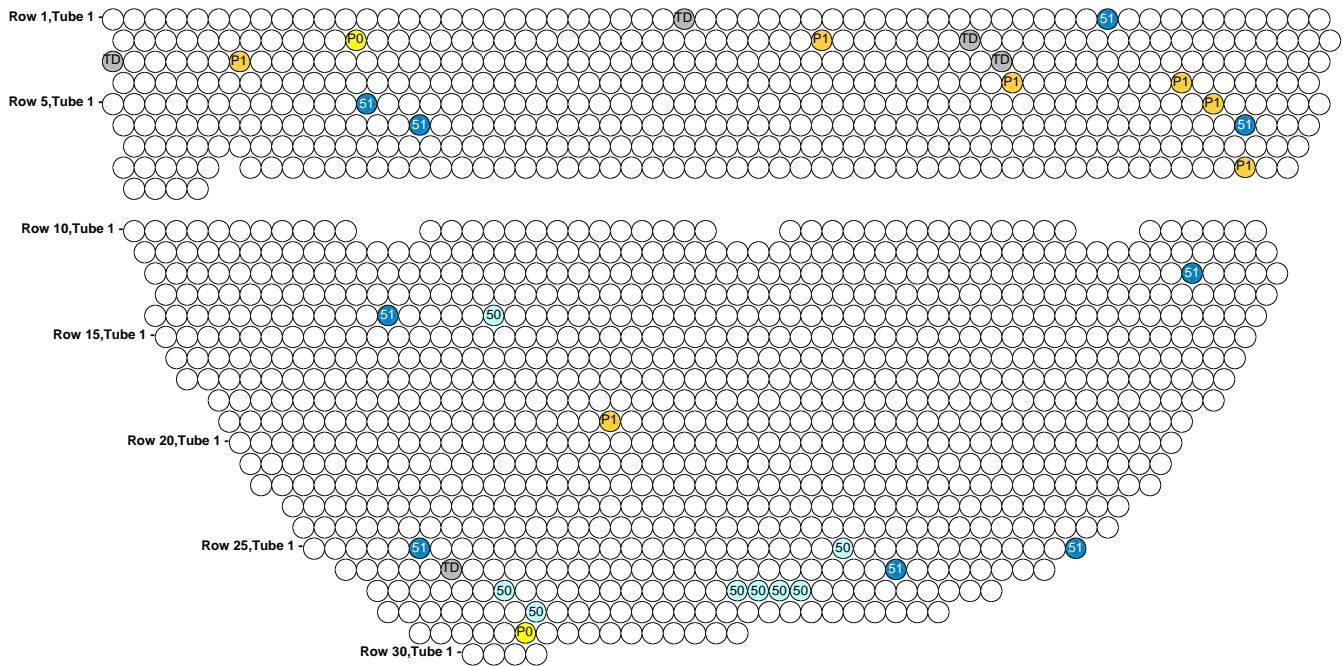
# B/H Condenser Section

- ⑤① = ID CORROSION < 20%
- ⑤② = ID CORROSION 20% - 39%
- ④① = ID PIT < 20%
- ④② = ID PIT 20% - 39%
- ③① = TESTED, DEBRIS

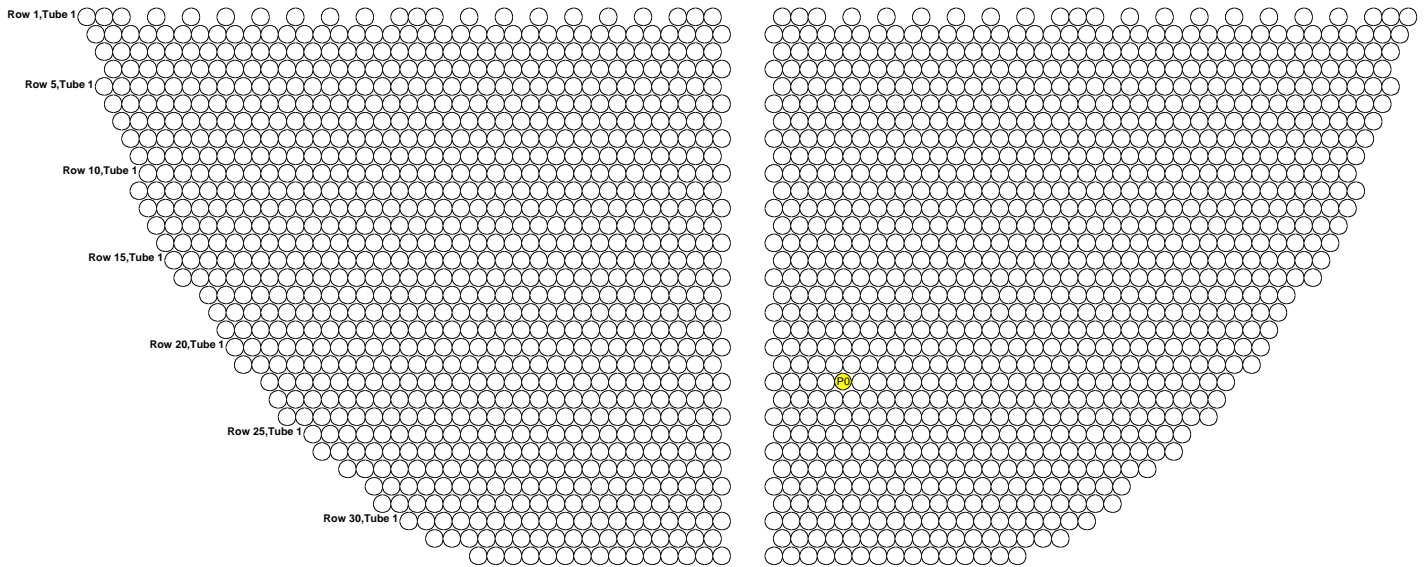
# Evaporator Section

= ID PIT < 20%

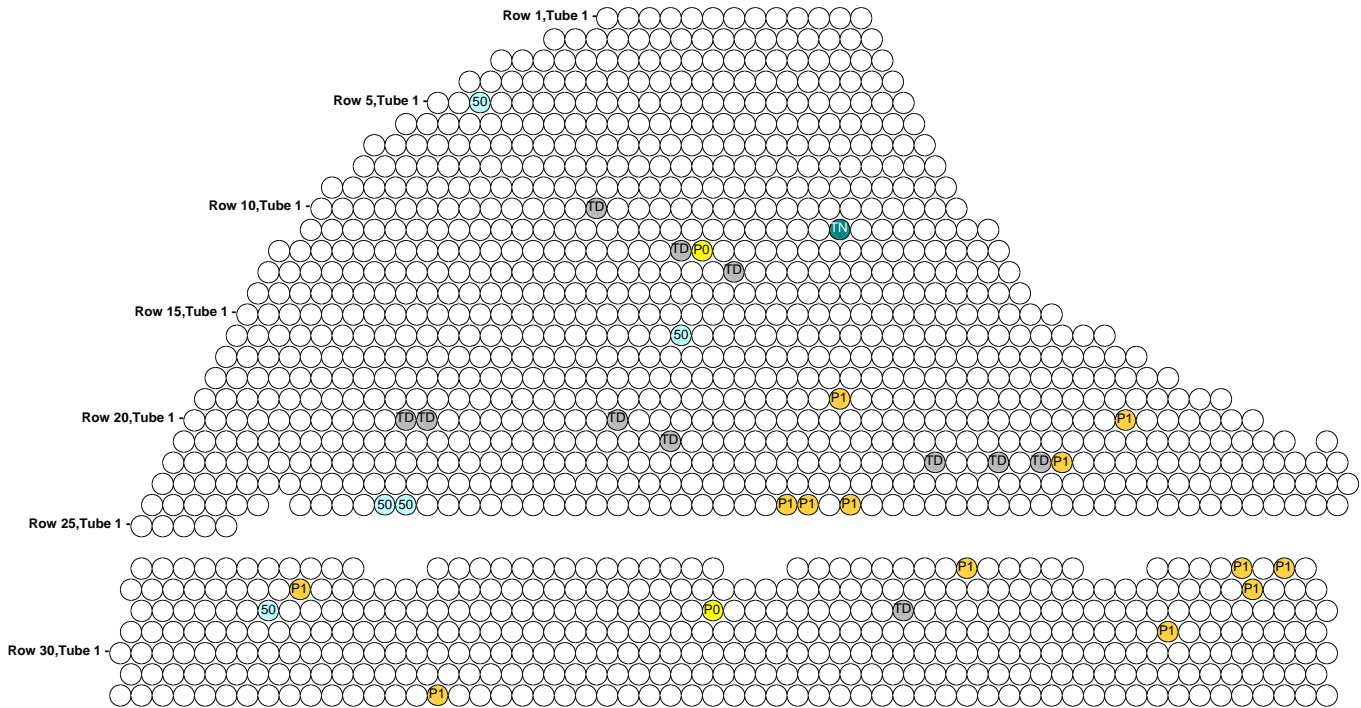
# T/H Condenser Section

50 = ID CORROSION < 20%

P0 = ID PIT < 20%

P1 = ID PIT 20% - 39%

TD = TESTED, DEBRIS

TN = TESTED, NO DEFECTS

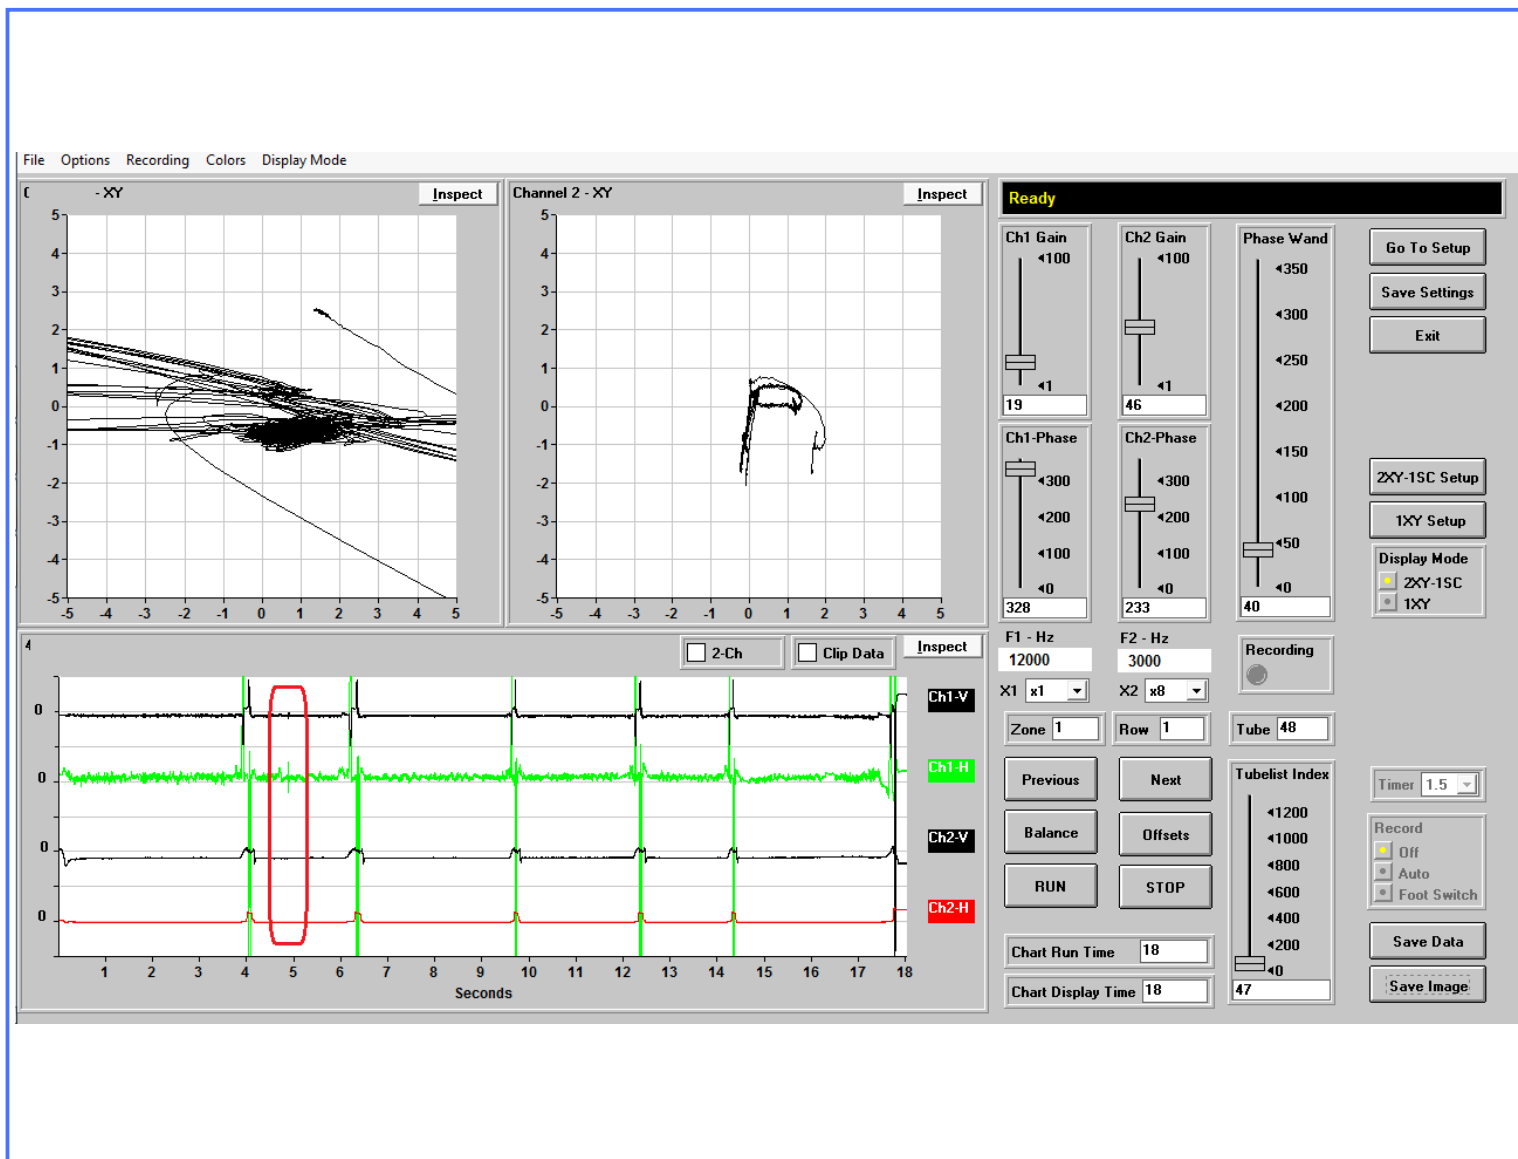
ID CORROSION 20% - 39% (Row 1 Tube 48)

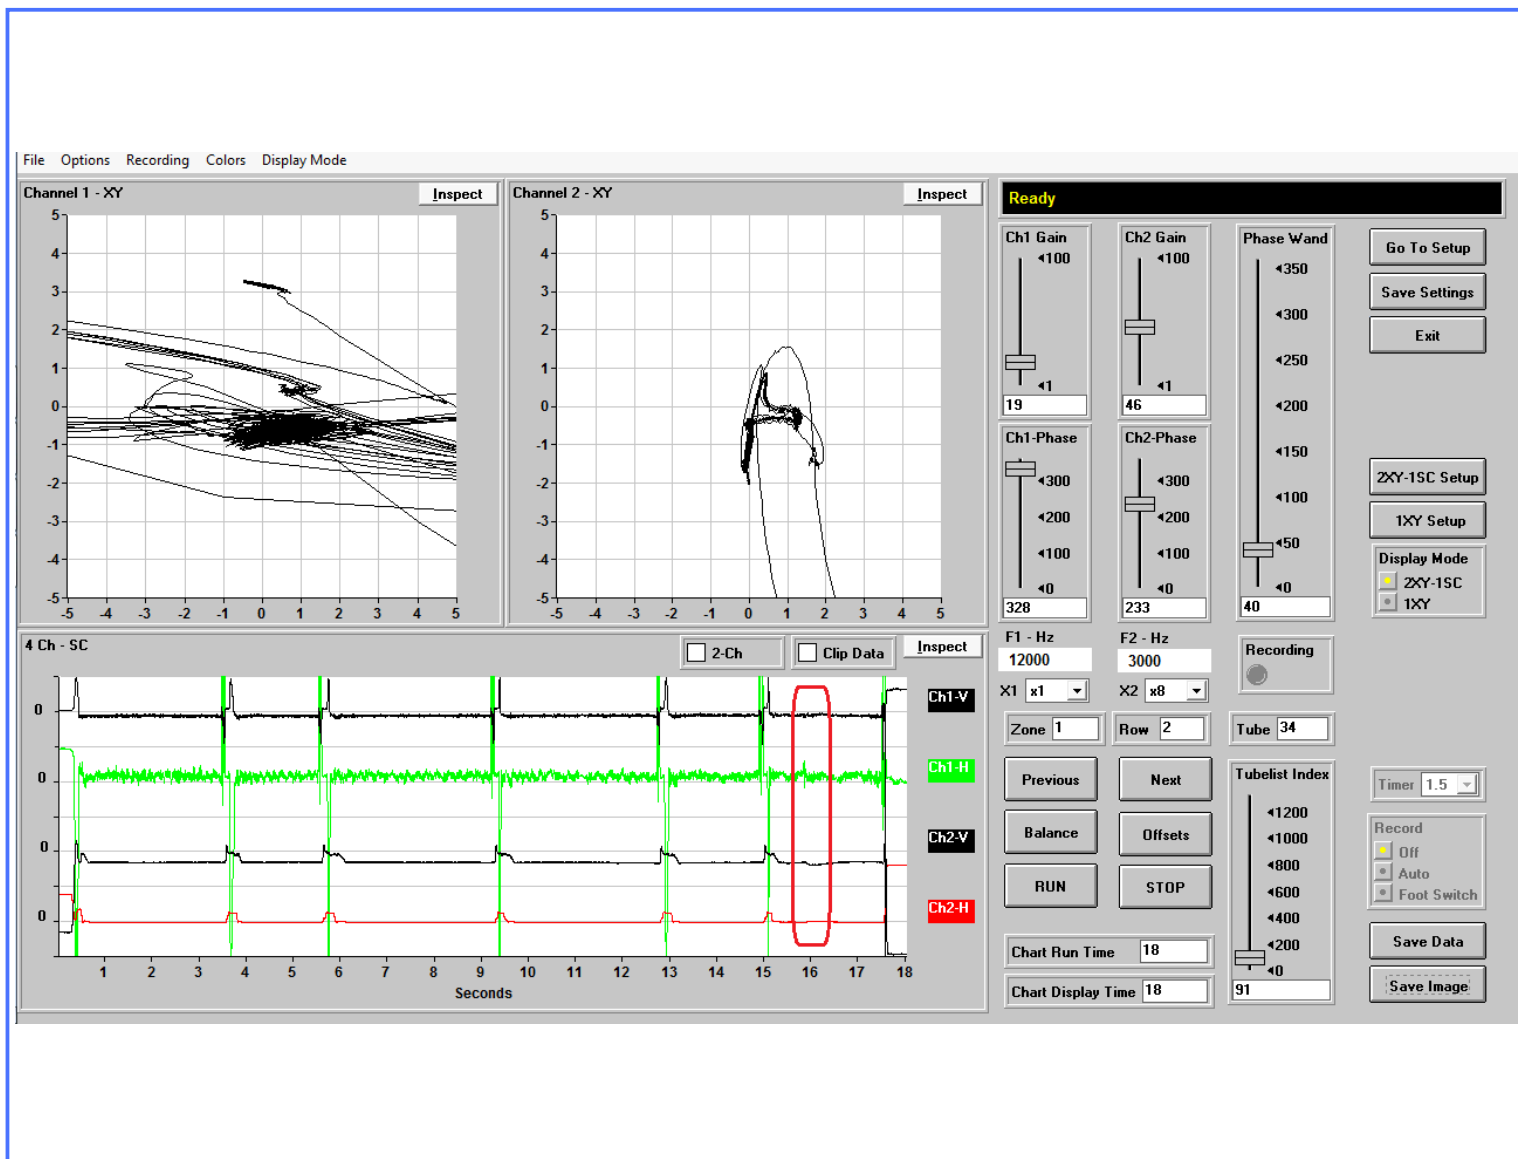
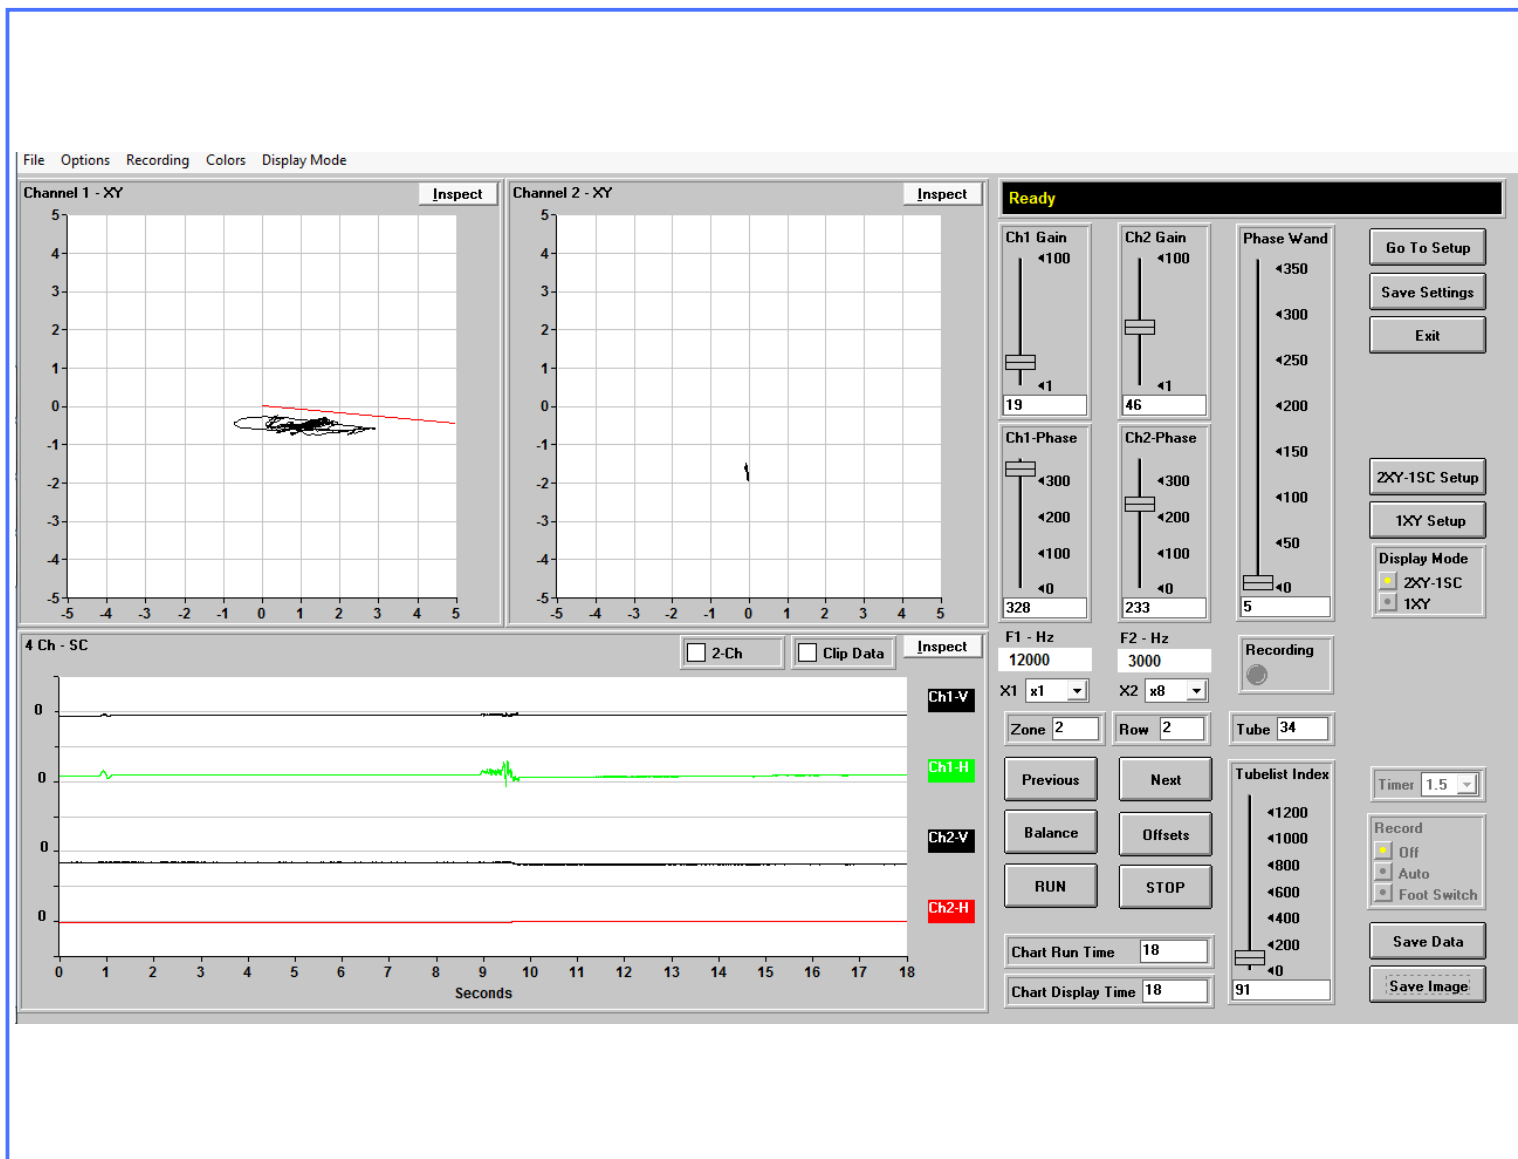
ID PIT 20% - 39% (Row 2 Tube 34)

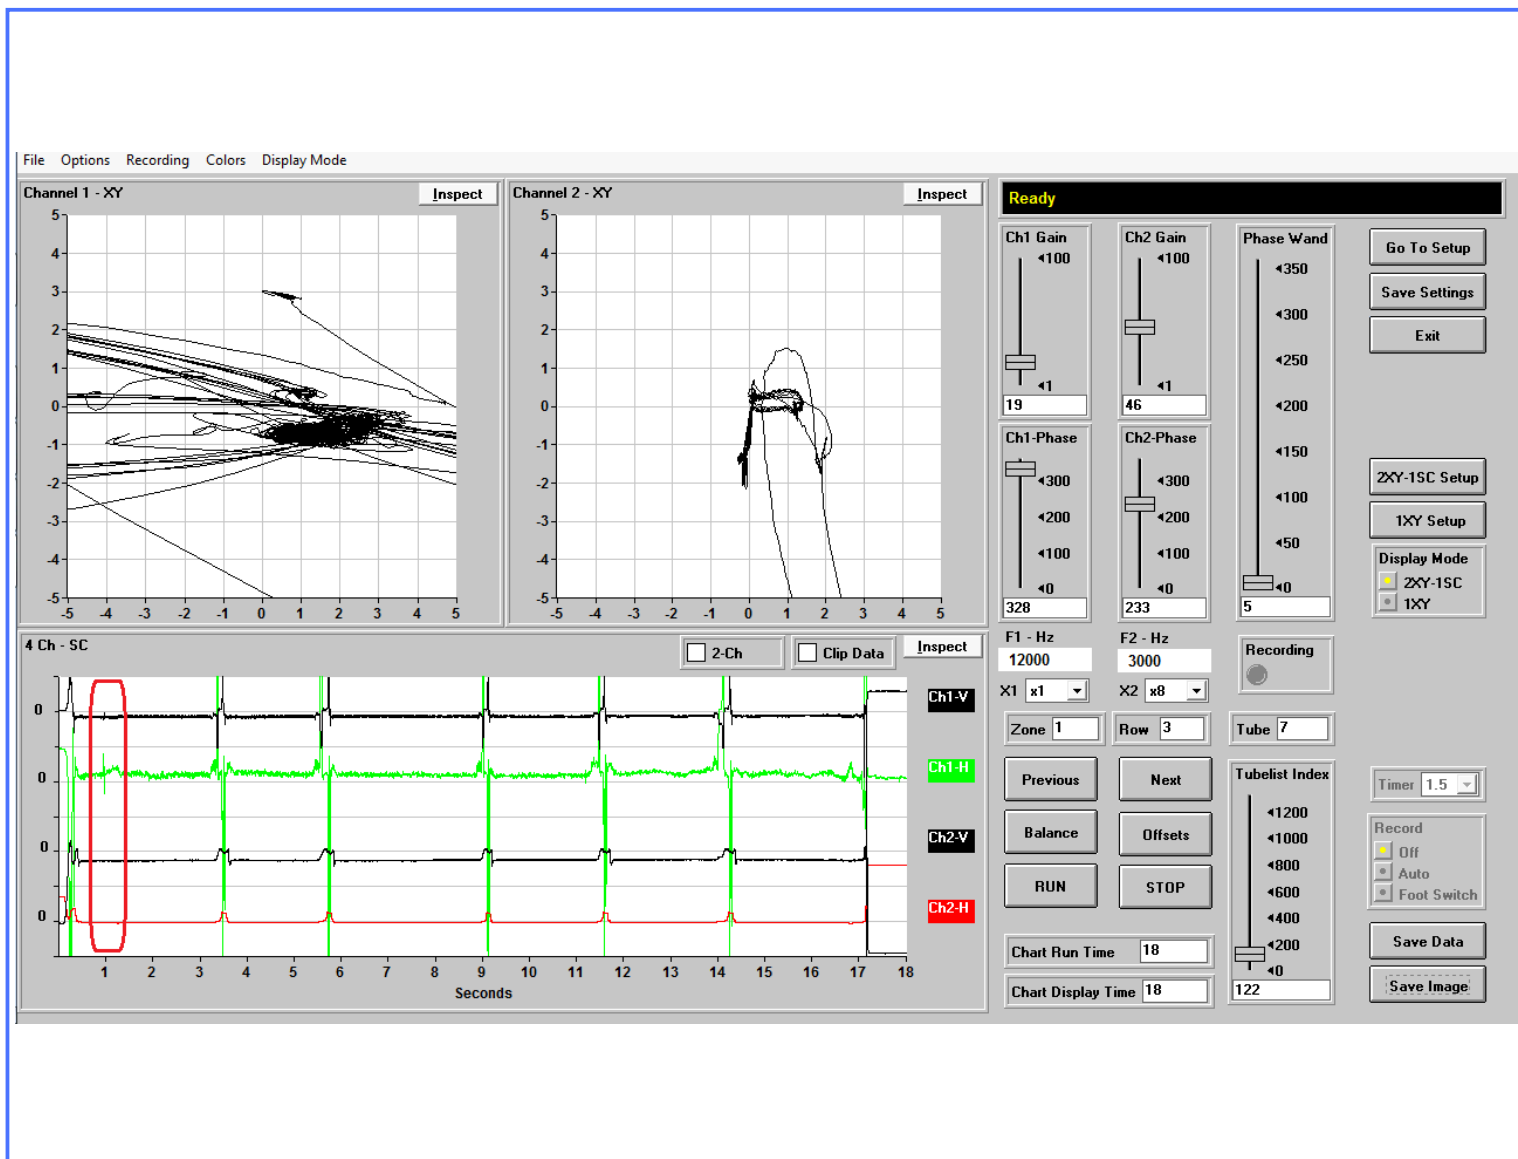
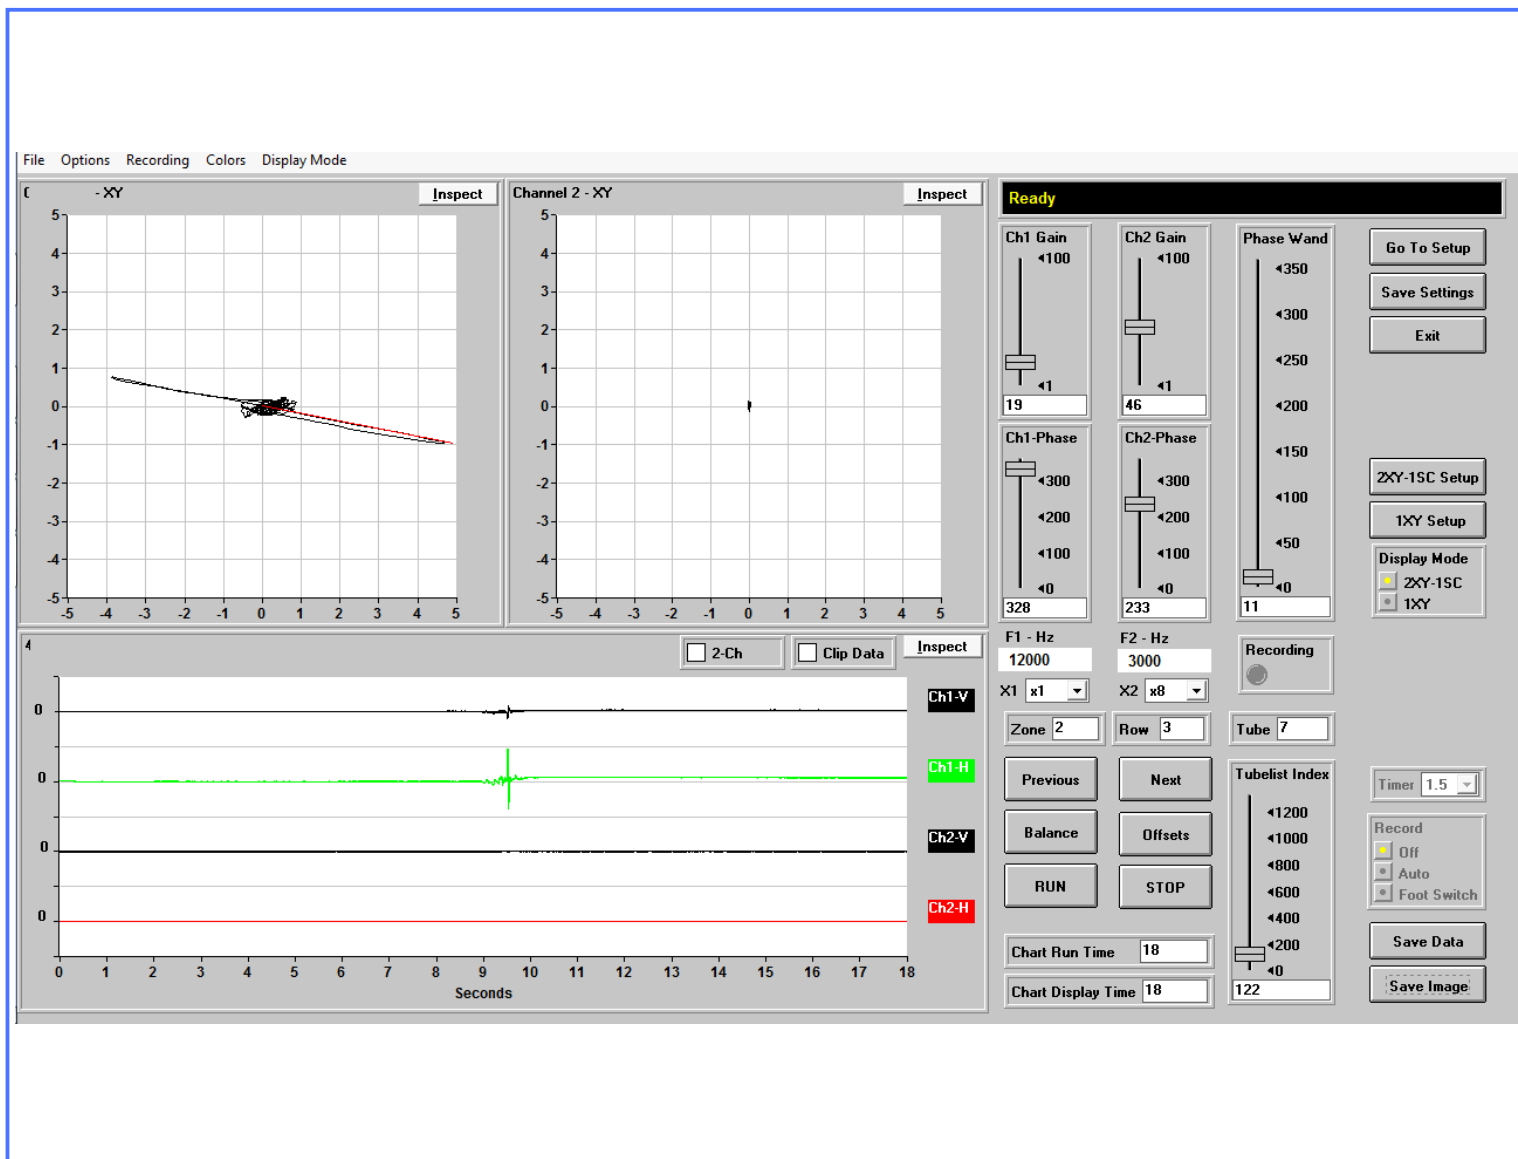
ID PIT 20% - 39% (Row 3 Tube 7)

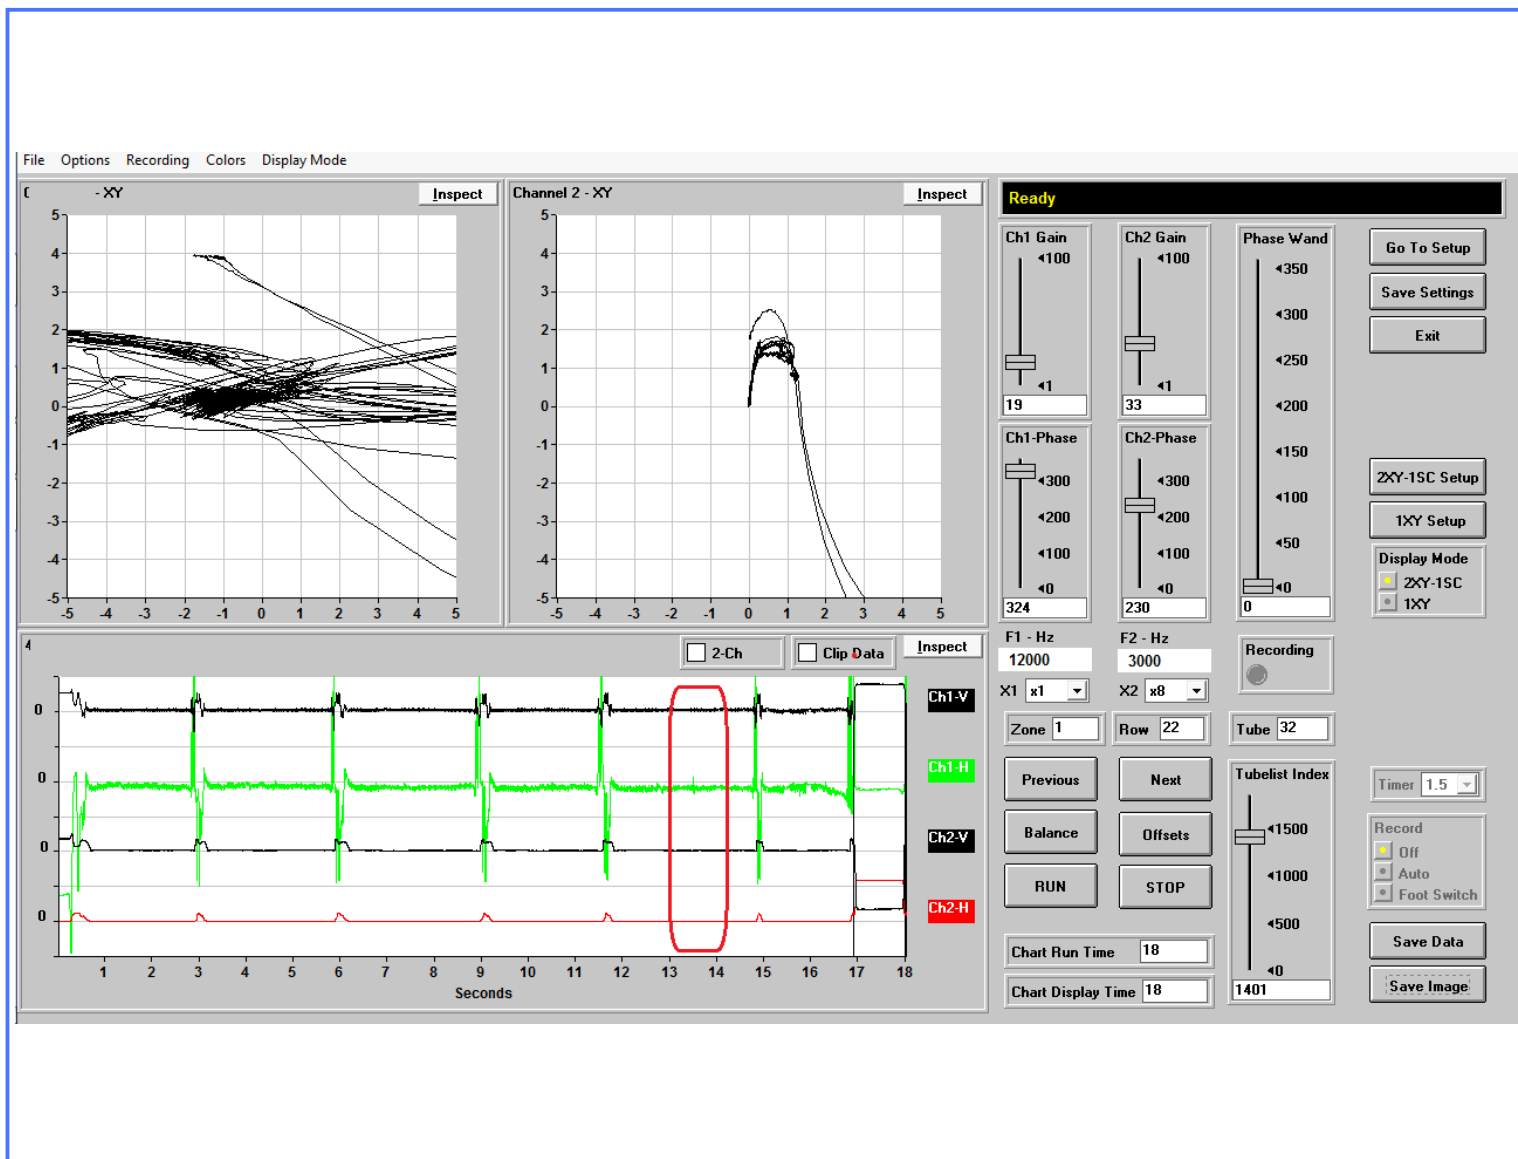
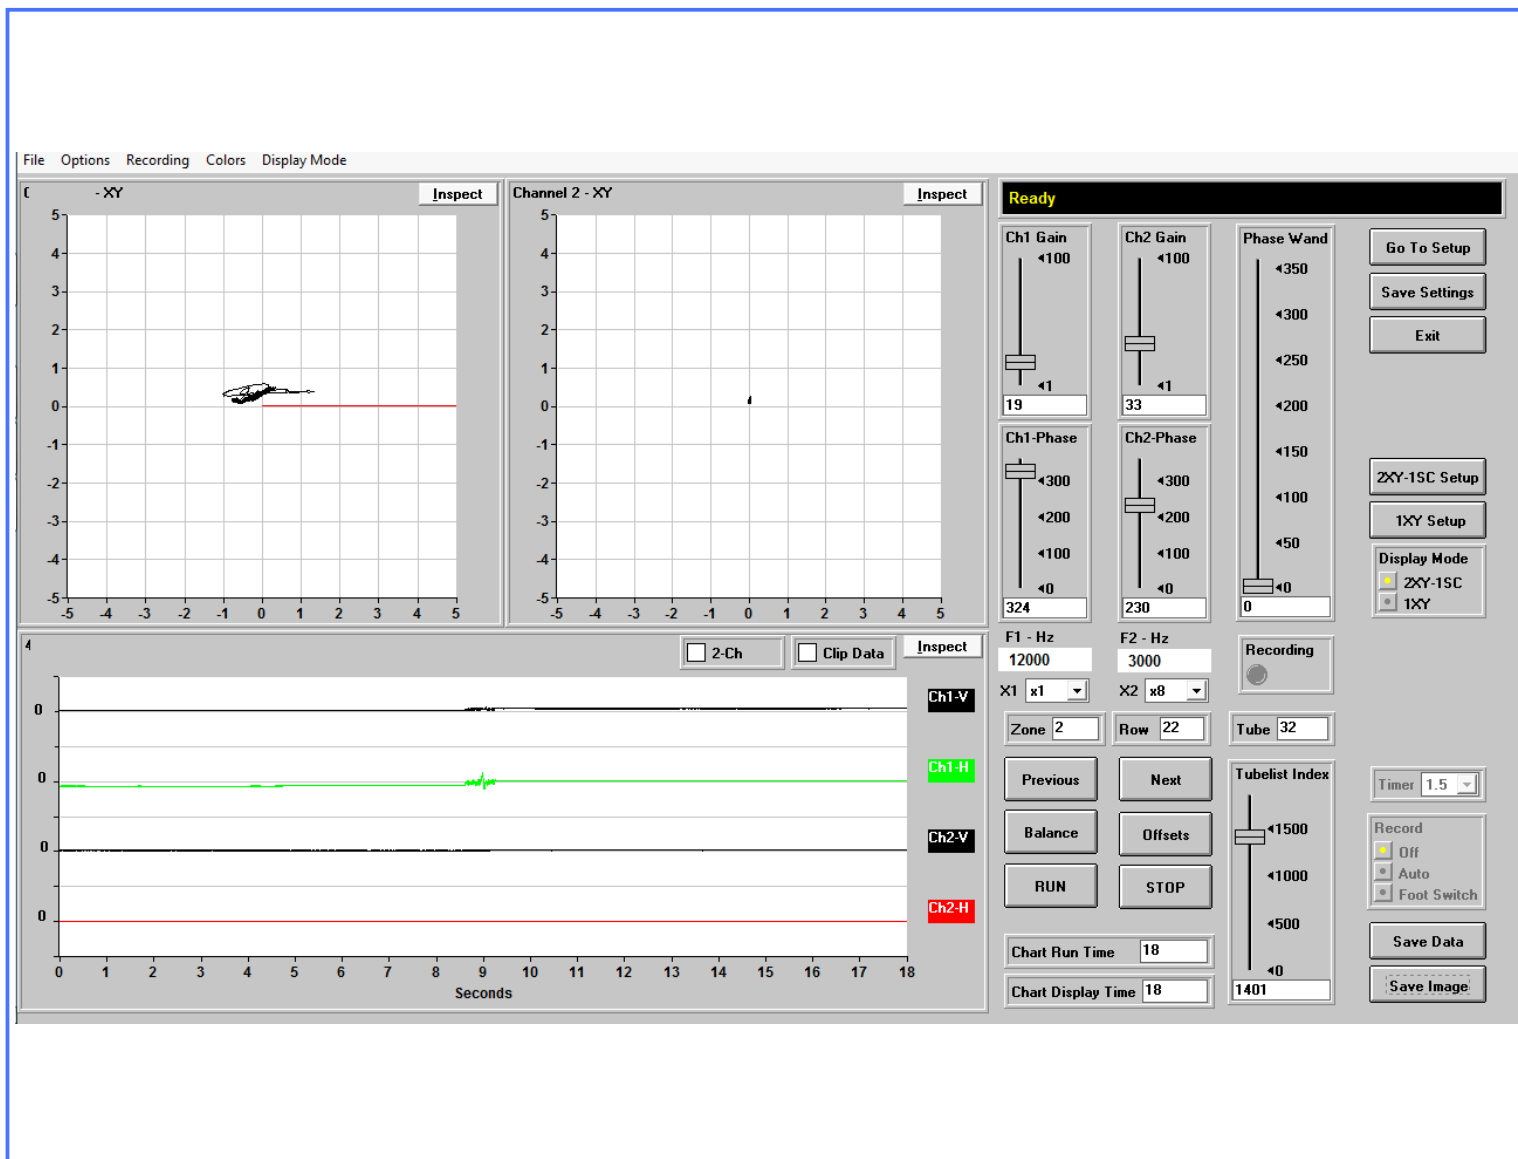
ID PIT < 20% (Row 22 Tube 32)

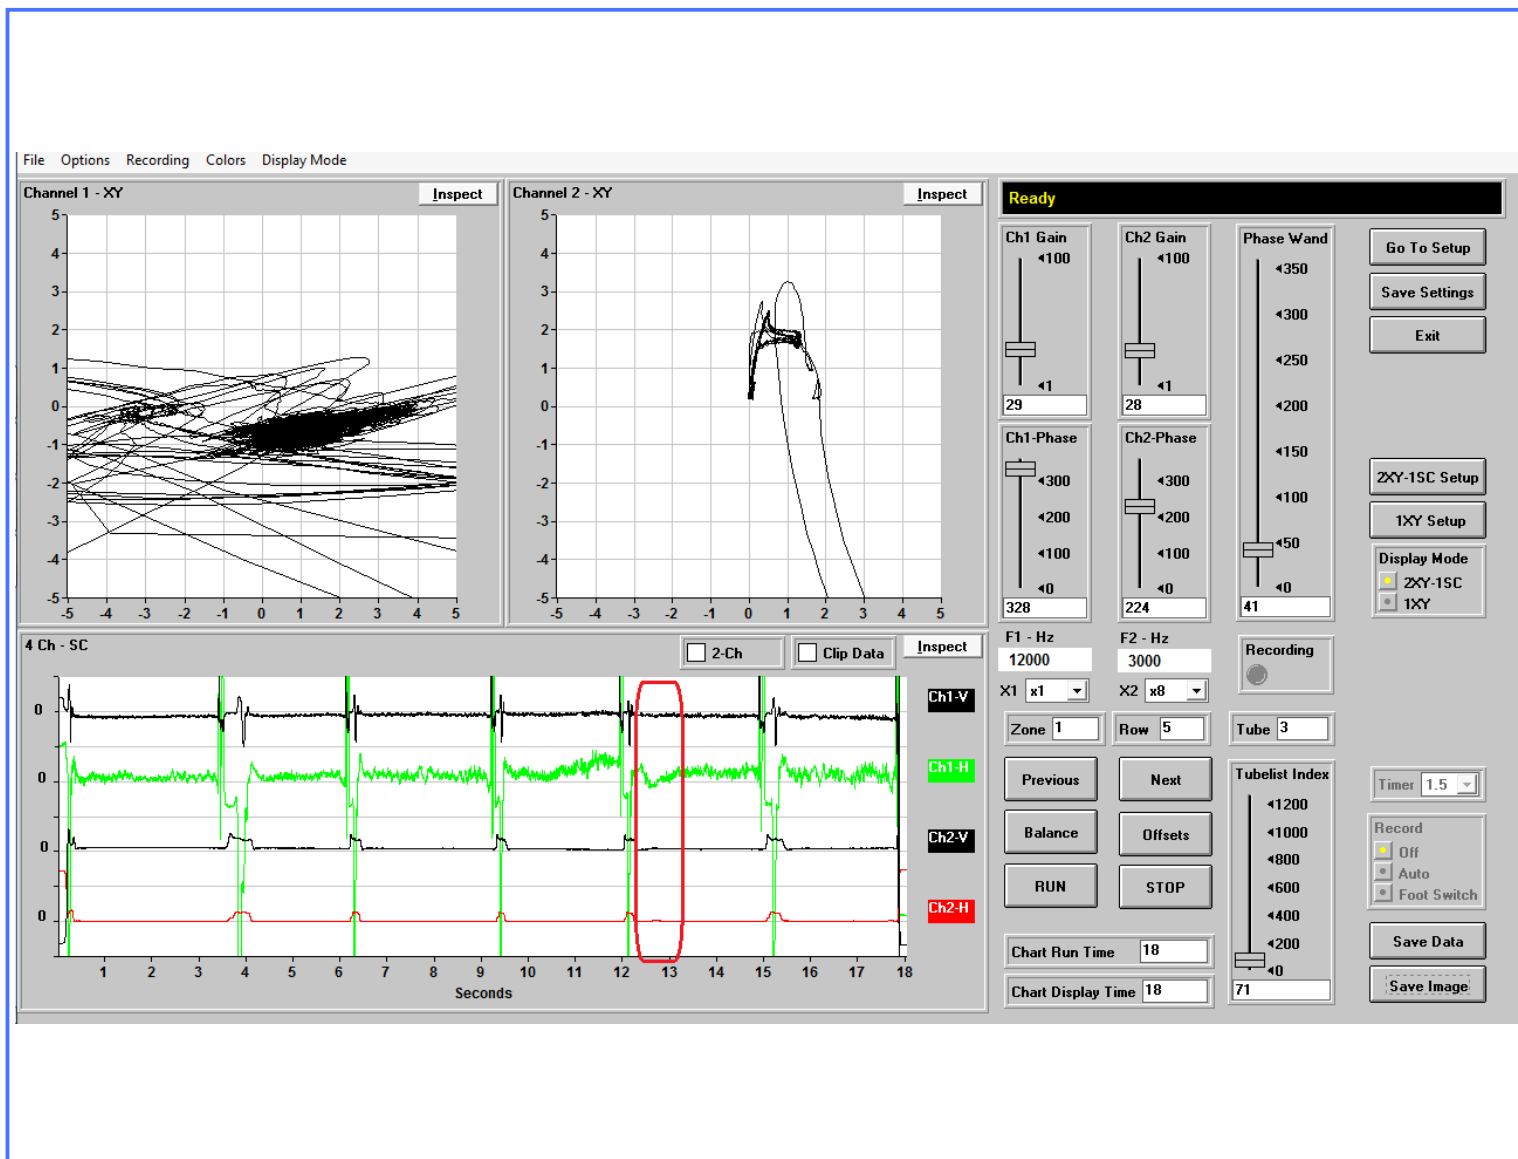
ID CORROSION < 20% (Row 5 Tube 3)

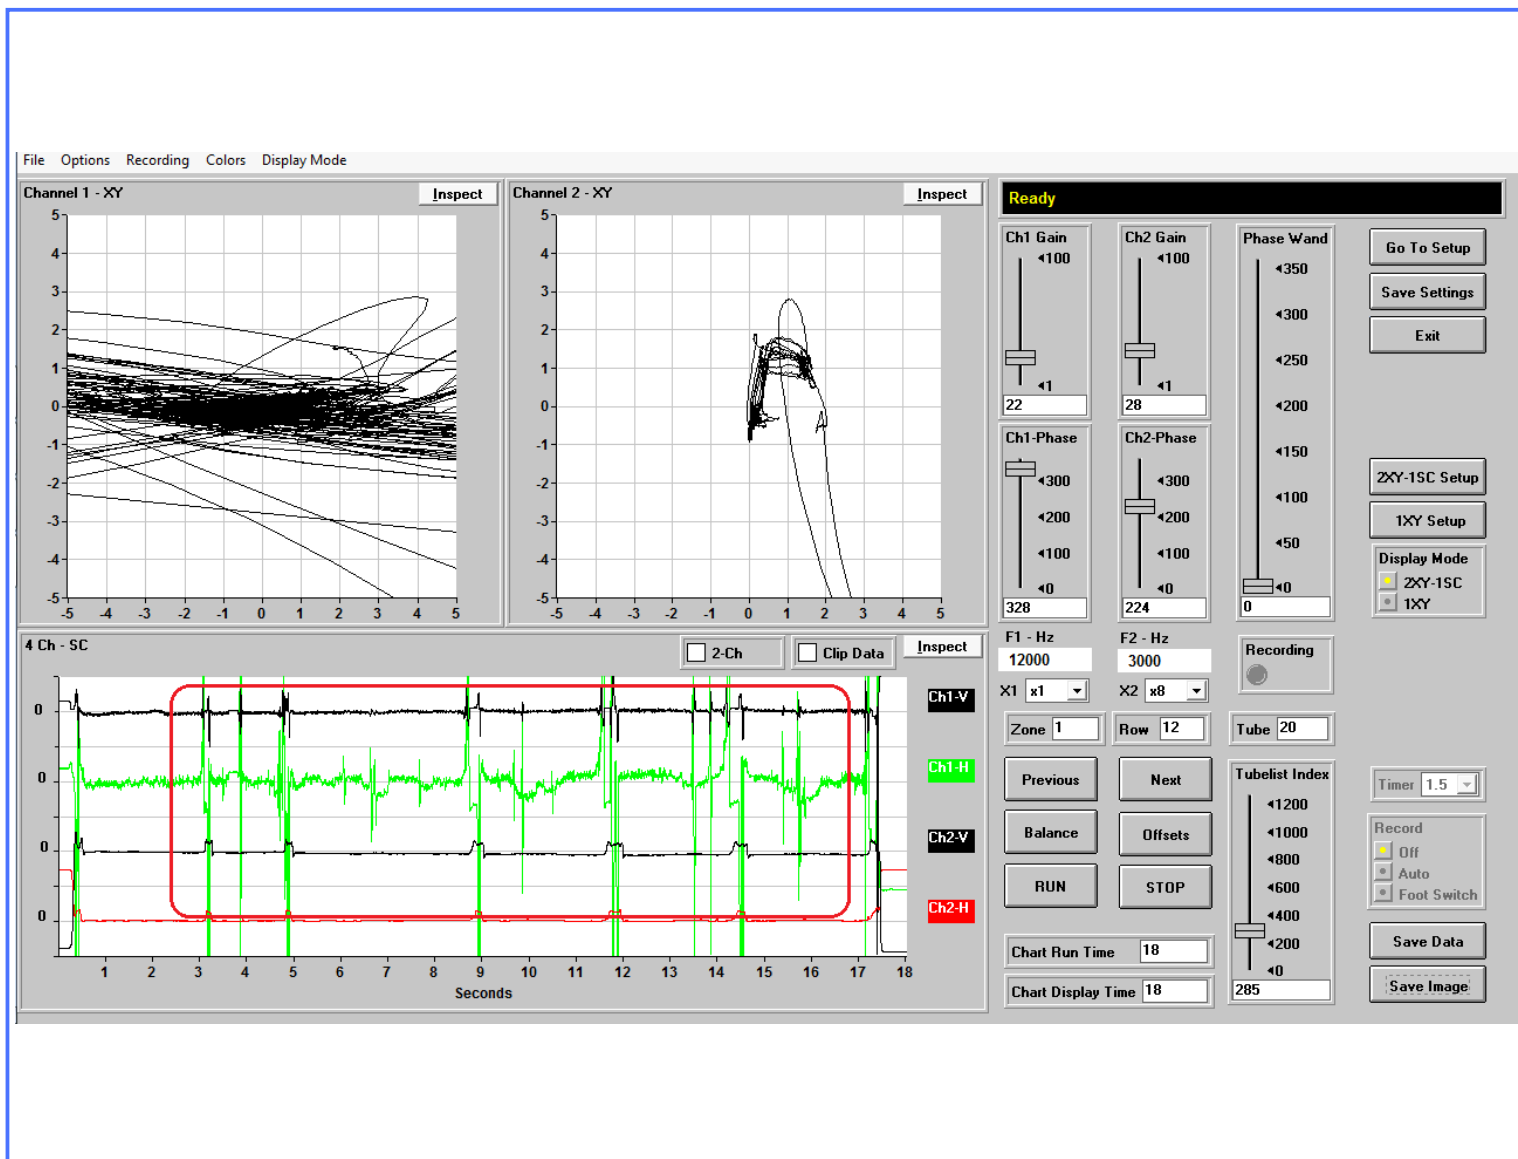
TESTED, DEBRIS (Row 12 Tube 20)
