## Report of Eddy Current Inspection

Manufacturer: York

Model: OM3000

Location: DUPONT EXPERIMENTAL STATION  
RT. 141 BETWEEN 52 & 202  
WILMINGTON, DE 19735

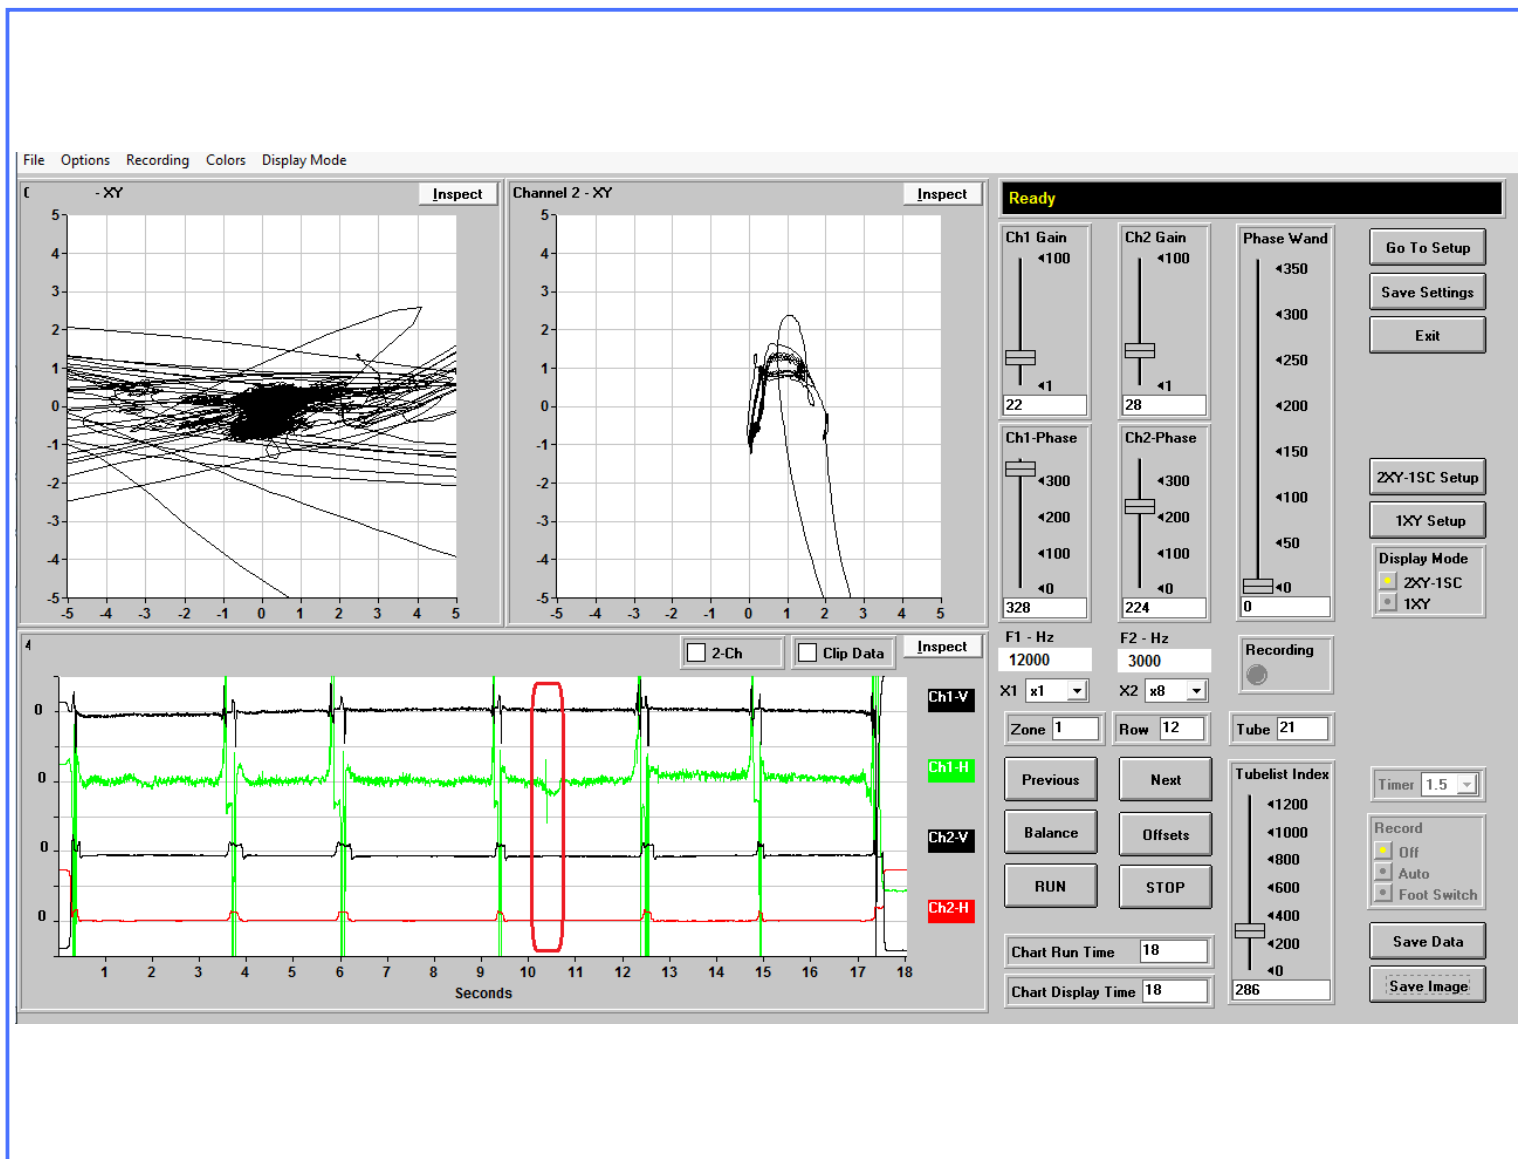
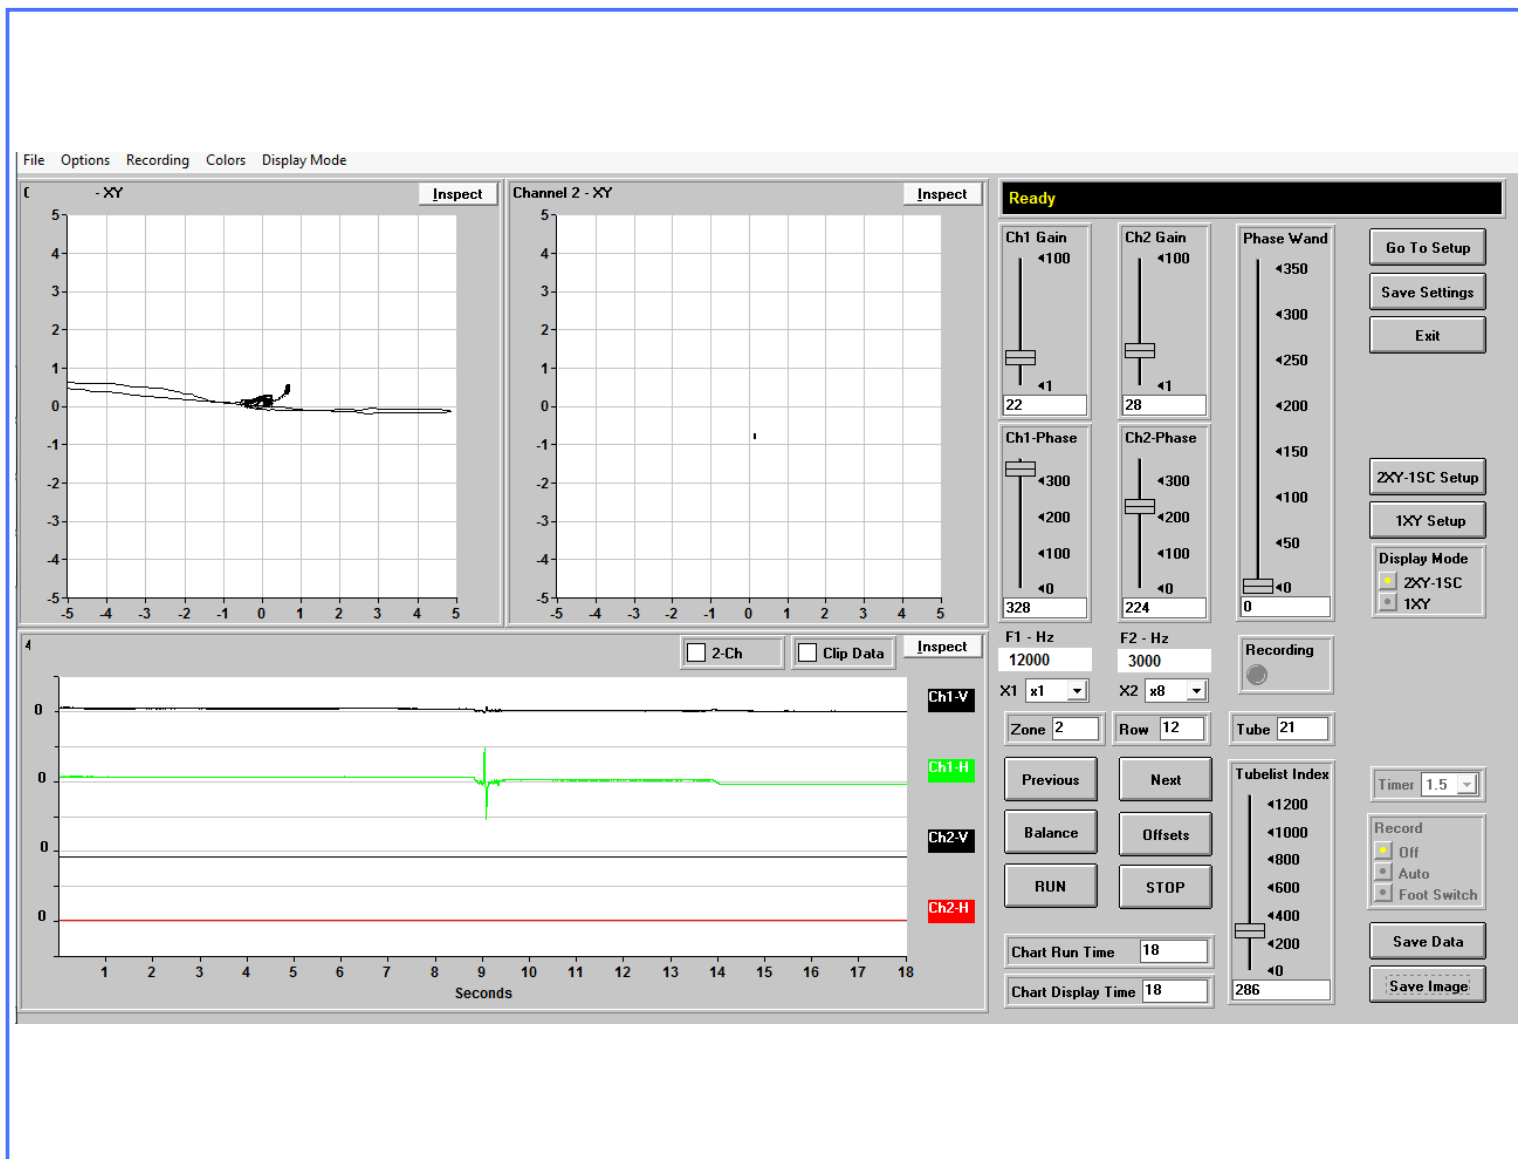
ID PIT < 20% (Row 12 Tube 21)

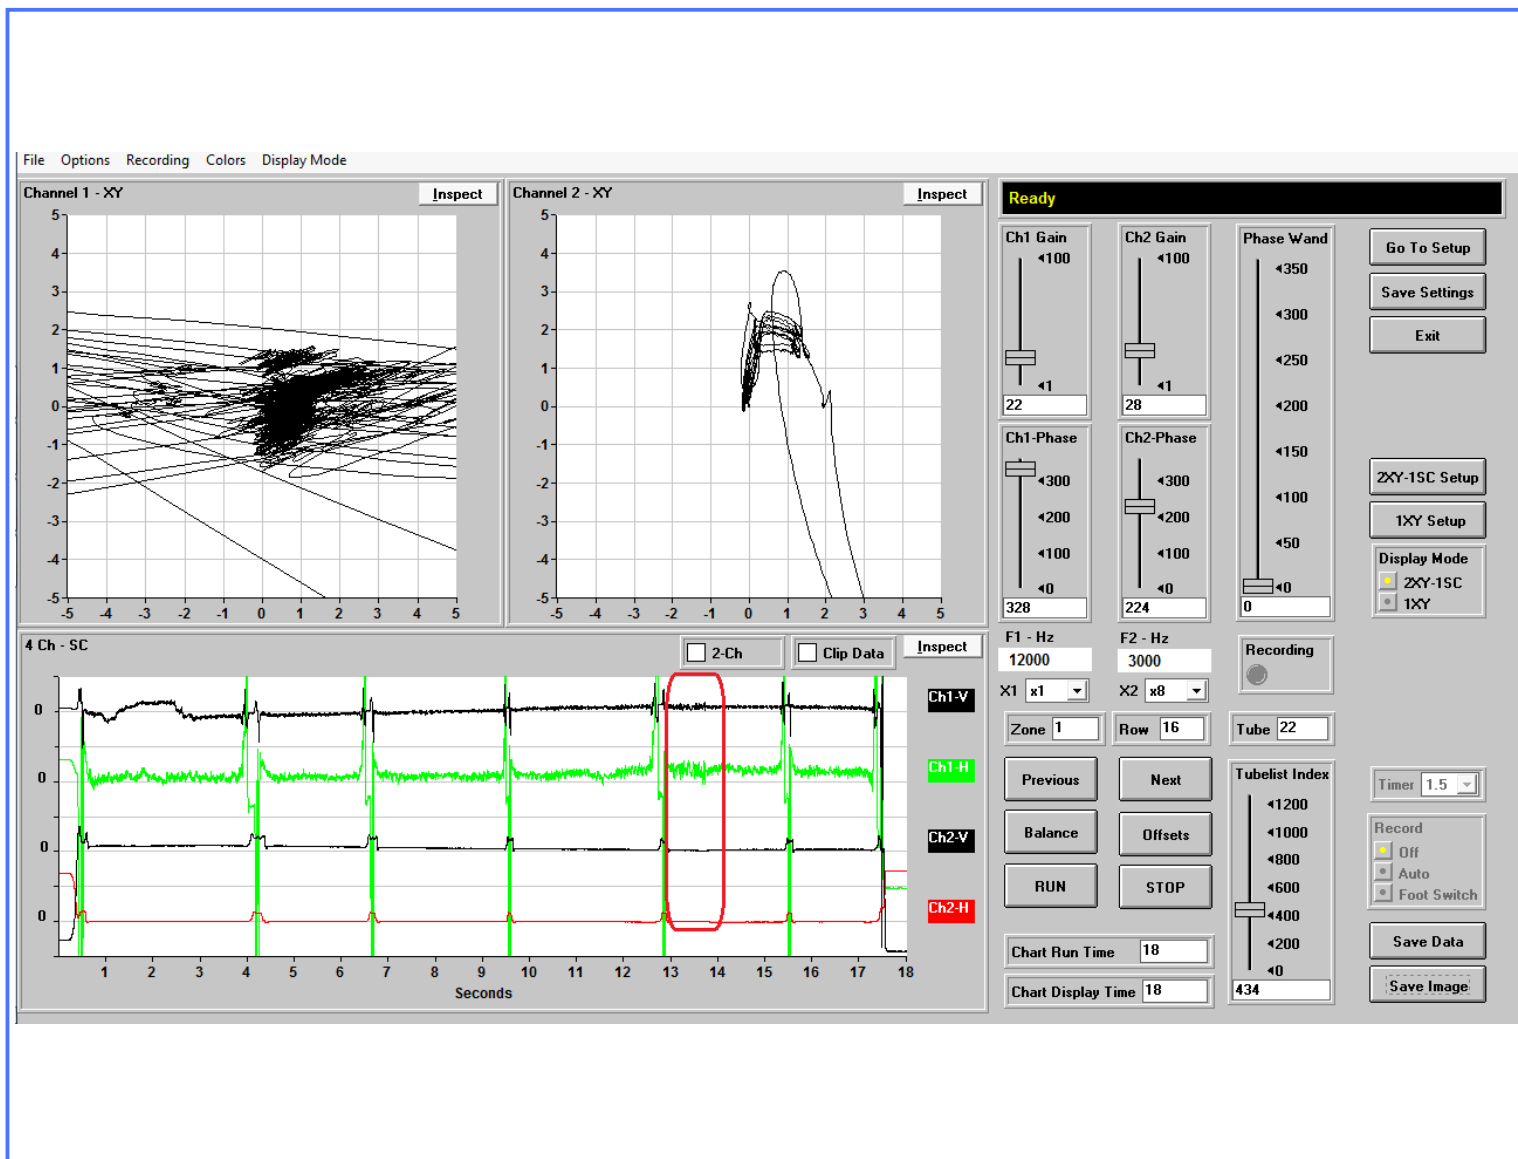
ID CORROSION < 20% (Row 16 Tube 22)

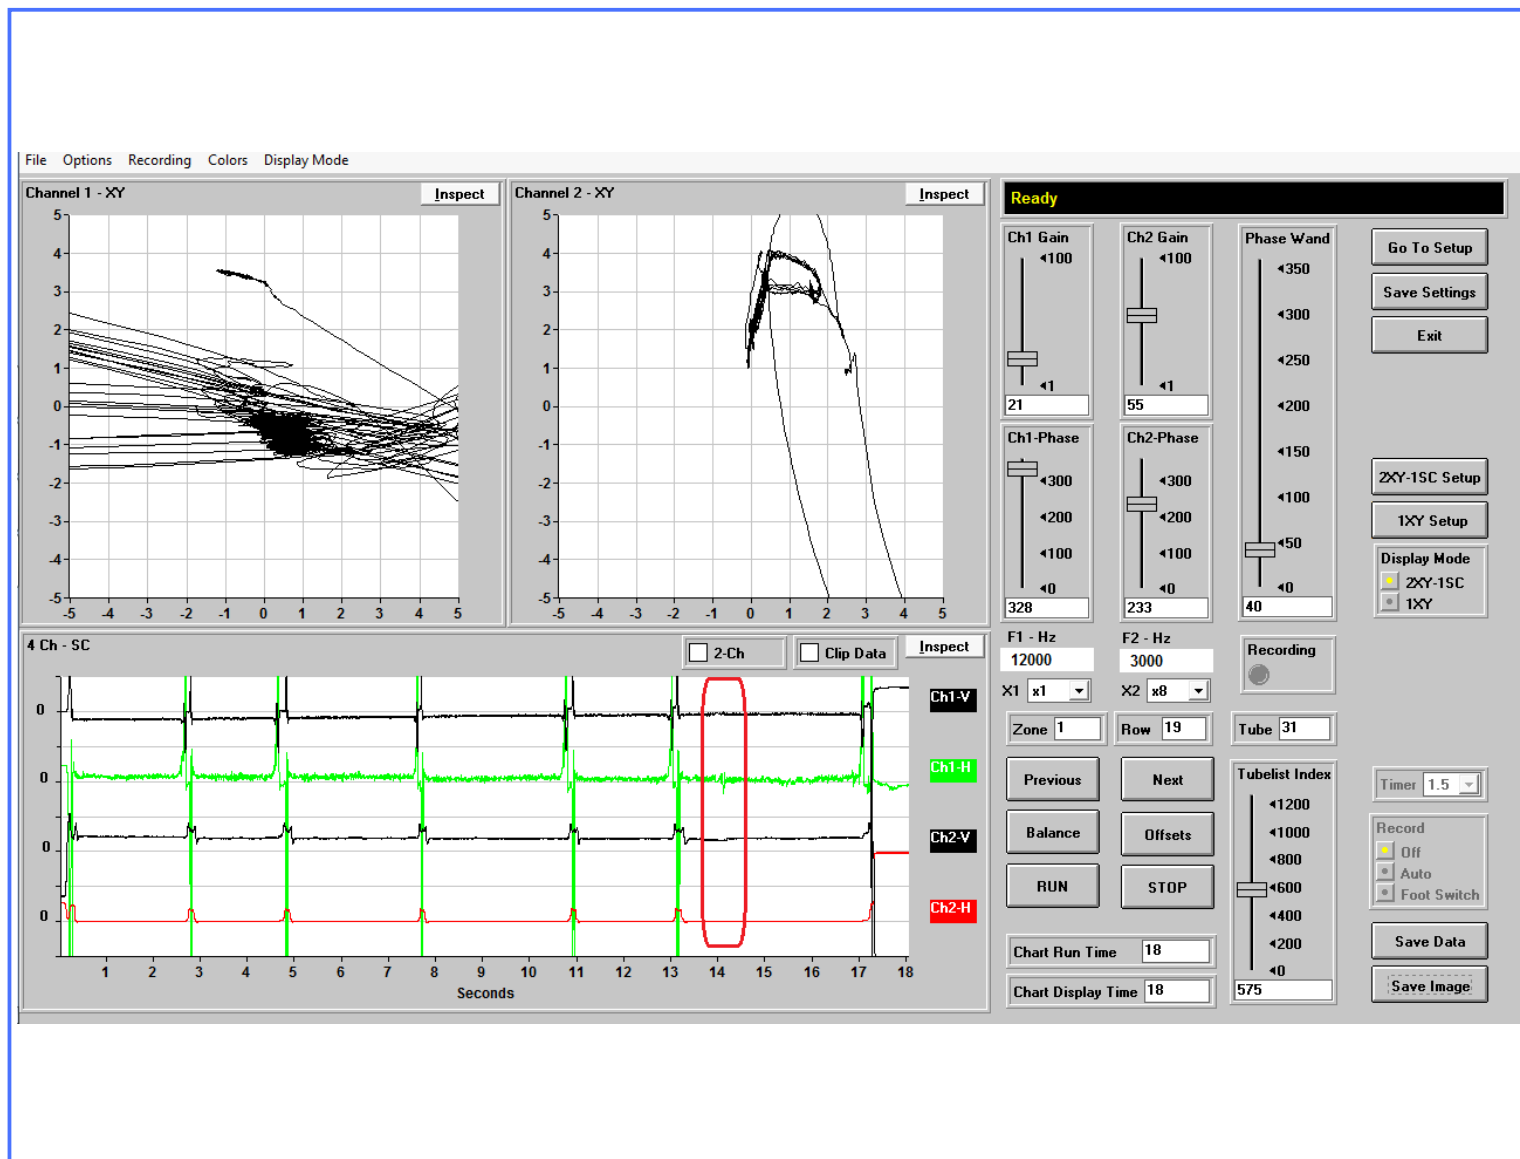
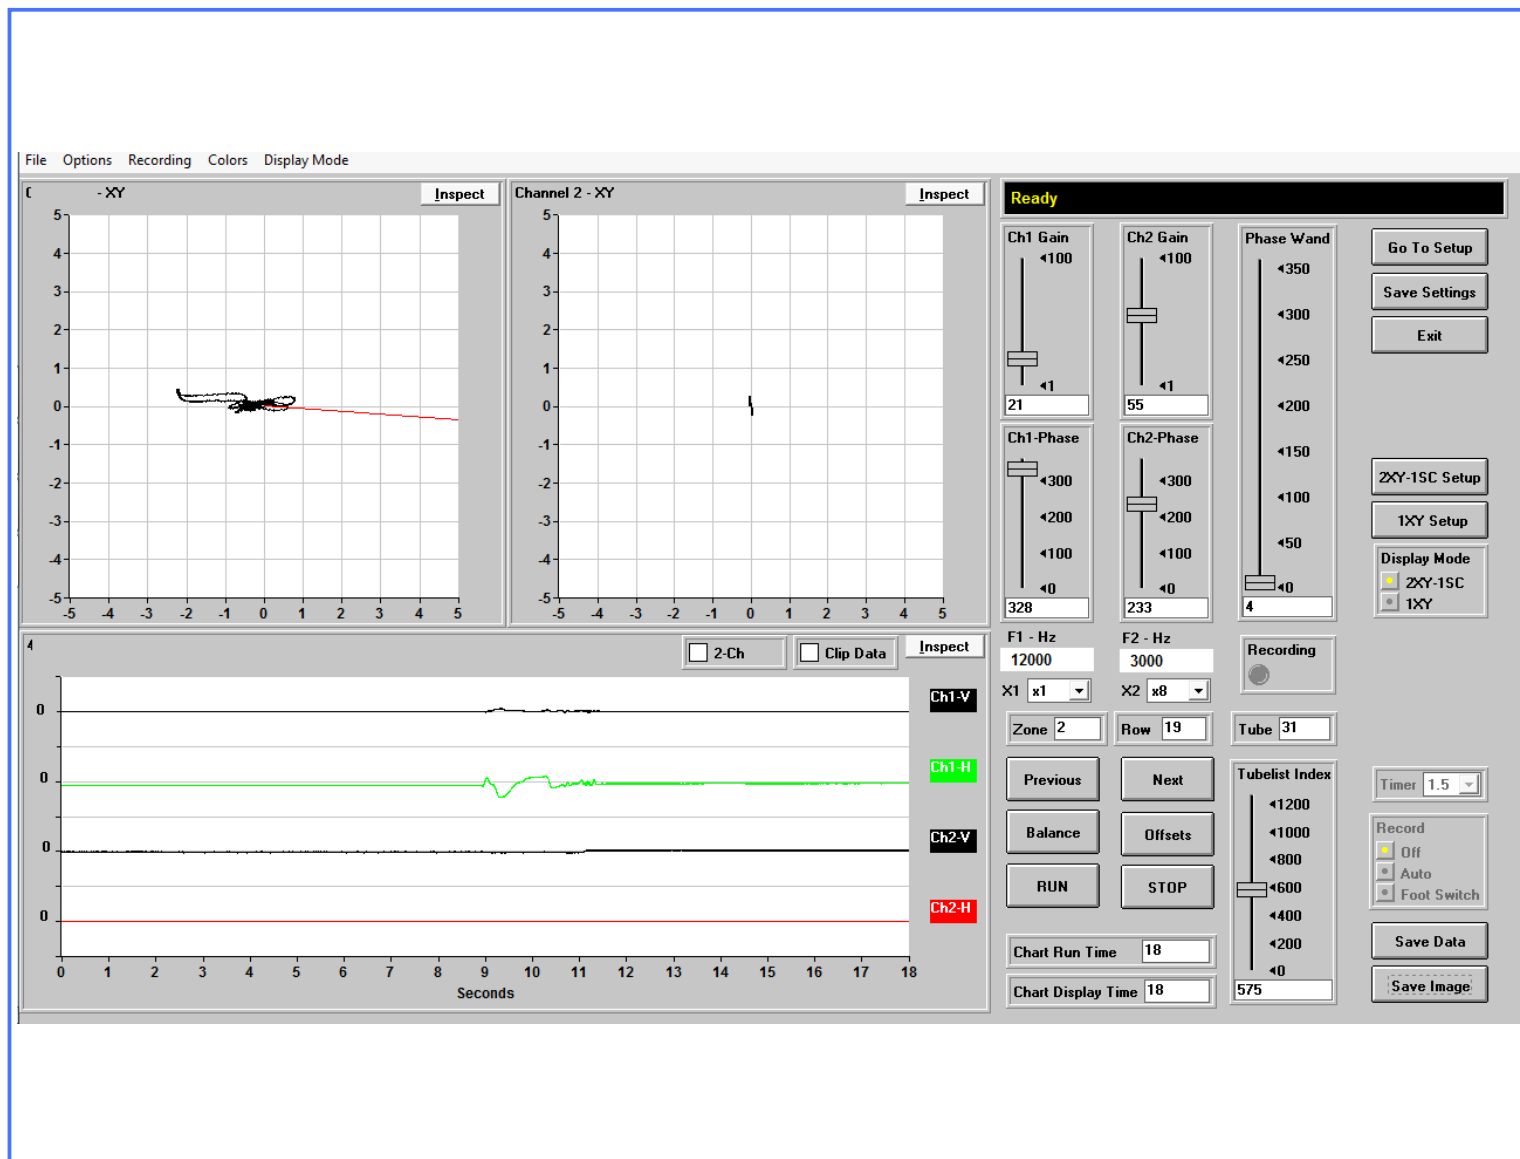
ID PIT 20% - 39% (Row 19 Tube 31)
