SB0028

ESG SERVICE BULLETINAffected Equipment: OptiView Panel Retrofits
HT/OT & Competitive Chillers**Subject: Recall of Retrofit Temperature Sensors 025-37825-004 & 025-37825-001
From Batches Manufactured 07/18/02 & Shipped 07/18/02 Thru 01/20/03****Issue Date: 01/28/03****Withdrawal Date: 02/28/03****Data Control Level: B****Materials Needed: Replacement Sensor 025-37825-004 and/or 025-37825-001****Tools Required: Combination Wrench (7/8"), Hand Tools and Pipe Thread Sealant****Estimated Time Required: 2 Hours for Sensors installed in Chillers****Warranty: Yes: Parts - Baltimore Parts Center. Labor: Service Aftermarket Warranty****Revision Notes: N/A****BACKGROUND**

025-37825-004 & 025-3785-001 Sensors Manufactured Jul 18, 2002 Failing Open Circuit

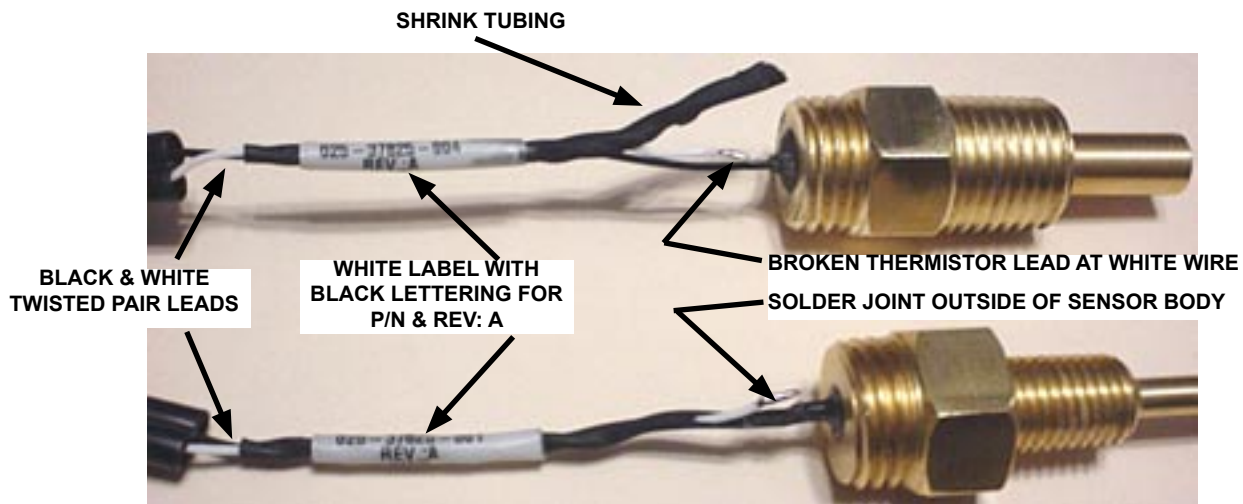
The Sensors thermistor-to-wire solder joints are supposed to be a minimum of ¼ " within the epoxied area of the sensor brass body. The affected sensors were mis-manufactured with the thermistor to white wire solder joint being made external to the epoxied area at the surface of the sensor body where normal bending of the lead wires is breaking the thermistor wire causing an open circuit failure of the sensor.

The recalled sensors are shown below with twisted pair black/white lead wires covered with black shrink tubing cut back to expose the broken thermistor lead at the solder joint to the White wire. The thermistor-to-wire solder joints are supposed to be a minimum of ¼ inch within the epoxied area of the sensor brass body.

When you have identified the number of the recalled Sensors that require replacements contact the Baltimore Parts Distribution Center (B-PDC) and request replacement sensors per B-PDC Warranty Return Authorization (WRA) procedures.

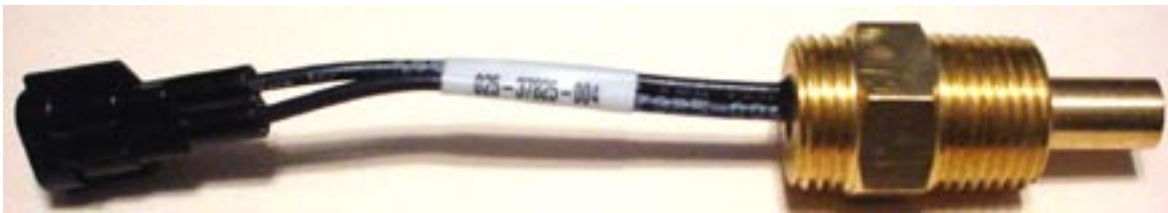
Below is a **Good 025-37825-004** sensor - shown with two single black lead wires and white label with black lettering of **P/N** on the first line and **MED** on the second line, wrapped around the wires.

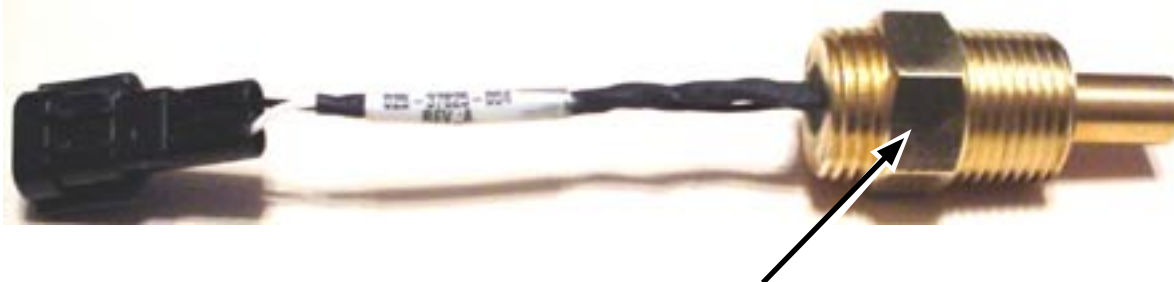
Below is a **Recalled 025-37825-004** sensor - shown with twisted pair black & white lead wires covered with black shrink tubing and white label with black lettering of **P/N** on the first line and **REV.:A** on the second line, wrapped around the shrink tubing.

The replacement sensor will be the same as above but will have **0103** (Jan 2003 mfg.) engraved on one of the sensor body flats.

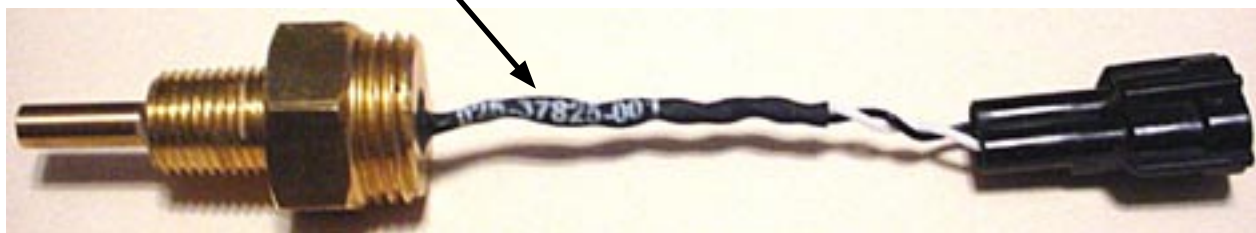
Below is a **Good 025-37825-001** sensor - shown with twisted pair black & white lead wires covered with black shrink tubing and white lettering of P/N imprinted directly on the shrink tubing.

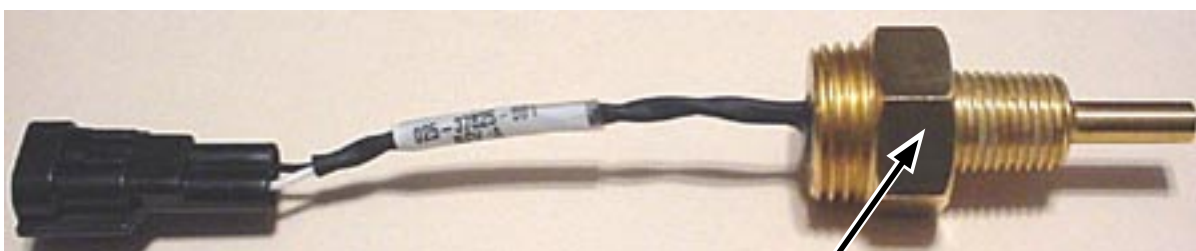
Below is a **Recalled 025-37825-001** sensor - shown with twisted pair black & white lead wires covered with black shrink tubing and white label with black lettering of P/N on the first line and **REV.:A** on the second line, wrapped around the shrink tubing.

The replacement sensor will be the same as above but will have **0103** (Jan 2003 mfg.) engraved on one of the sensor body flats.
