JOHNSON CONTROLS, INC.
812 First State Blvd
Delmarva Branch N28
Wilmington, DE 19804
(302)996-0275

Report of Eddy Current Inspection

Serial: GACM127699 #10

Location: DUPONT EXPERIMENTAL STATION
RTE. 141 BETWEEN 52 & 202
WILMINGTON, DE 19735

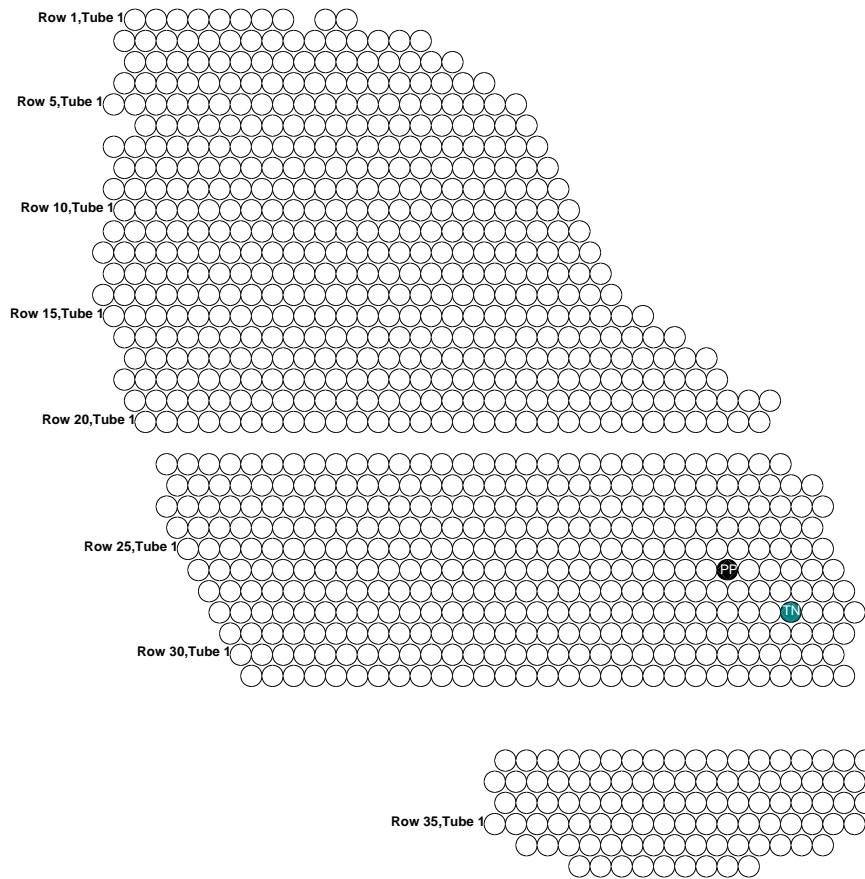
Condenser Section

Tubes marked as Previously Plugged, had been plugged prior to this inspection.

Tubes marked as Tested, No Measurable Defects were marked during the previous inspection as having ID Pits. The previously marked defects were not detectable during this inspection. The indications are believed to have been caused by debris and/or foreign material which is not present now.

PP = PREVIOUSLY PLUGGED

TN = TESTED, NO DEFECTS

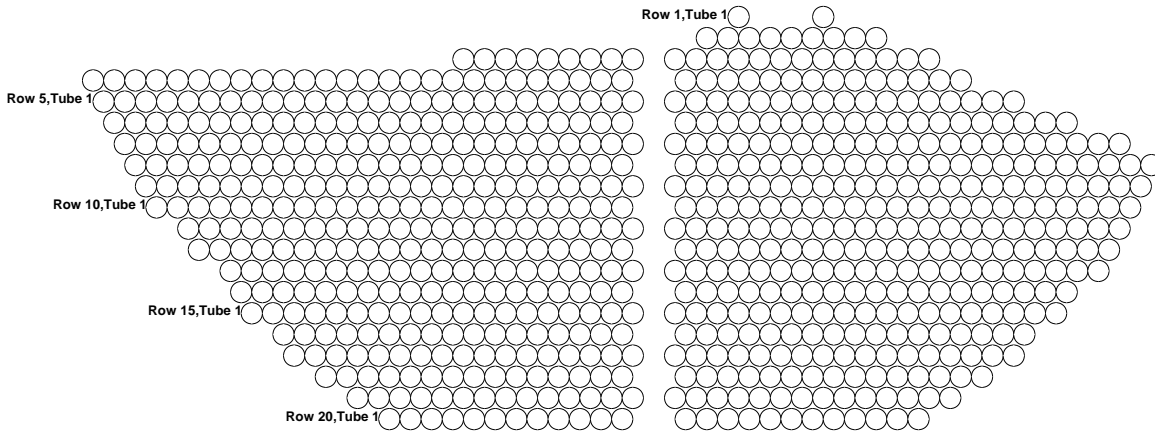
Evaporator Section

No Significant defects were found.

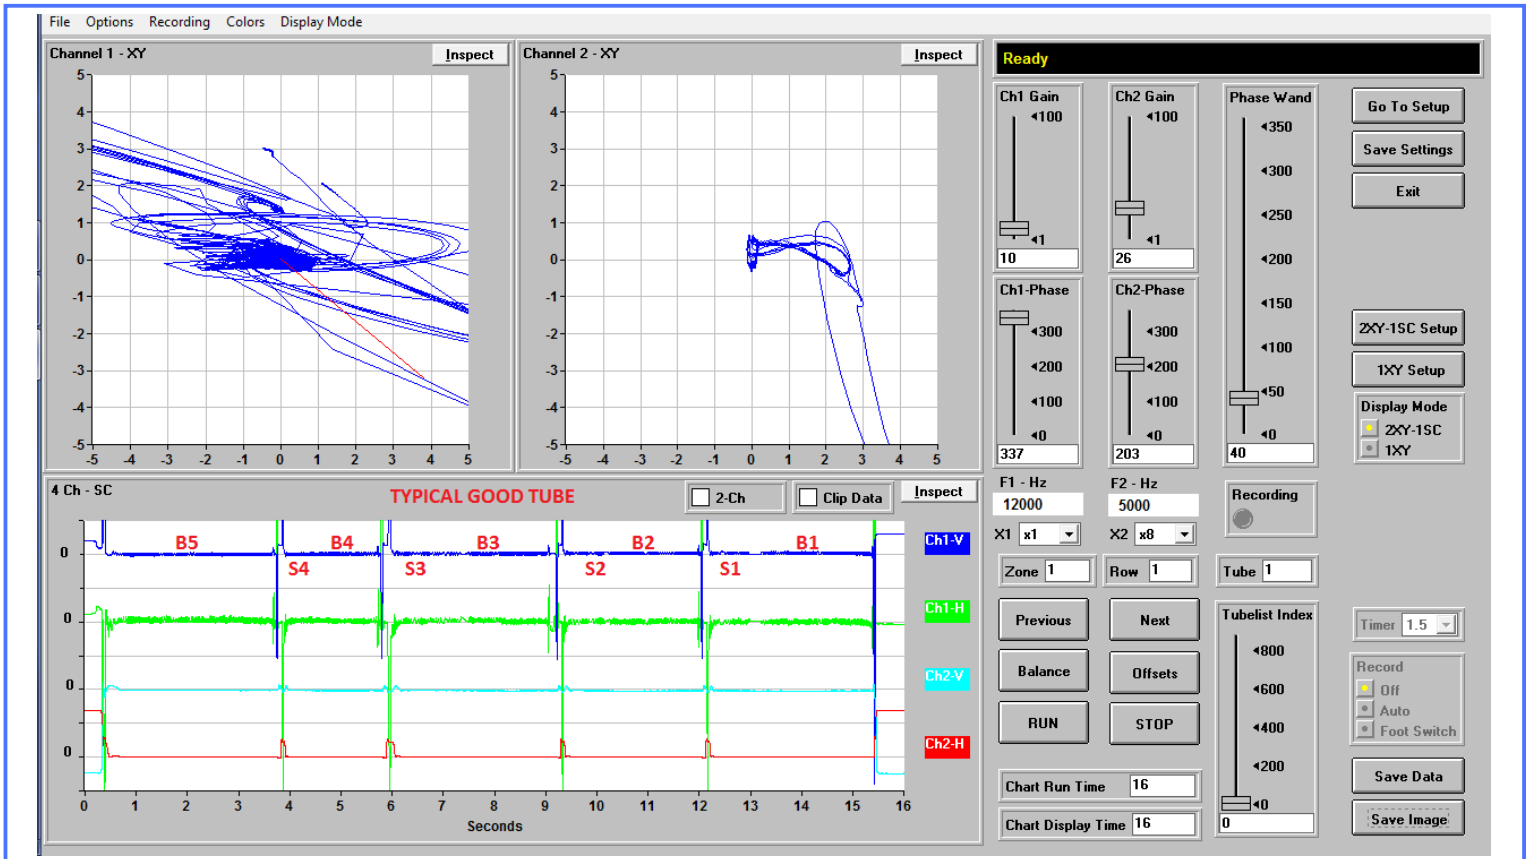
NO SIGNIFICANT DEFECTS (Row 1 Tube 1)

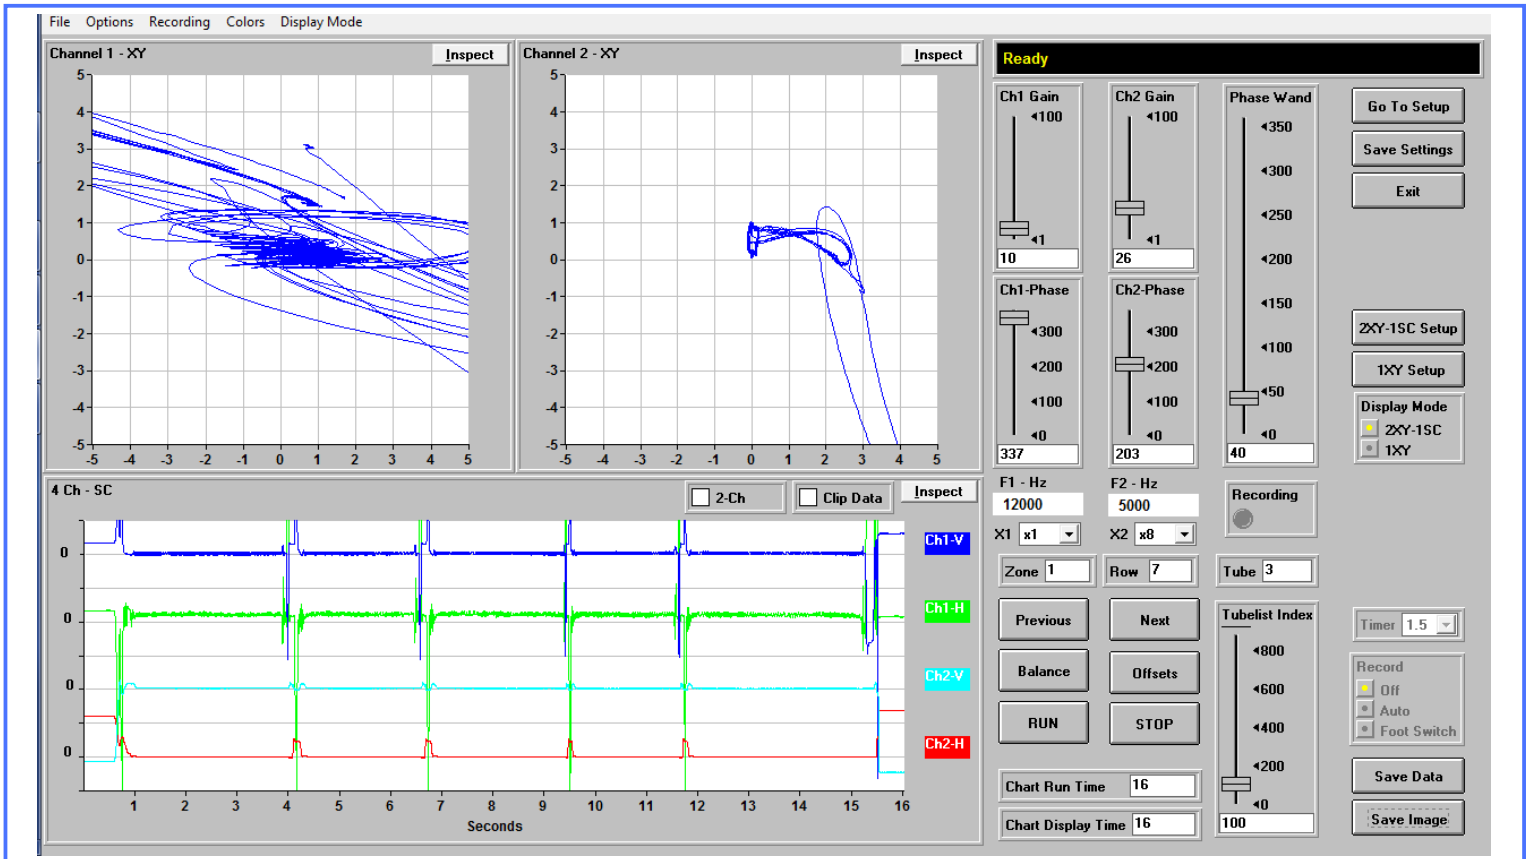
NO SIGNIFICANT DEFECTS (Row 7 Tube 3)

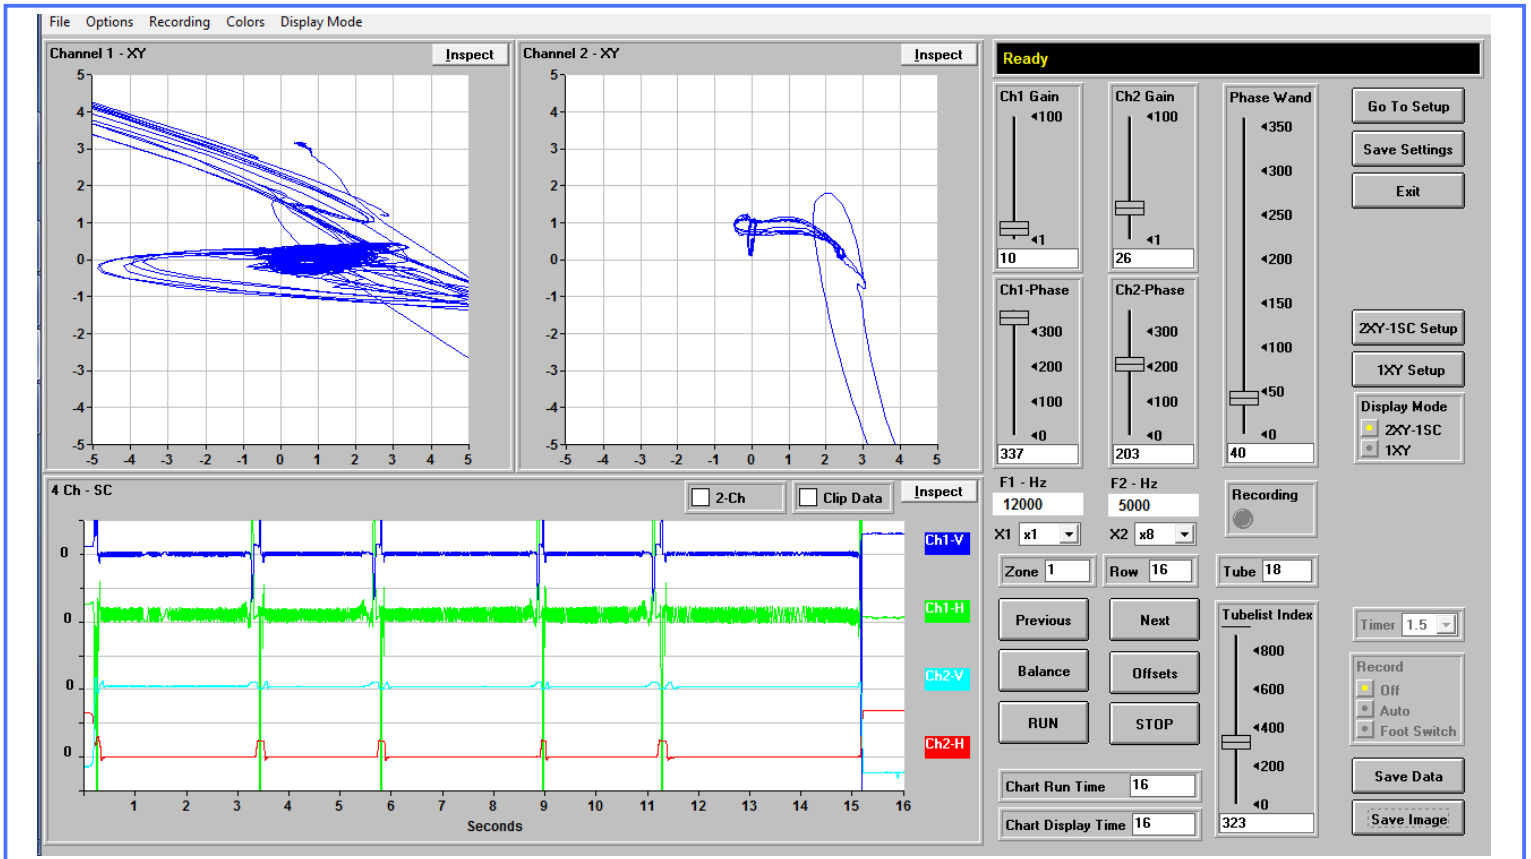
NO SIGNIFICANT DEFECTS (Row 16 Tube 18)

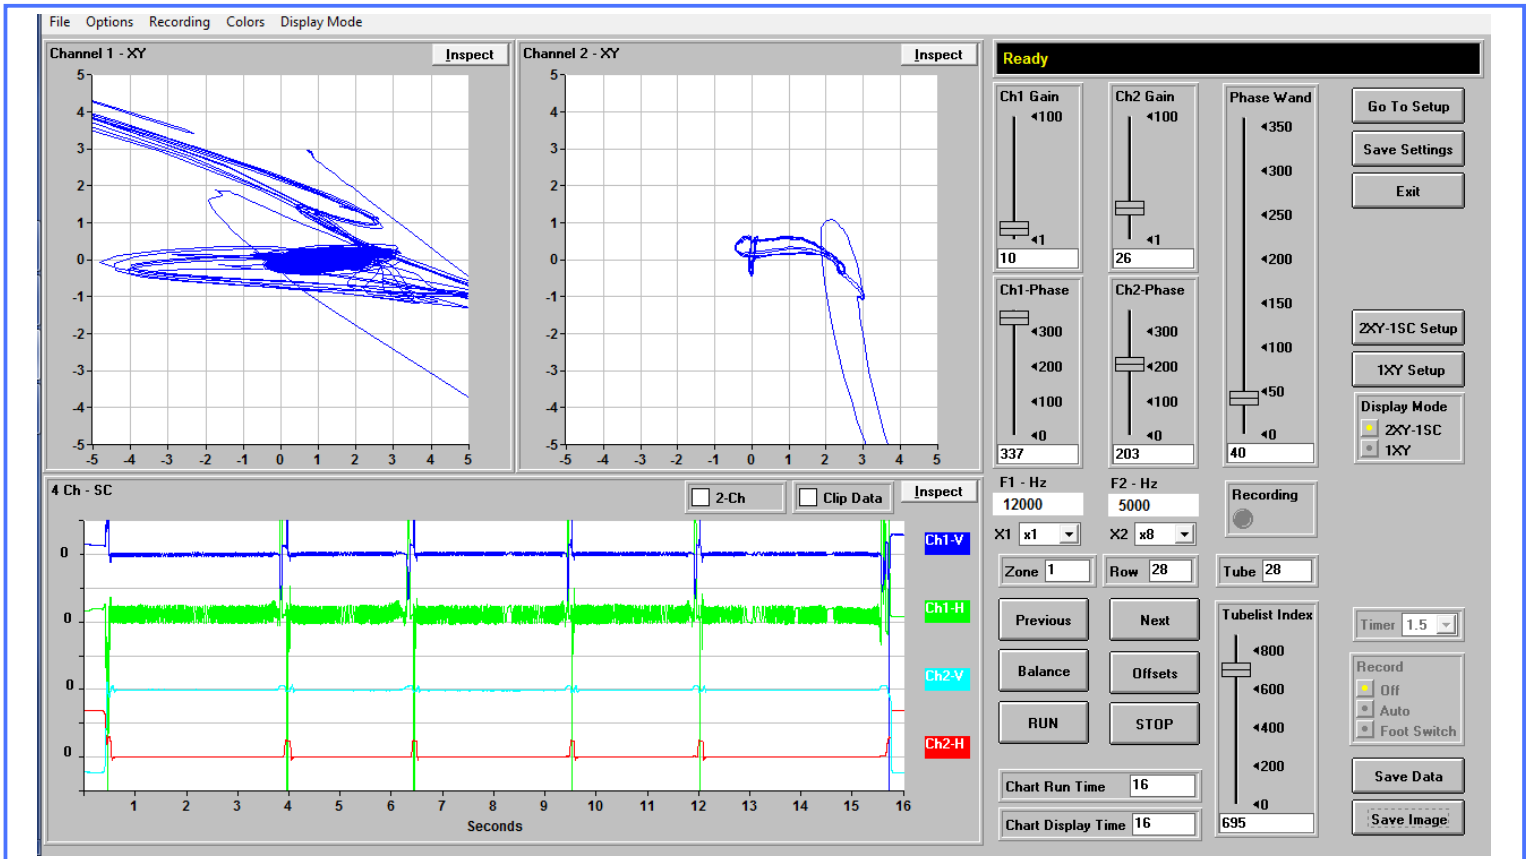
TESTED, NO DEFECTS (Row 28 Tube 28)

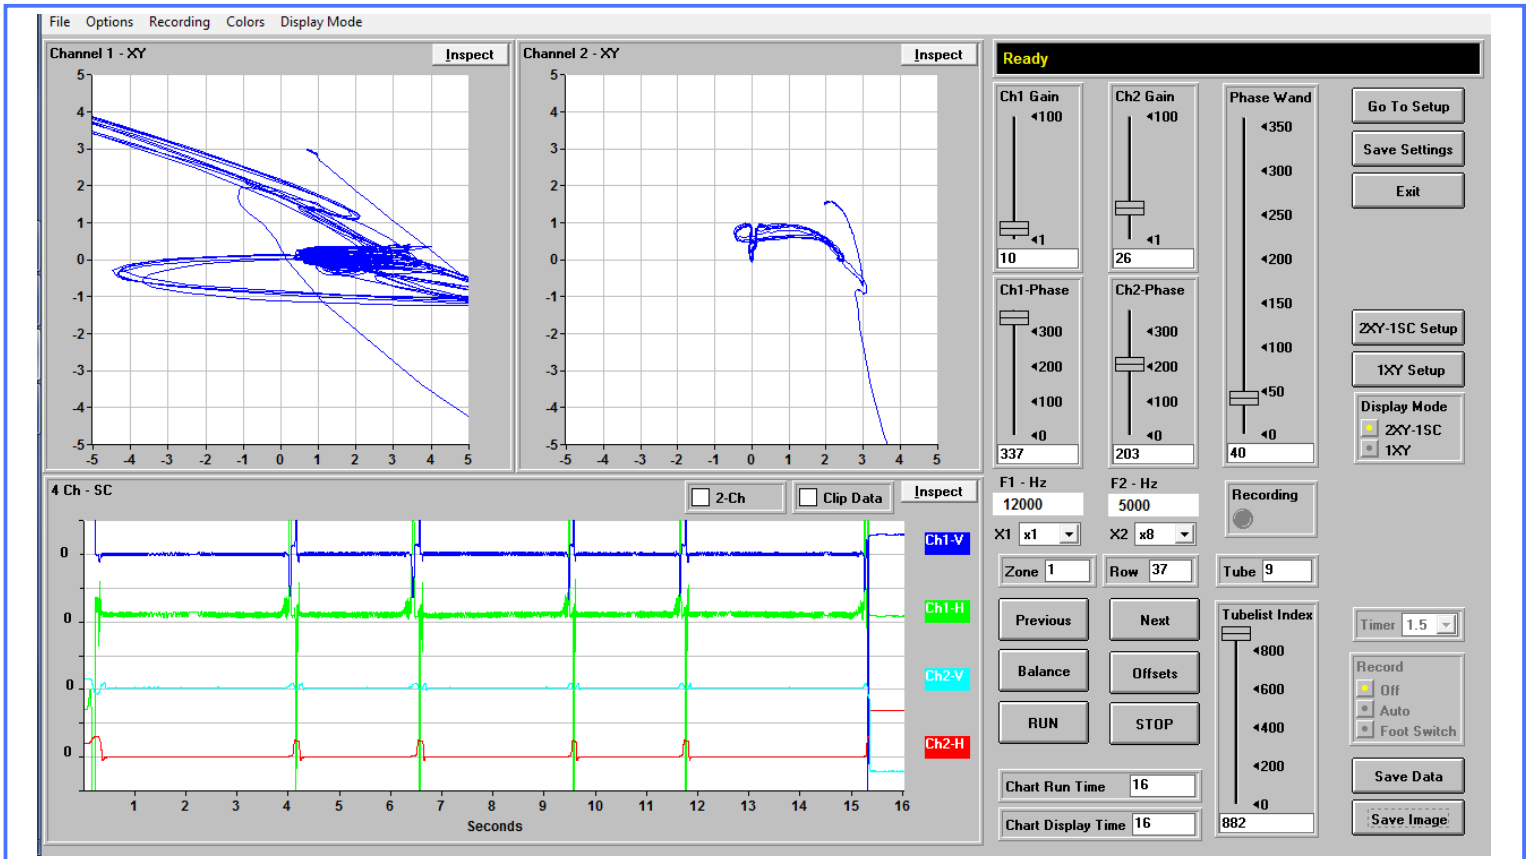
NO SIGNIFICANT DEFECTS (Row 37 Tube 9)

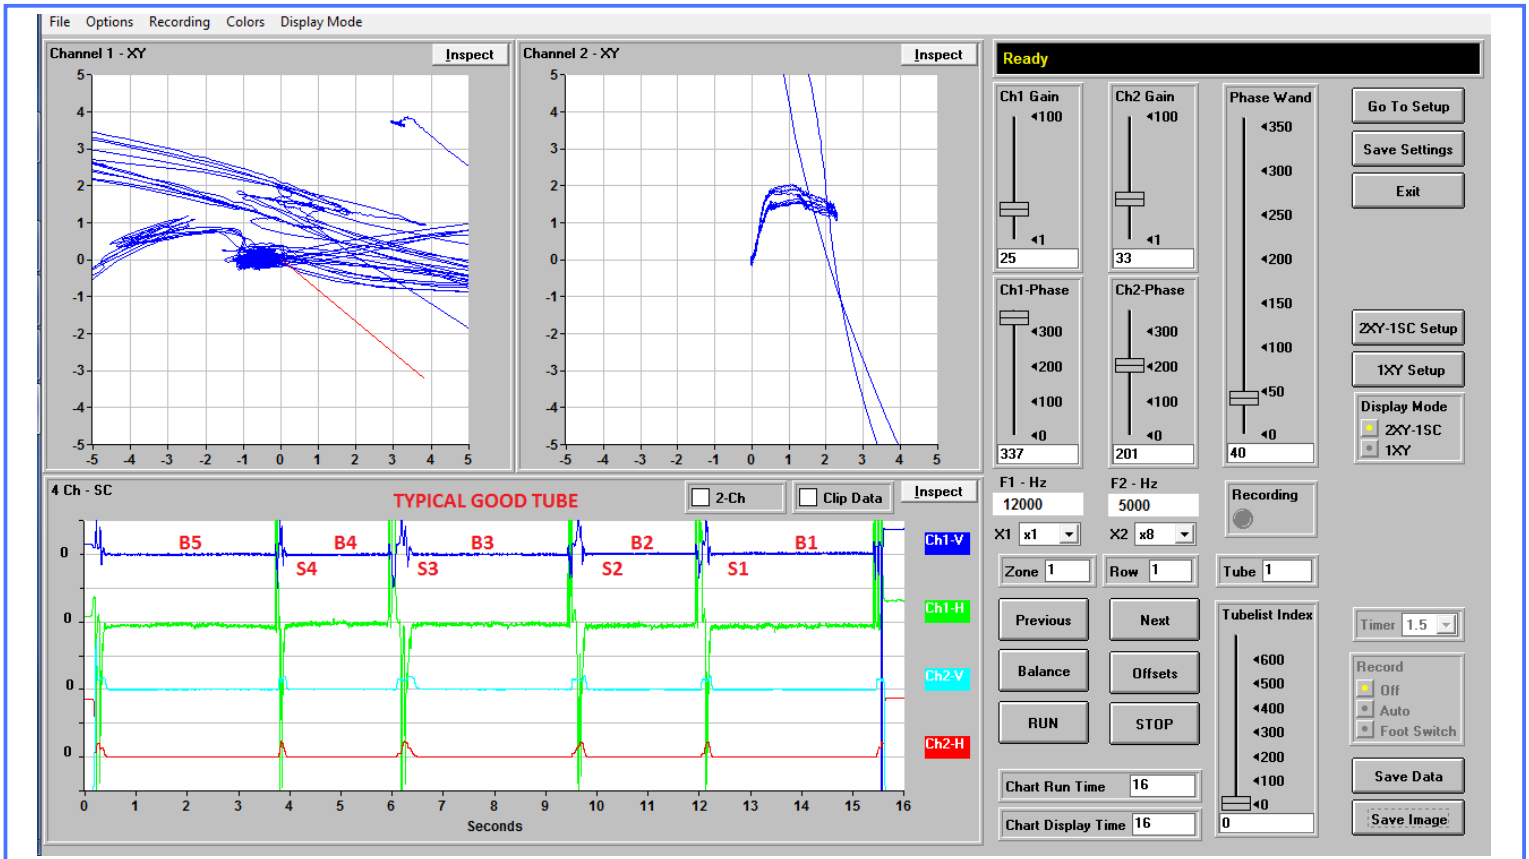
NO SIGNIFICANT DEFECTS (Row 1 Tube 1)

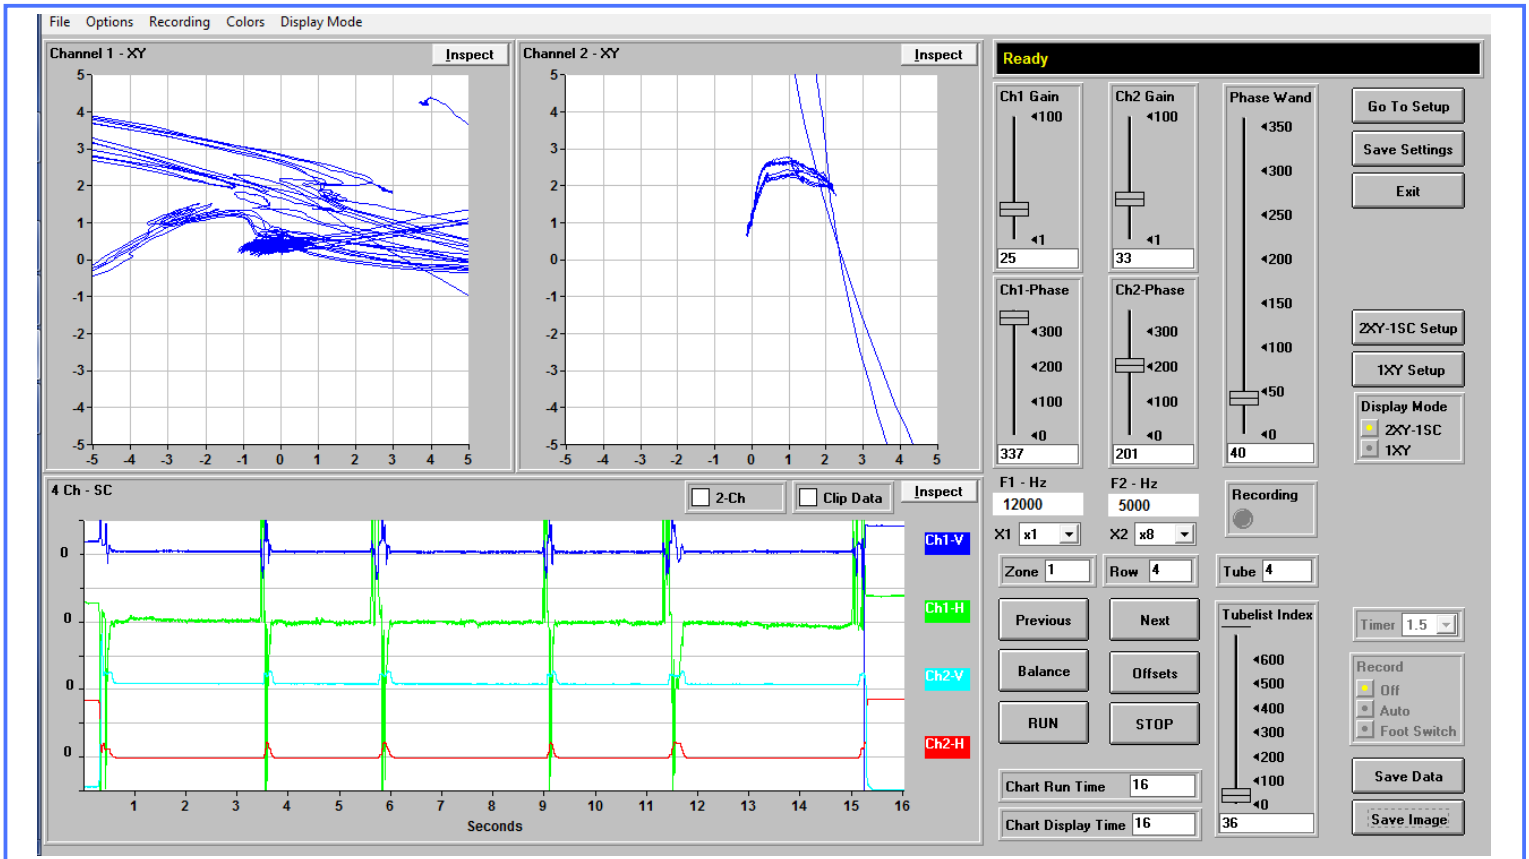
NO SIGNIFICANT DEFECTS (Row 4 Tube 4)

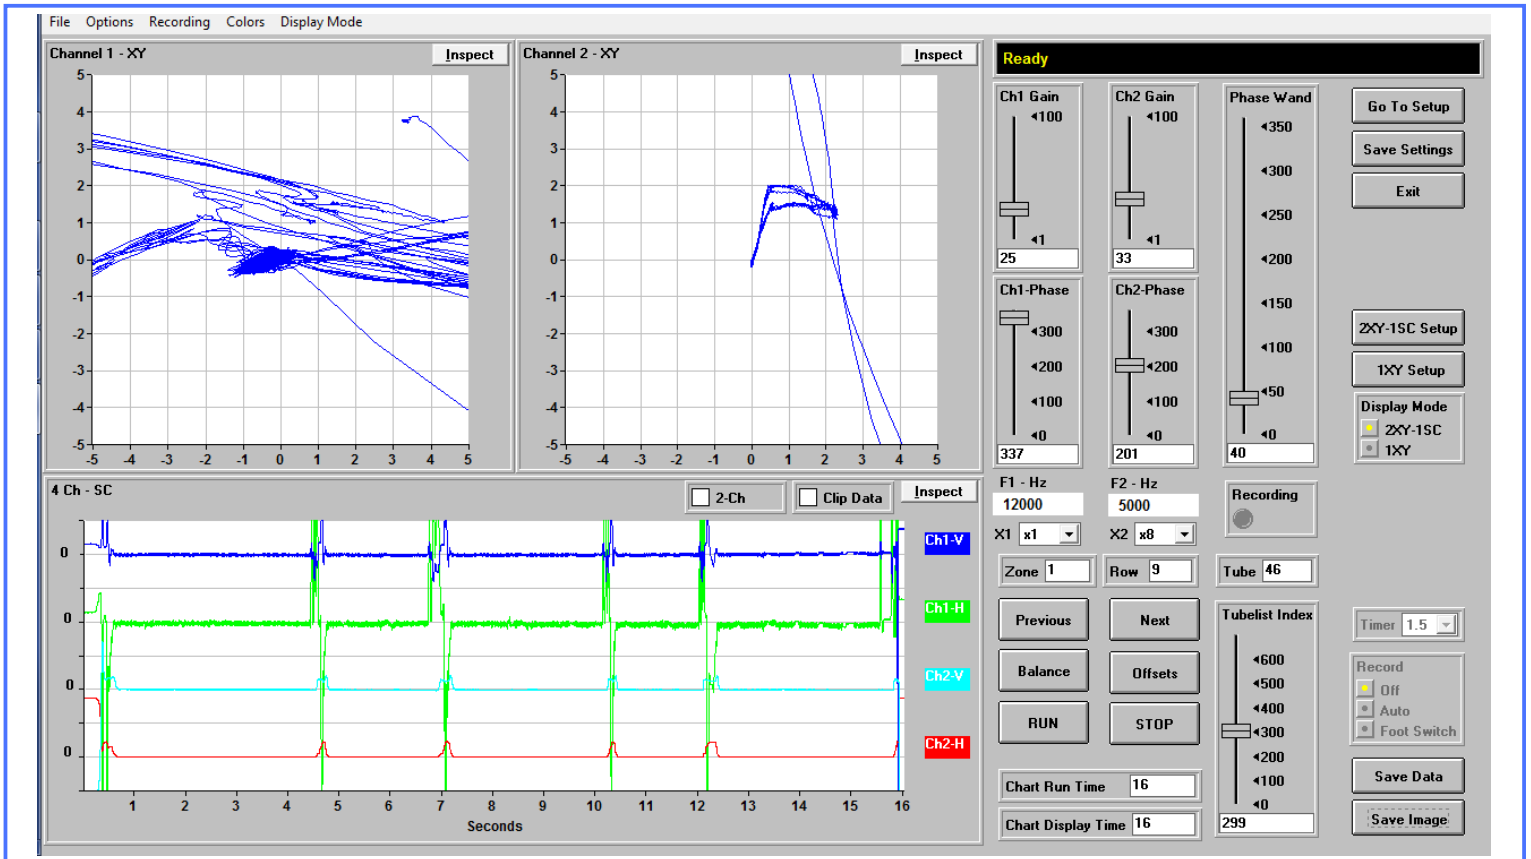
NO SIGNIFICANT DEFECTS (Row 9 Tube 46)

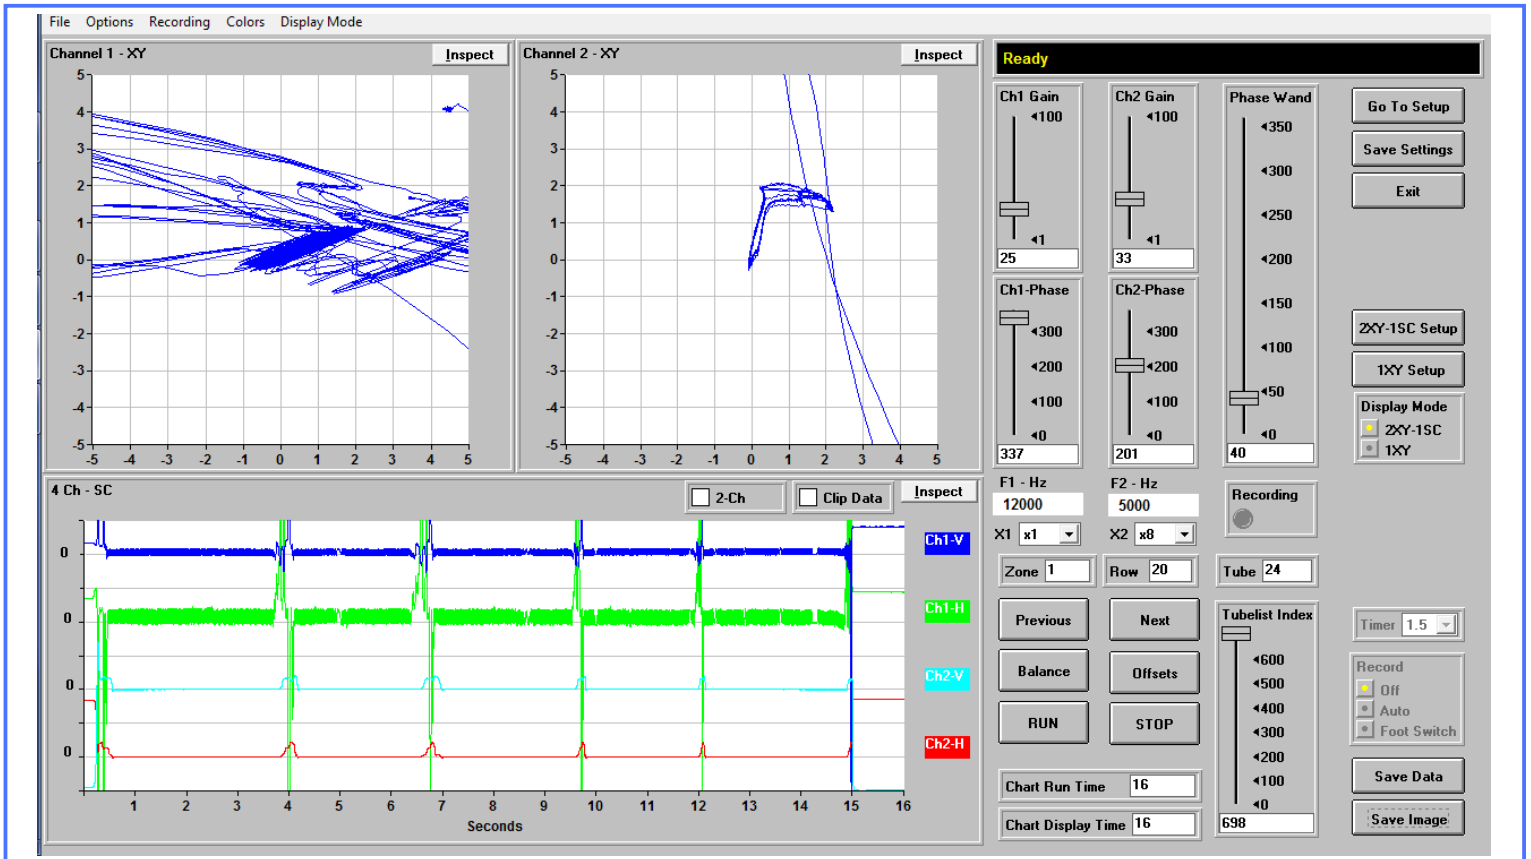
NO SIGNIFICANT DEFECTS (Row 20 Tube 24)
