## Report of Eddy Current Inspection

Manufacturer: York

Model: OTT4G2-ZBES

Serial: GACM117864 #8

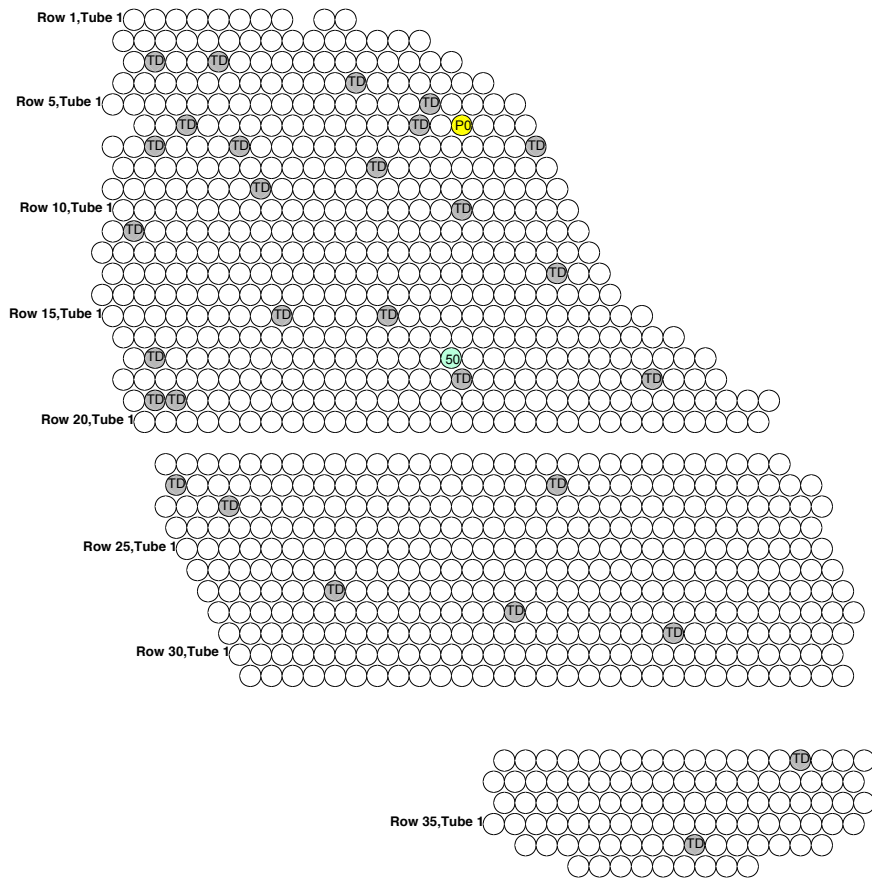
Inlet End

(NOTE: Many tubes in this bundle had plastic debris from water tower.)

- 50 = ID CORROSION < 20%
- PIT = ID PIT < 20%
- ID = TESTED, DEBRIS

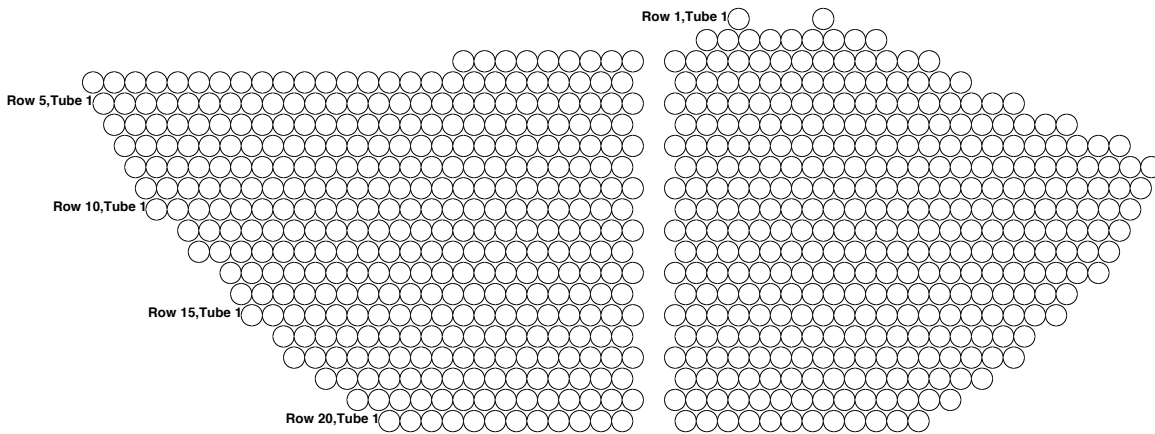
Top of Vessel

No Significant defects were found.

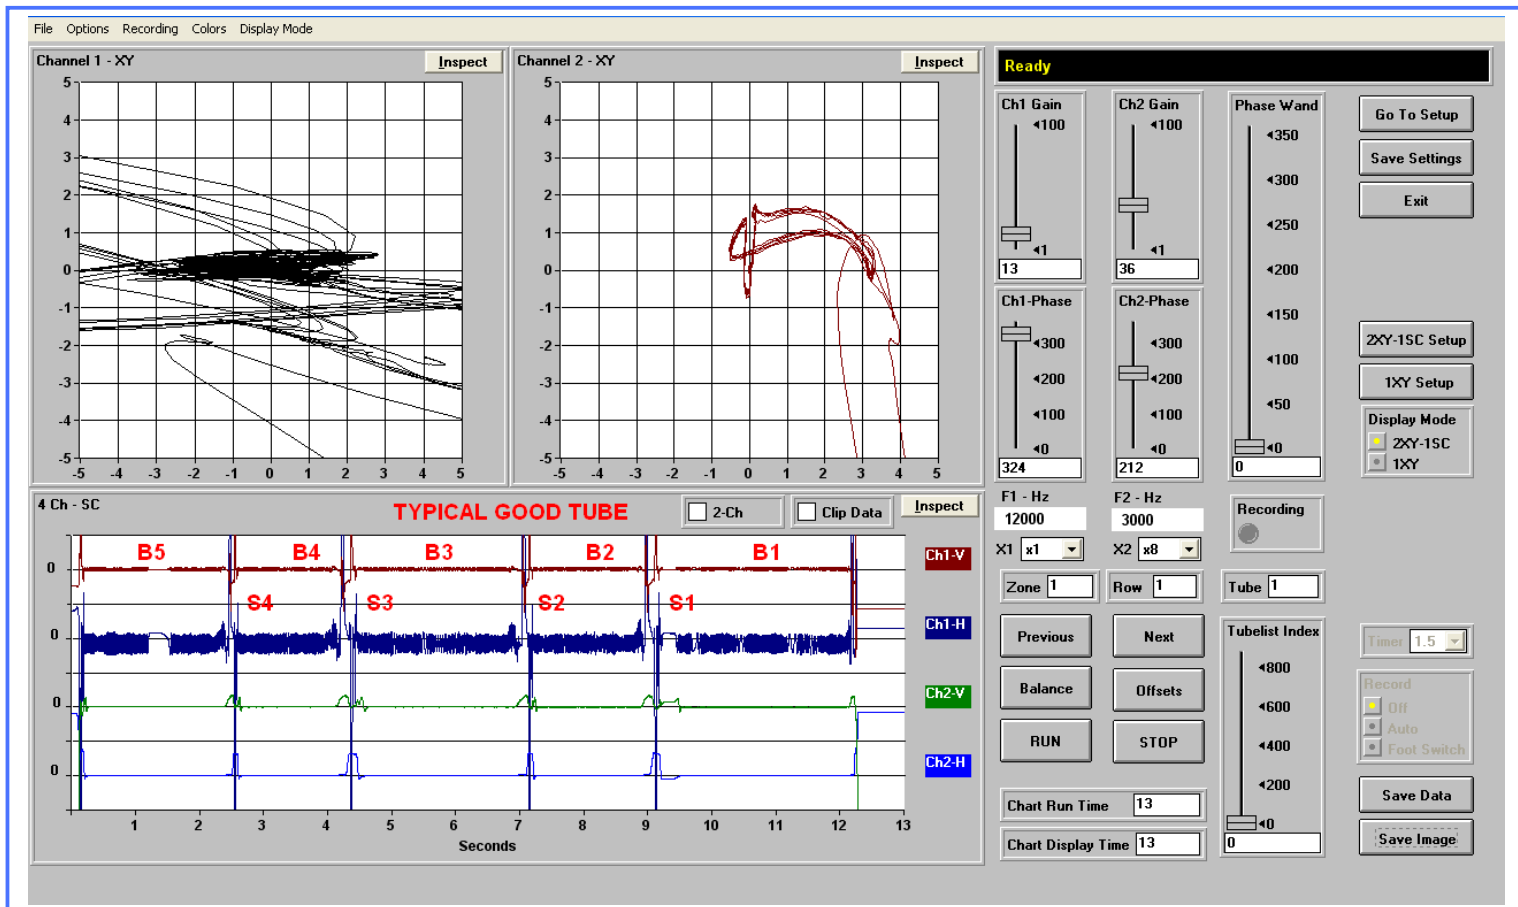
NO SIGNIFICANT DEFECTS (Row 1 Tube 1)

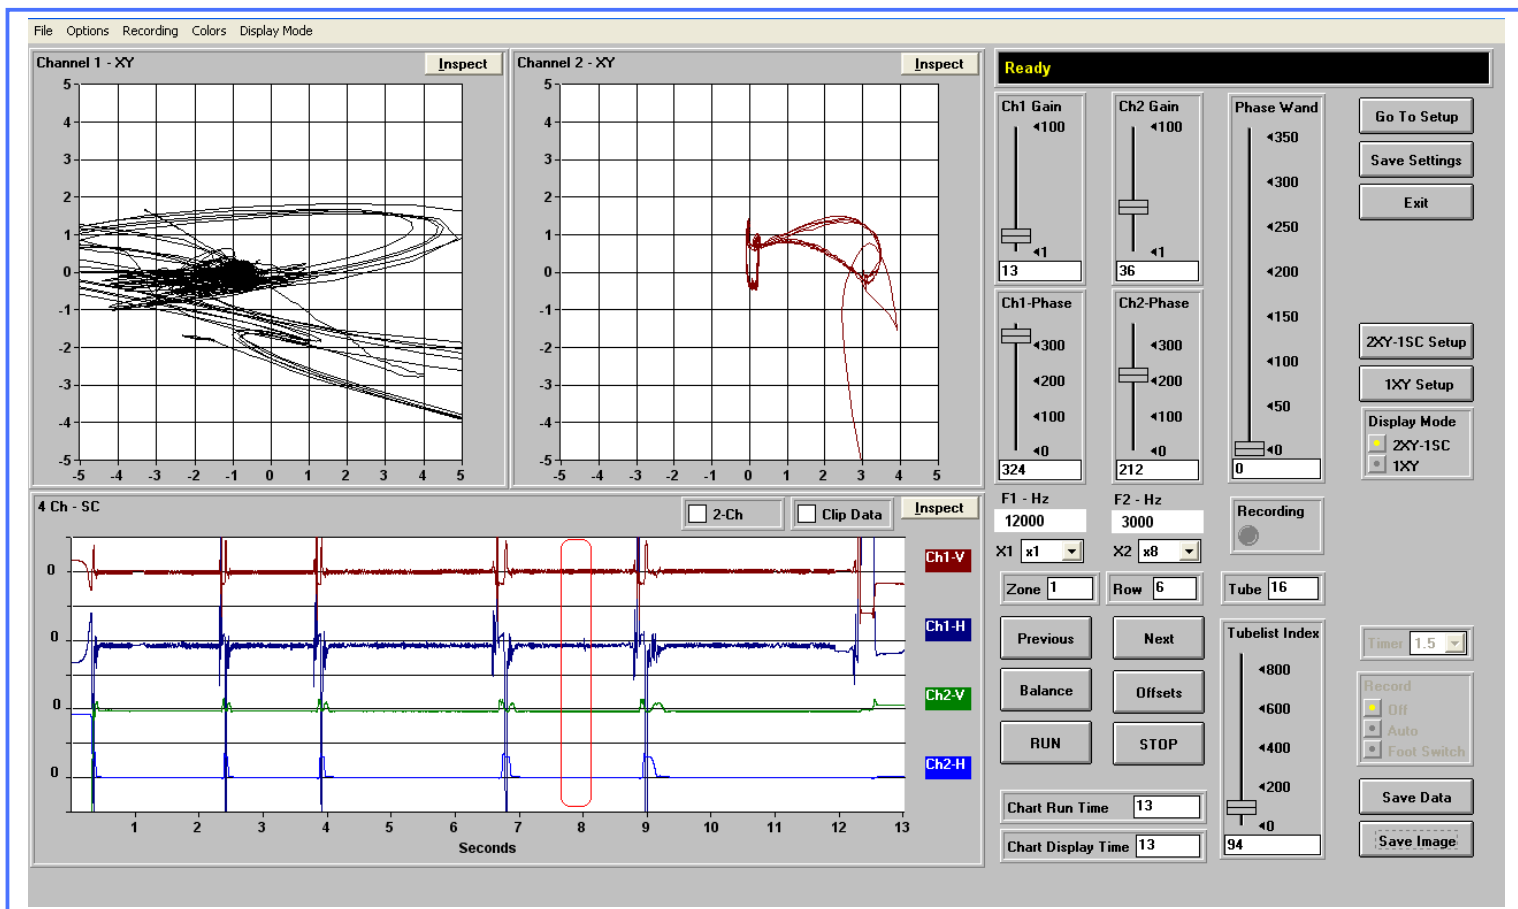
Tubes indicating ID Pits require no corrective action at this time. However, this type damage should be monitored for defect growth, as it can be progressive.

ID PIT < 20% (Row 6 Tube 16)

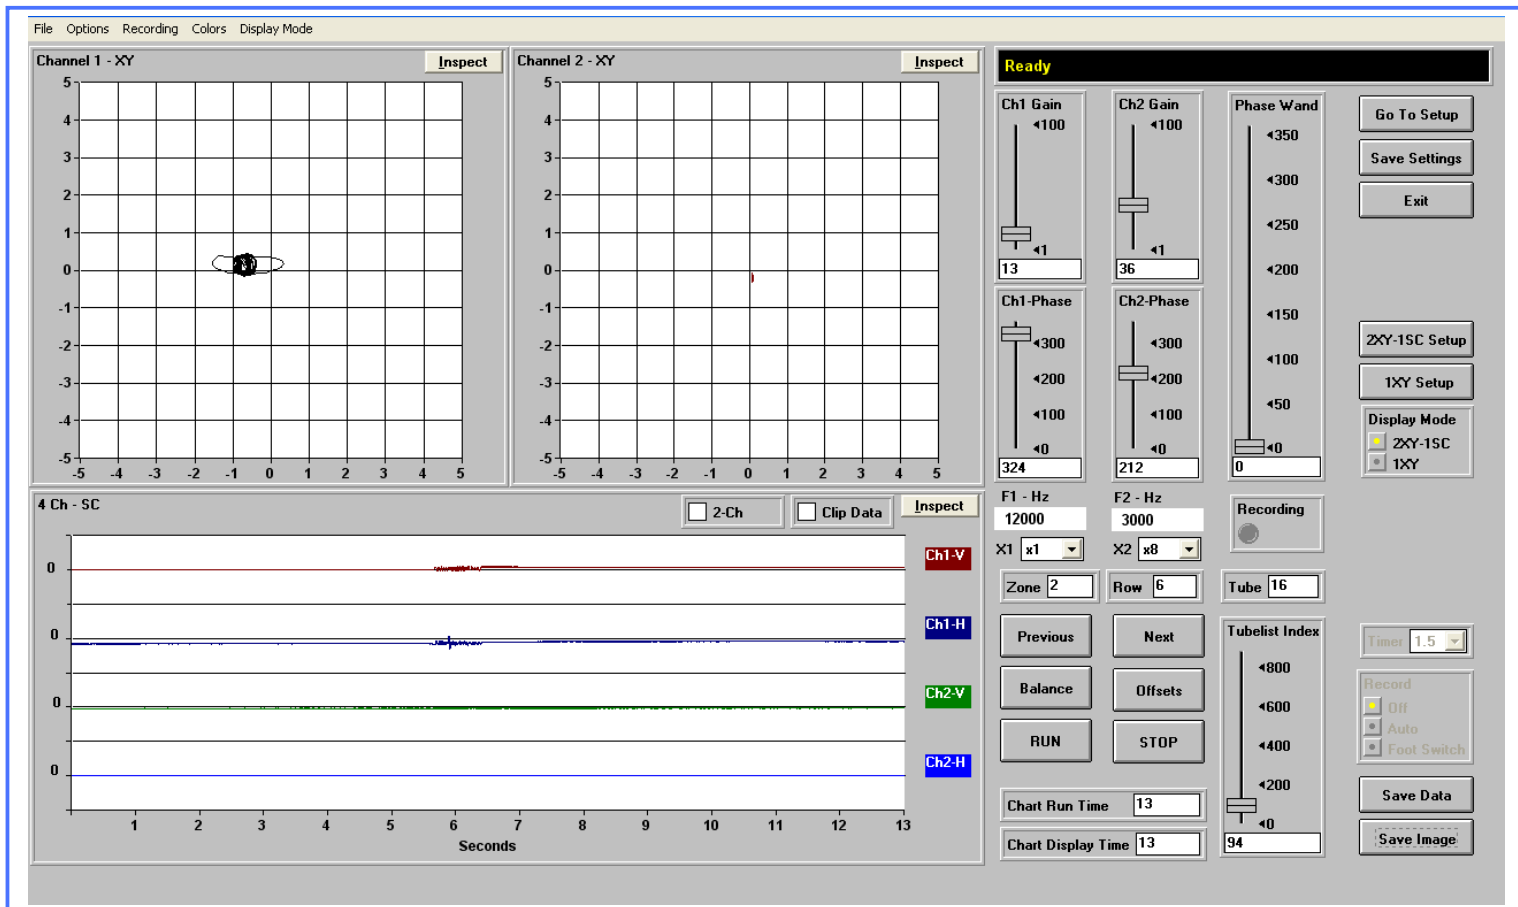
ID PIT < 20% (Row 6 Tube 16)

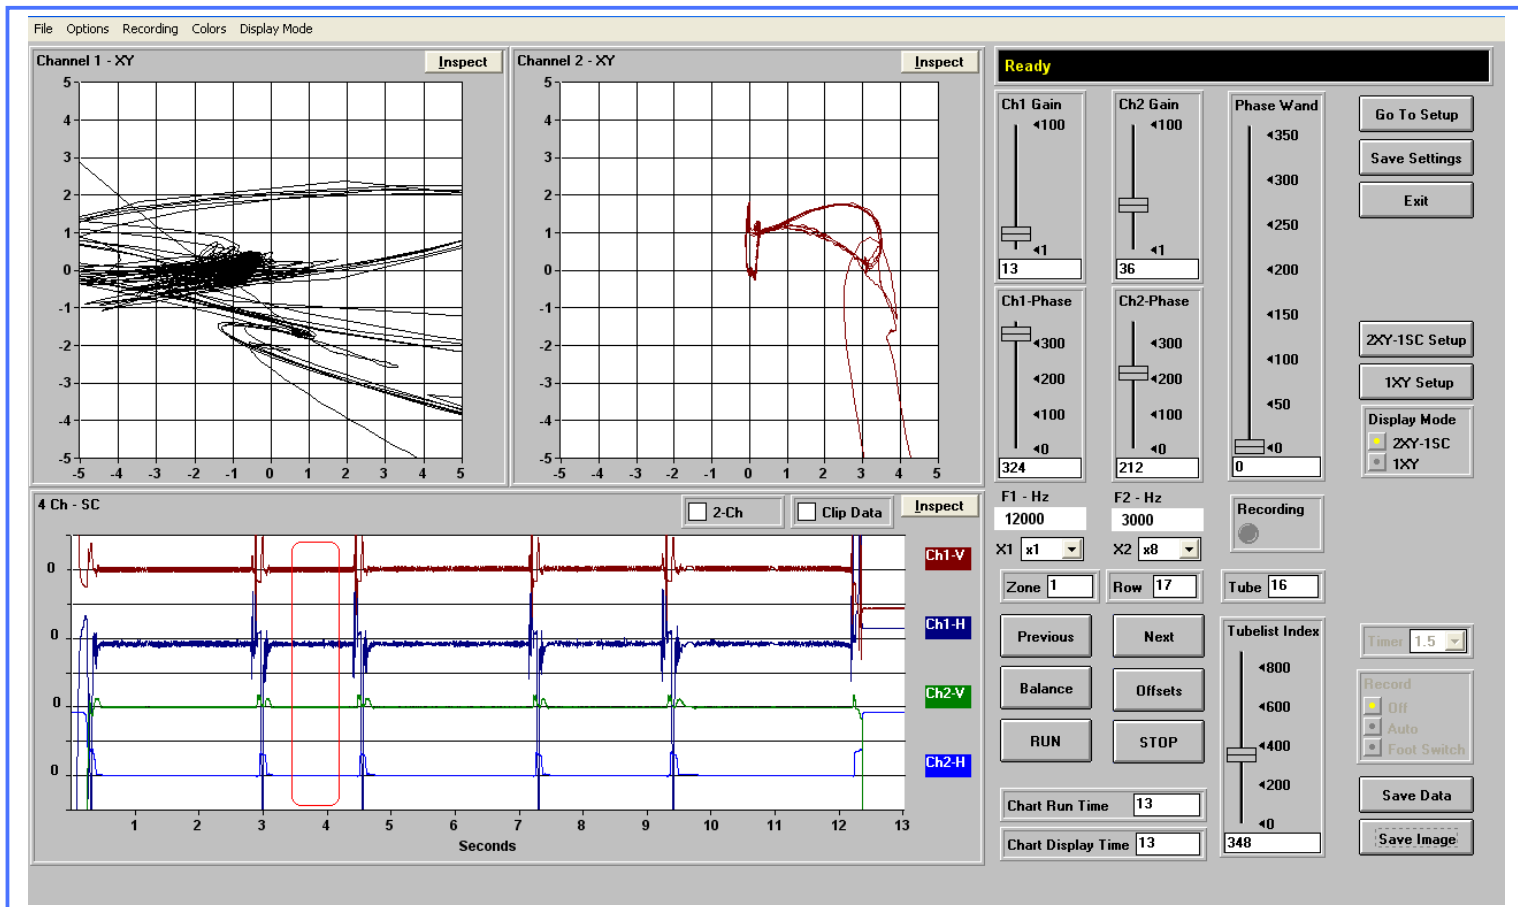
The ID Corrosion detected appears minor and requires no corrective action at this time. ID Corrosion is the deterioration of the tube's inner surface due to biological or chemical attack and is usually progressive.

ID CORROSION < 20% (Row 17 Tube 16)

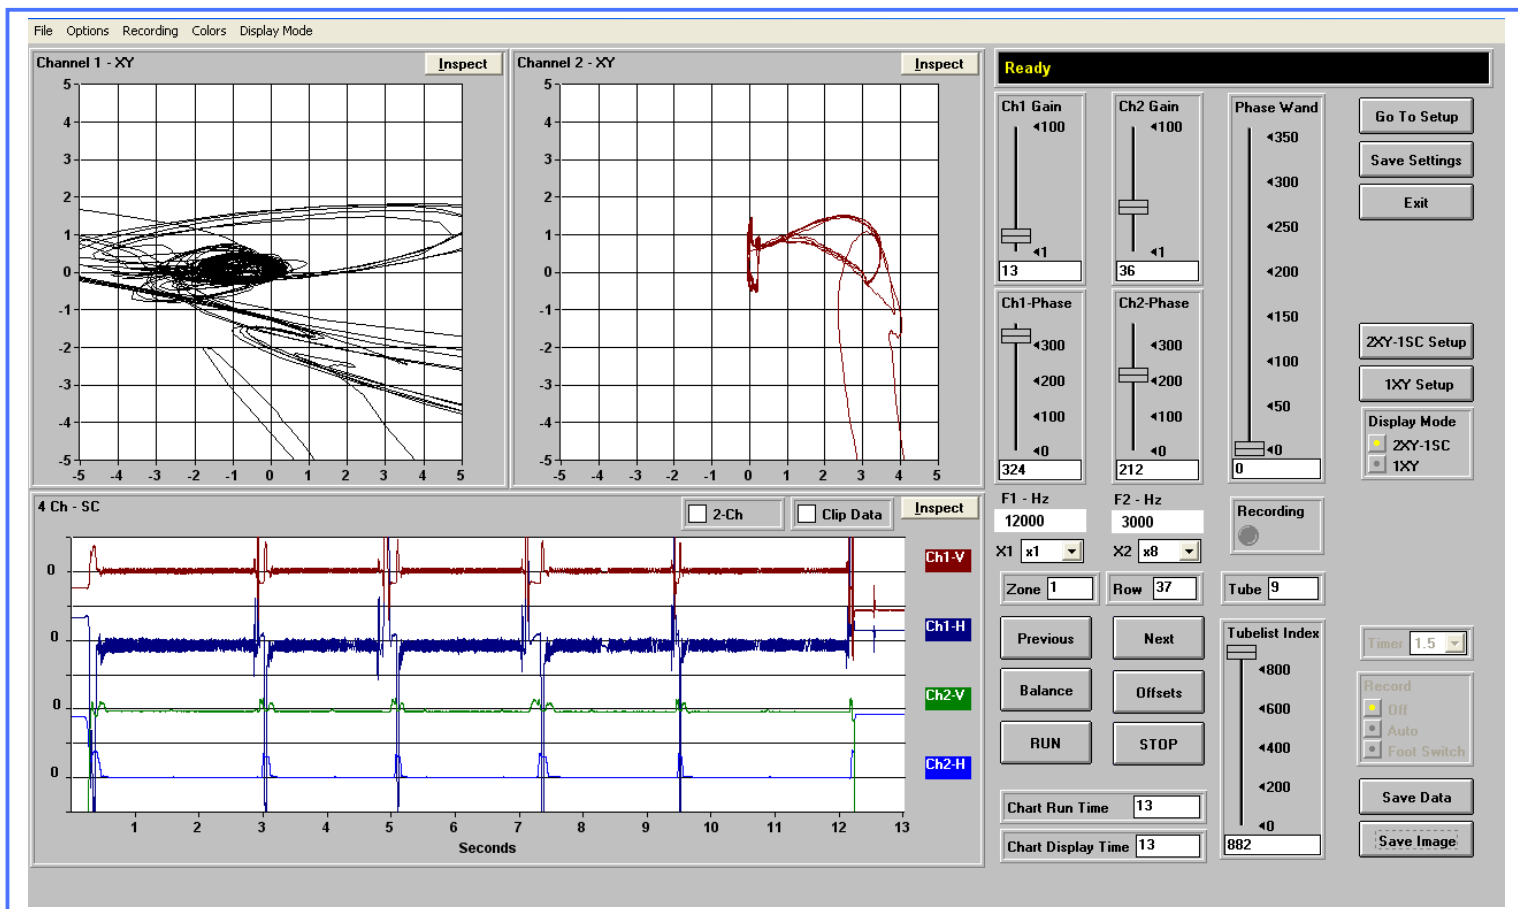
NO SIGNIFICANT DEFECTS (Row 37 Tube 9)

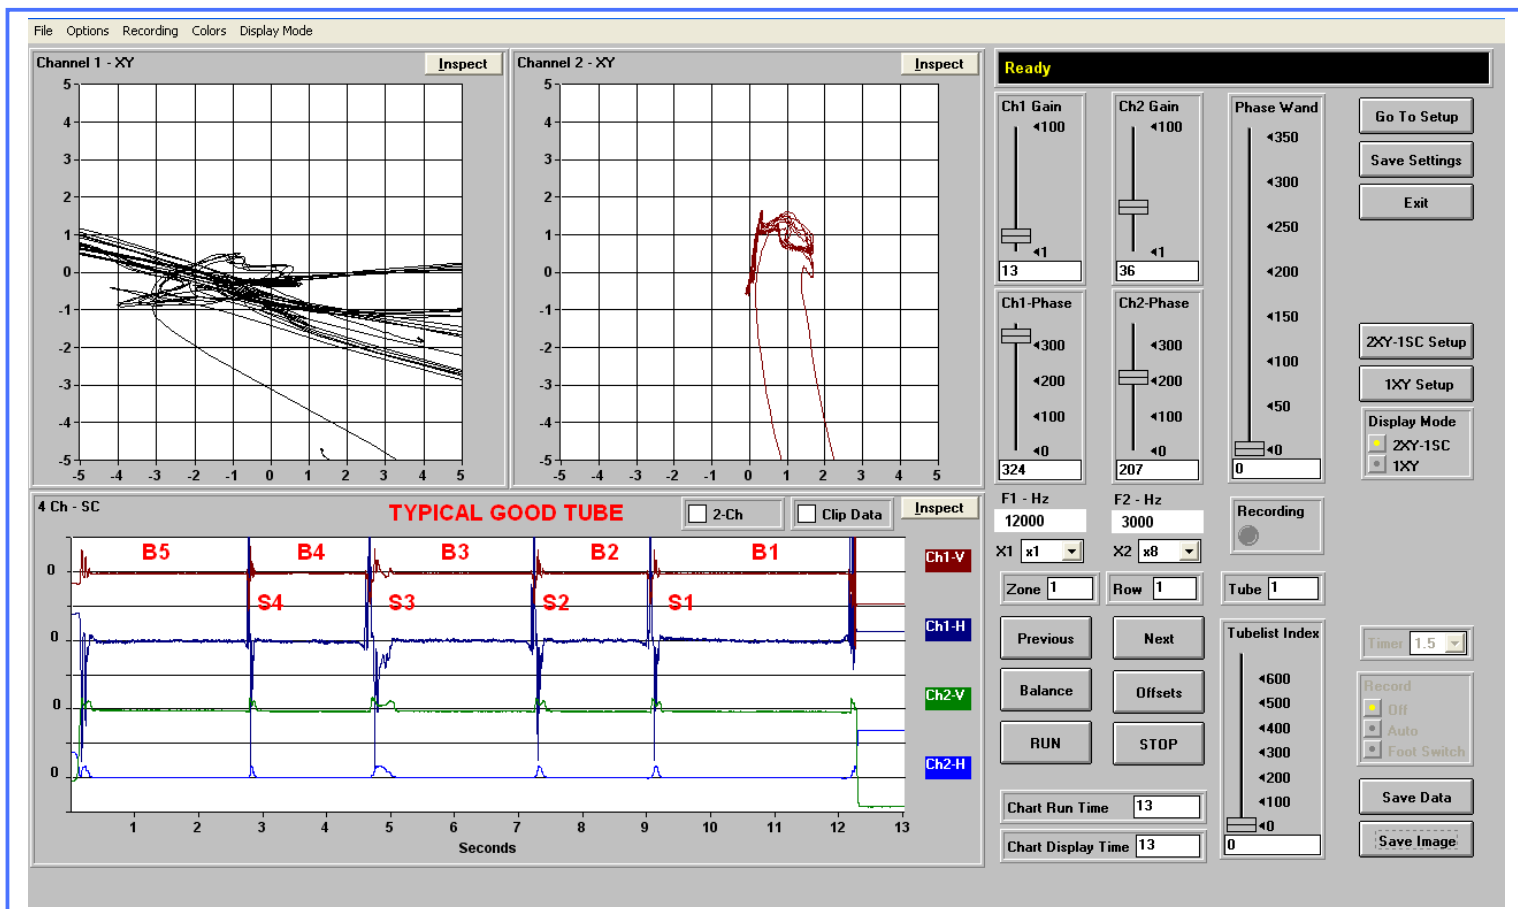
NO SIGNIFICANT DEFECTS (Row 1 Tube 1)

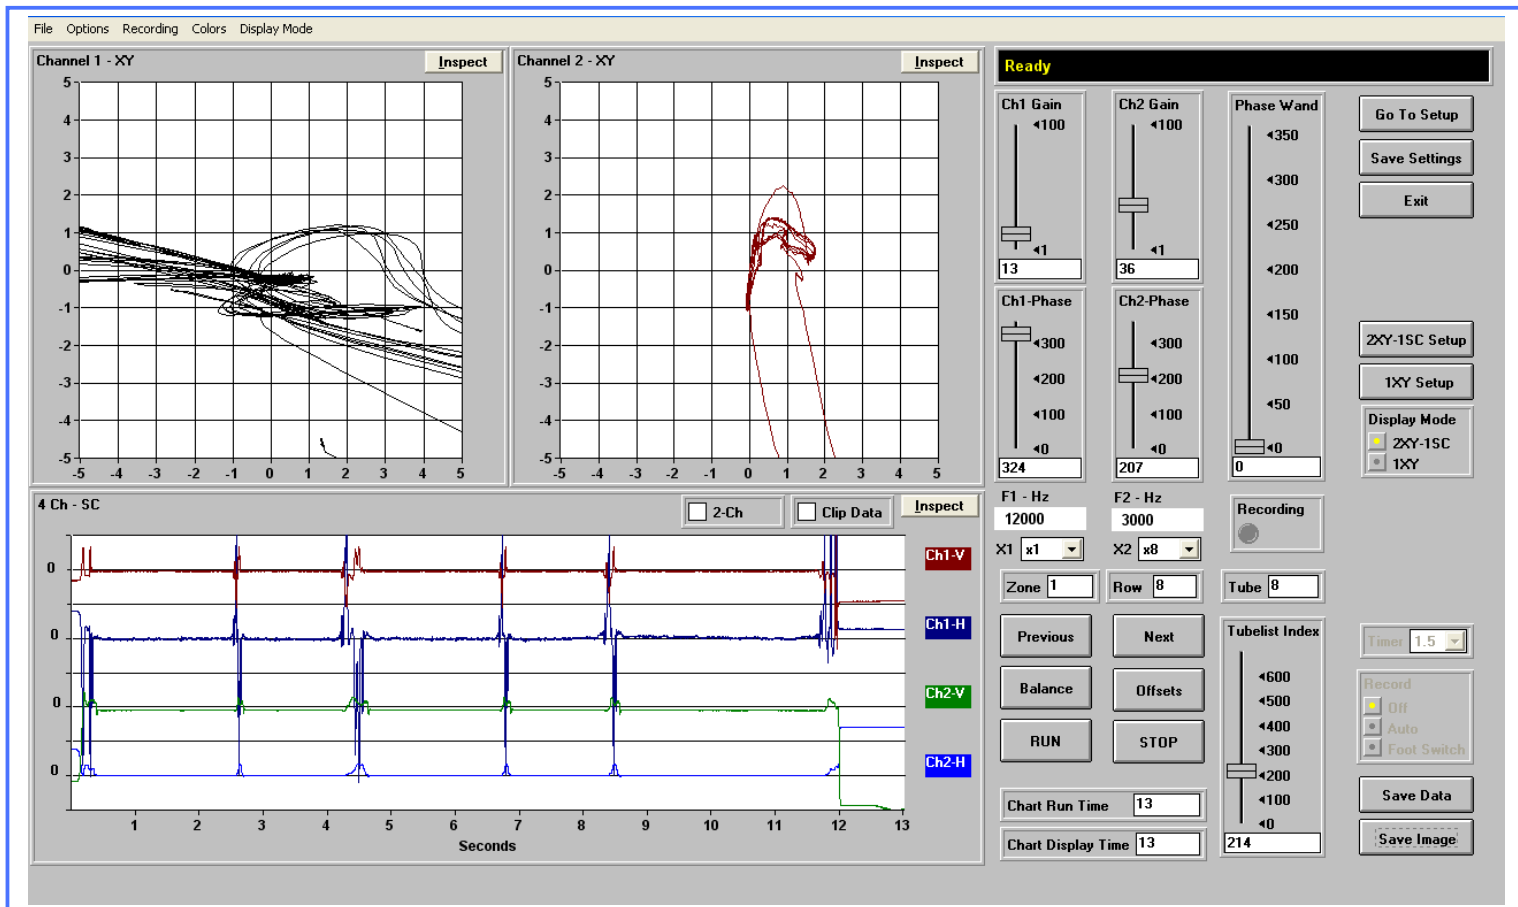
NO SIGNIFICANT DEFECTS (Row 8 Tube 8)

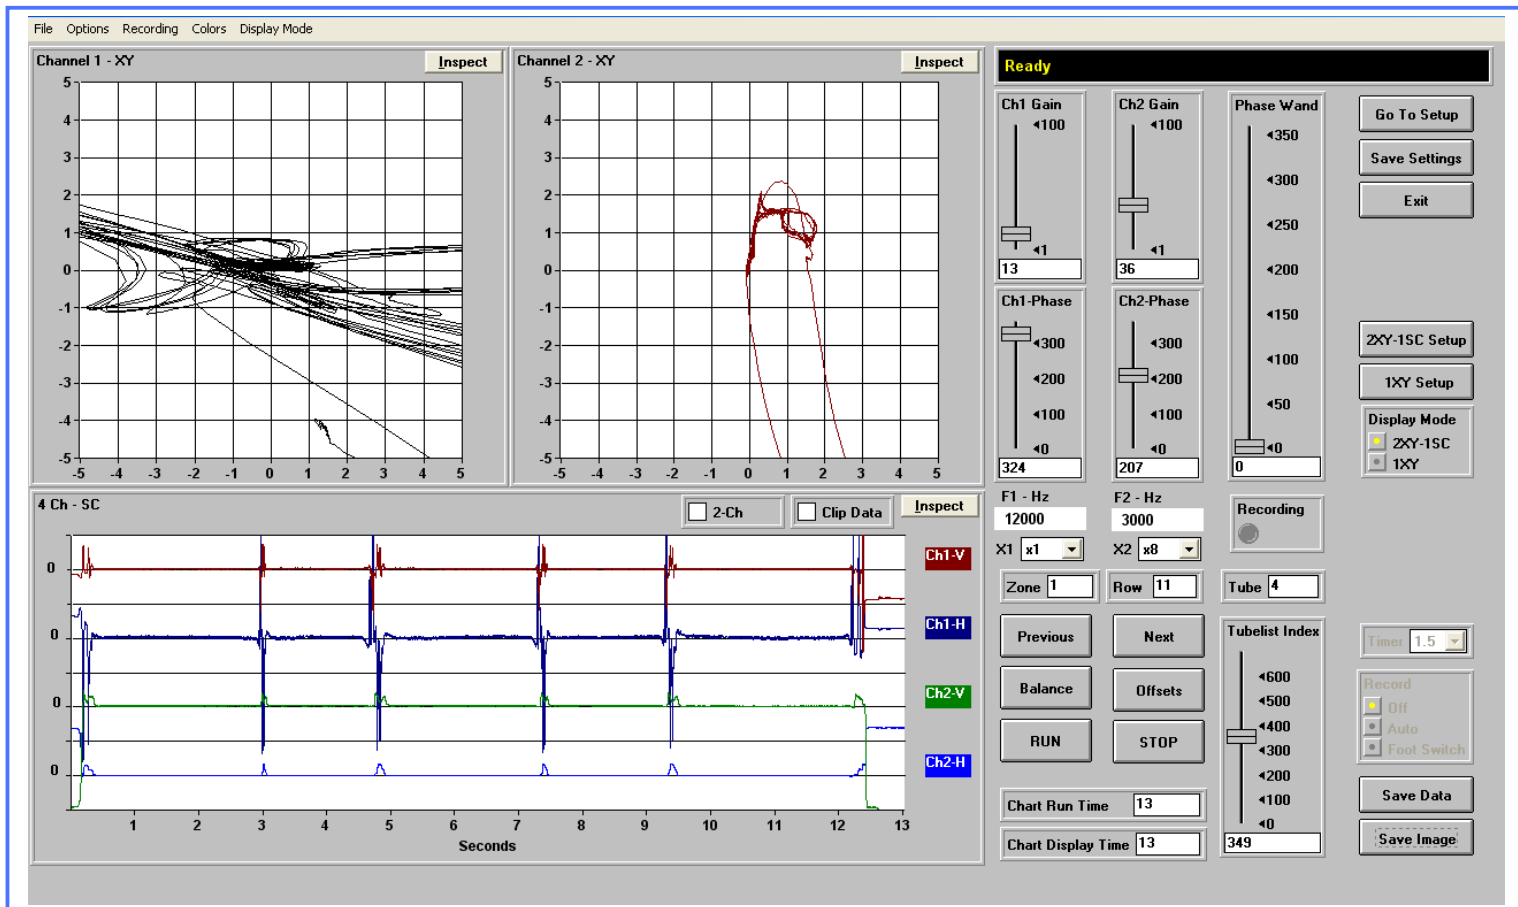
NO SIGNIFICANT DEFECTS (Row 11 Tube 4)

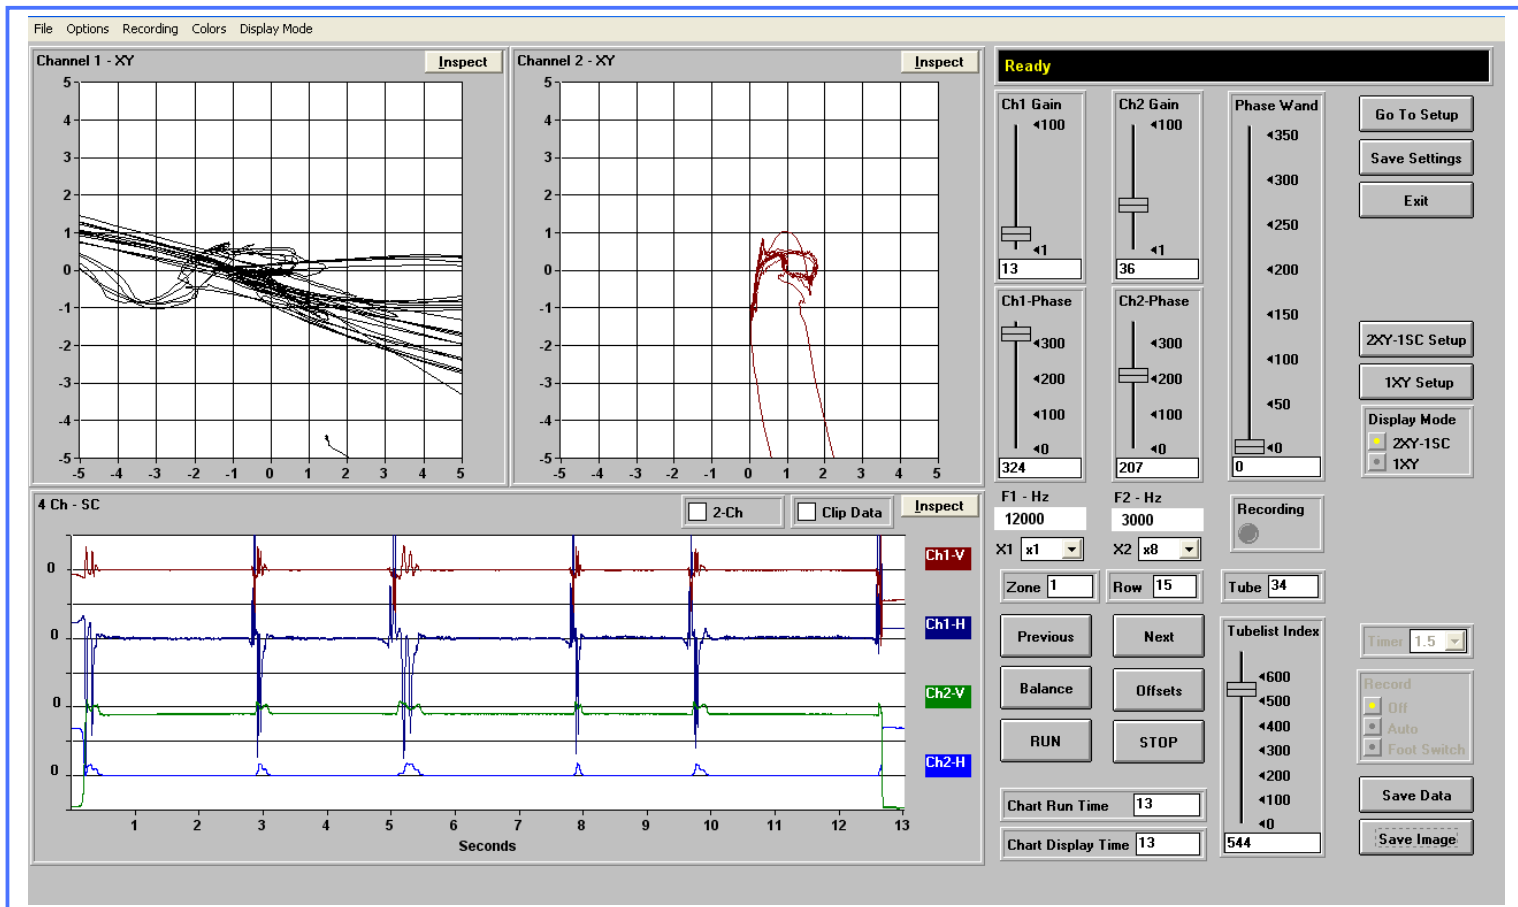
NO SIGNIFICANT DEFECTS (Row 15 Tube 34)

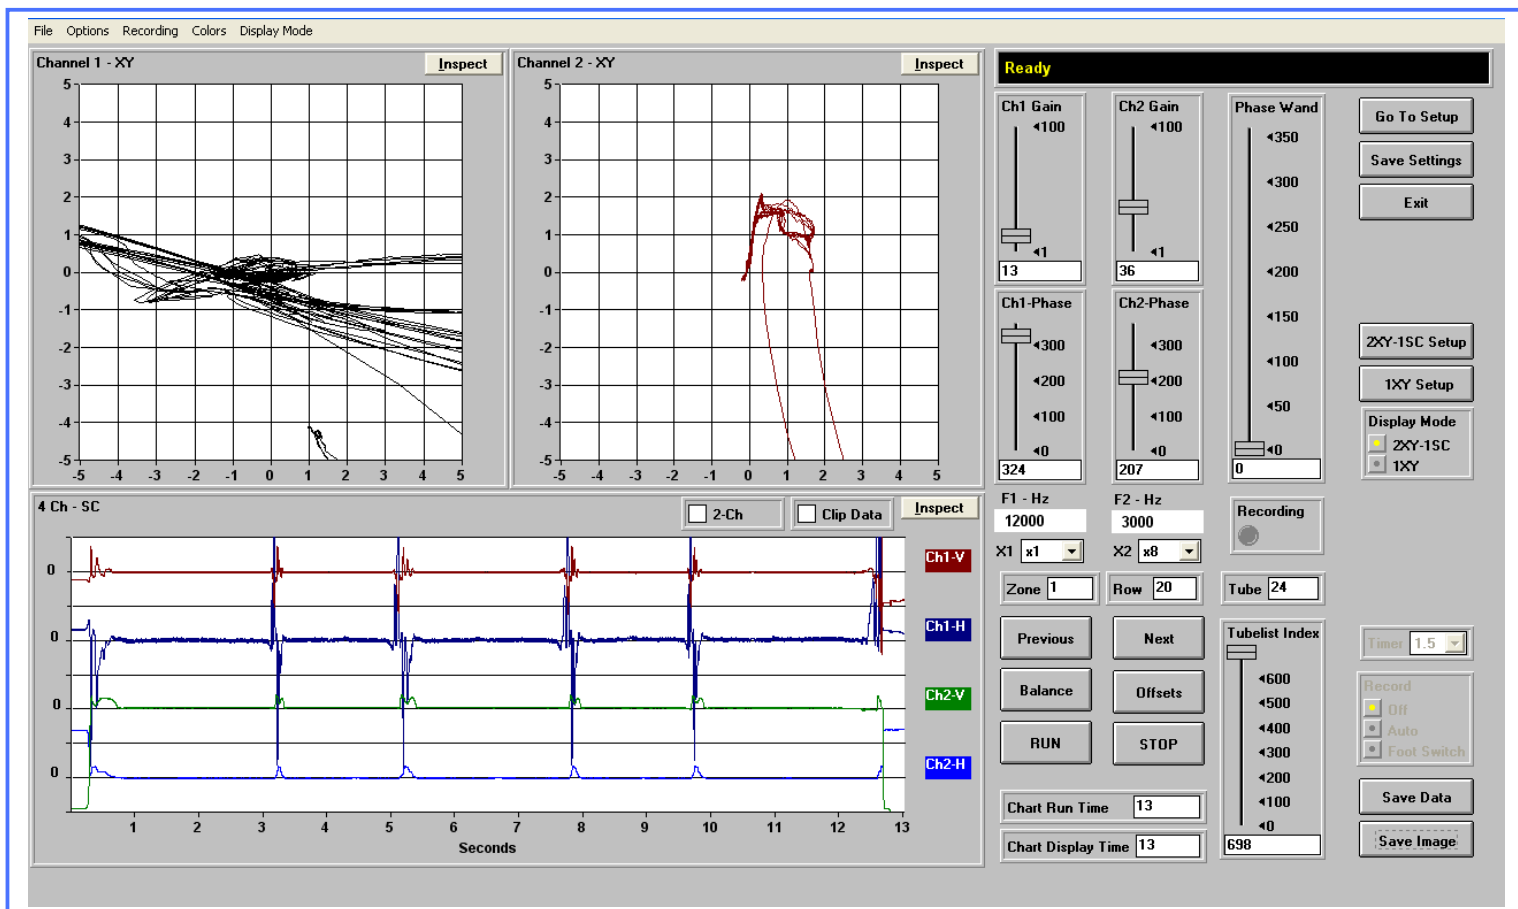
NO SIGNIFICANT DEFECTS (Row 20 Tube 24)
