## Report of Eddy Current Inspection

Manufacturer: York

Model: OTT4G2-ZBES

Inspected: February 24, 2017

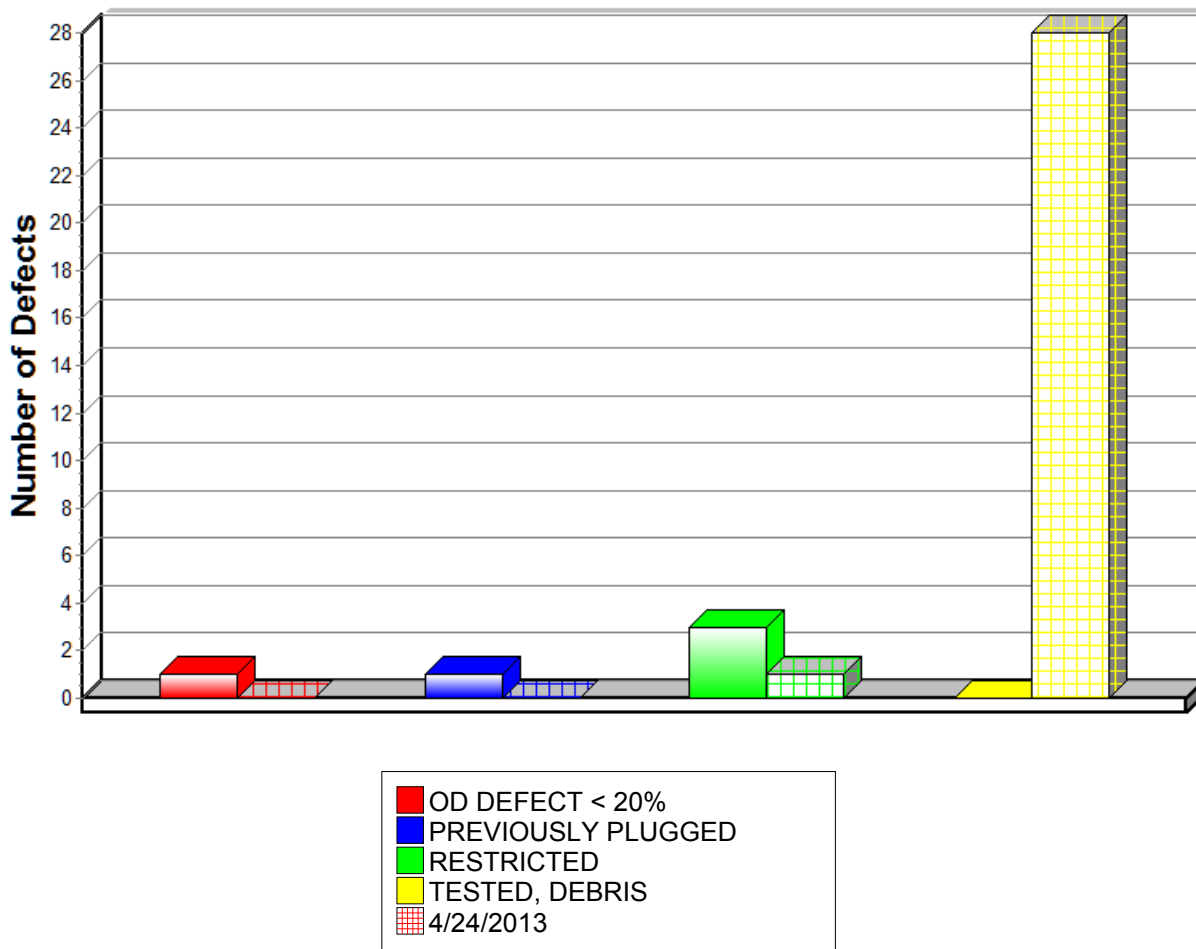
### Condenser Defects

Condenser: 883 Tubes		
Tubes Tested: 883 Tubes		
Significant/Measurable Indications	Number of Tubes Marked	Percent of Bundle
OD DEFECT < 20%	1	.11
PREVIOUSLY PLUGGED	1	.11
RESTRICTED	3	.34
<b>Totals</b>	<b>5</b>	<b>.56</b>

The tubes marked for OD Defects require no corrective action at this time.

Tubes marked as Previously Plugged, had been plugged prior to this inspection.

Tubes marked as Restricted contained defects, or foreign material which prevented the inspection probe from passing. The condition of these tubes at and beyond the obstruction remains unknown. (NOTE: Many tubes in this bundle had plastic debris from the water tower in them. All effort was made to clean the obstructions to no prevail. The tubes were tested from the opposite side to the obstructions.)

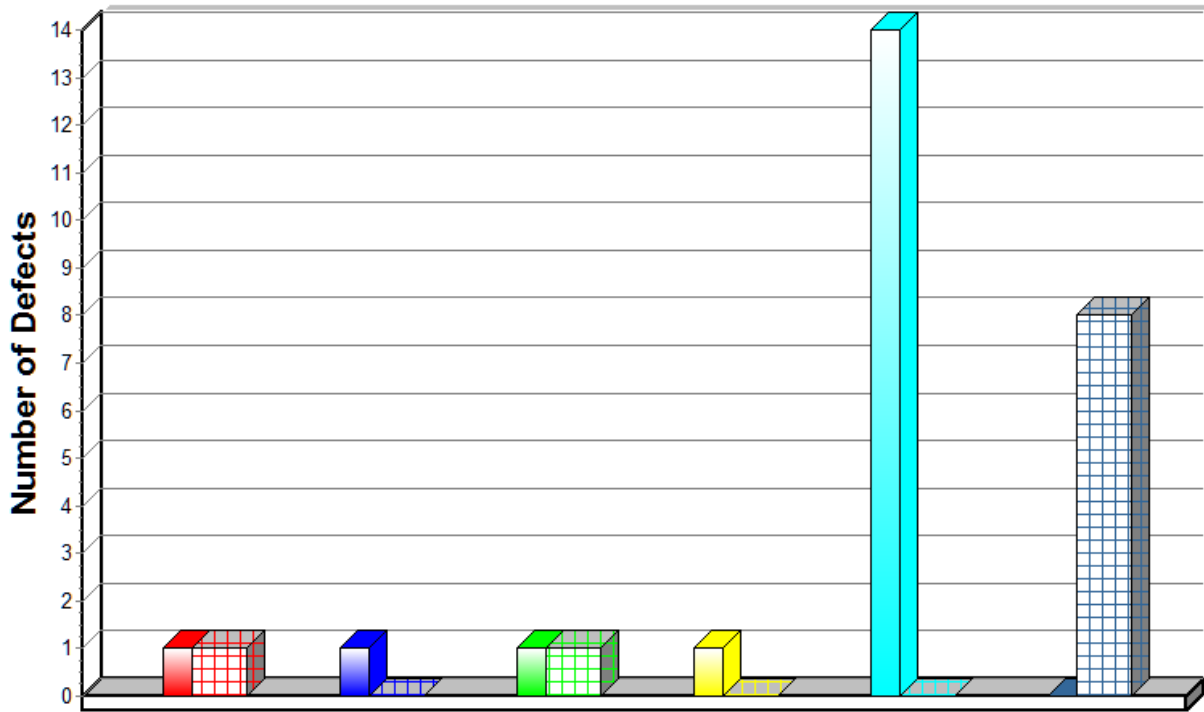
### Evaporator Defects

Evaporator: 699 Tubes		
Tubes Tested: 699 Tubes		
Significant/Measurable Indications	Number of Tubes Marked	Percent of Bundle
OD DEFECT < 20%	1	.14
ID DEFECT < 20%	1	.14
DENT, NOMINAL	1	.14
MISSING LAND	1	.14
RESTRICTED, TESTED	14	2.00
<b>Totals</b>	<b>18</b>	<b>2.56</b>

The tubes marked for OD Defects require no corrective action at this time.

The ID Defects detected appear minor at this time, and require no immediate corrective action. However, the damage mechanism and growth rates are unknown. If leaks are suspected, we recommend these tubes be pressure tested and/or isolated from the system.

Tubes indicated as "Dent, Nominal" require no corrective action at this time.

Tubes missing support landings showed no detectable loss and require no corrective action.

Tubes marked as Restricted/Tested contained foreign material or other obstruction and could not be tested with the size probe normally used. These tubes were tested using a smaller .500 diameter probe. No tube damage was detected. It should be noted that using a smaller probe can increase inspection noise, and reduce sensitivity.

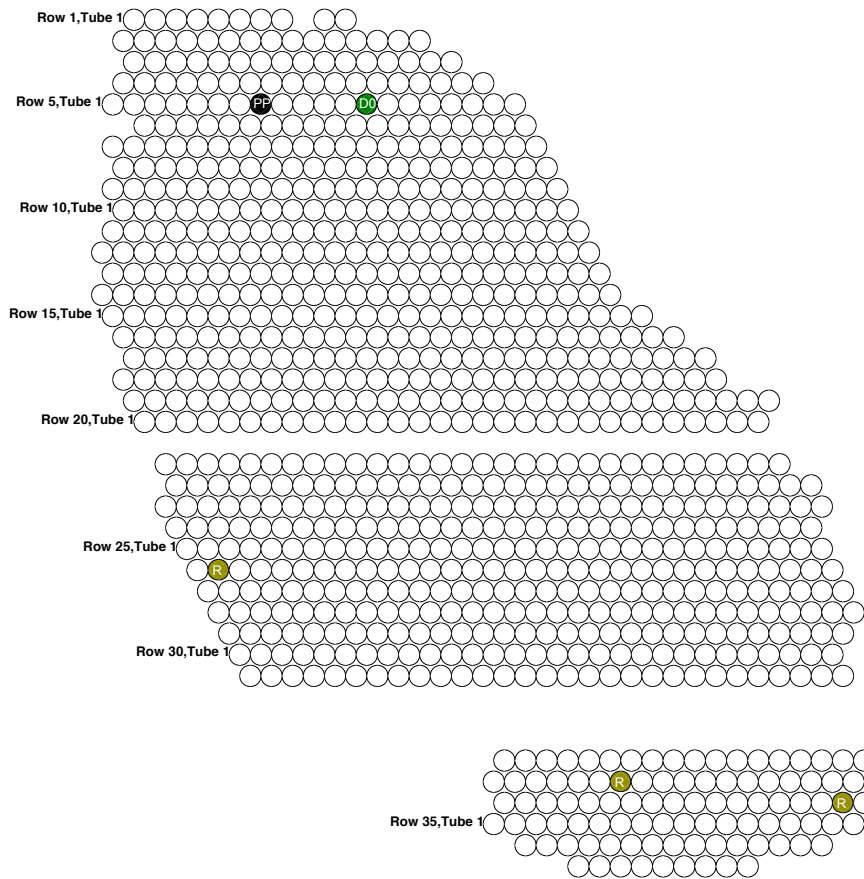
# Condenser Section

= OD DEFECT < 20%
-

= PREVIOUSLY PLUGGED
-

= RESTRICTED

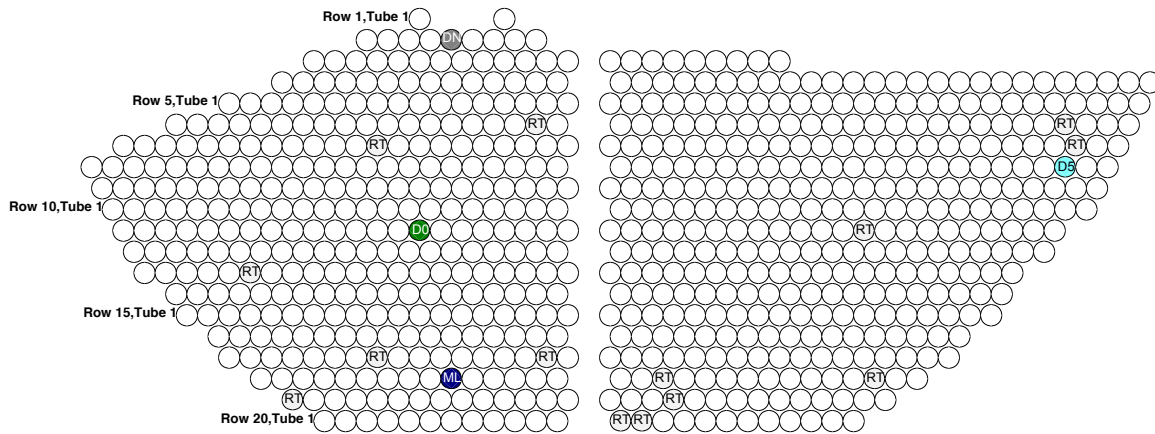
# Evaporator Section

- OD = OD DEFECT < 20%
- ID = ID DEFECT < 20%
- DN = DENT, NOMINAL
- ML = MISSING LAND
- RT = RESTRICTED, TESTED

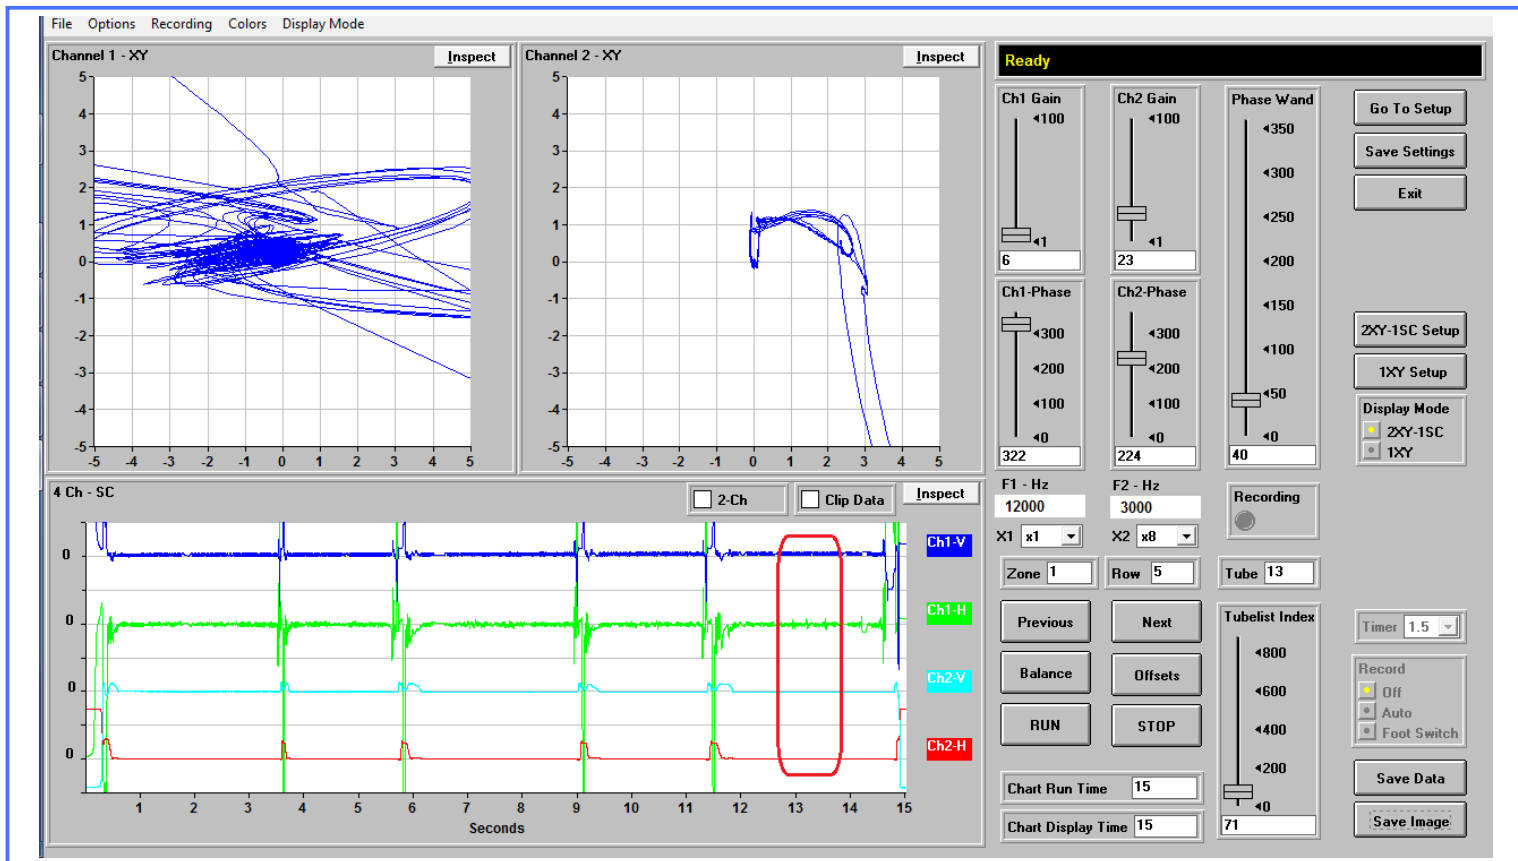
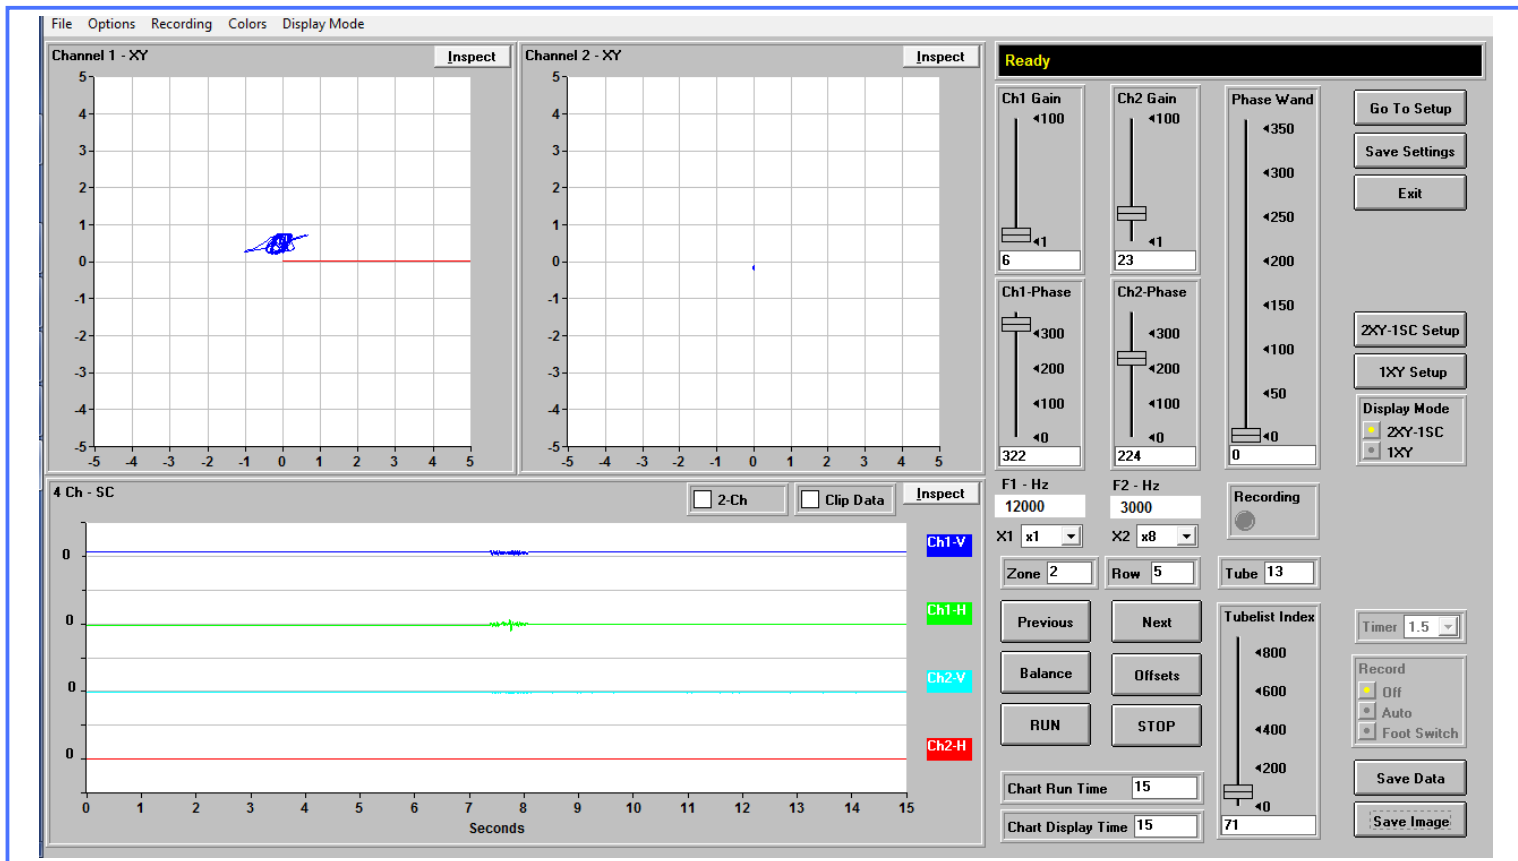
OD DEFECT < 20% (Row 5 Tube 13)

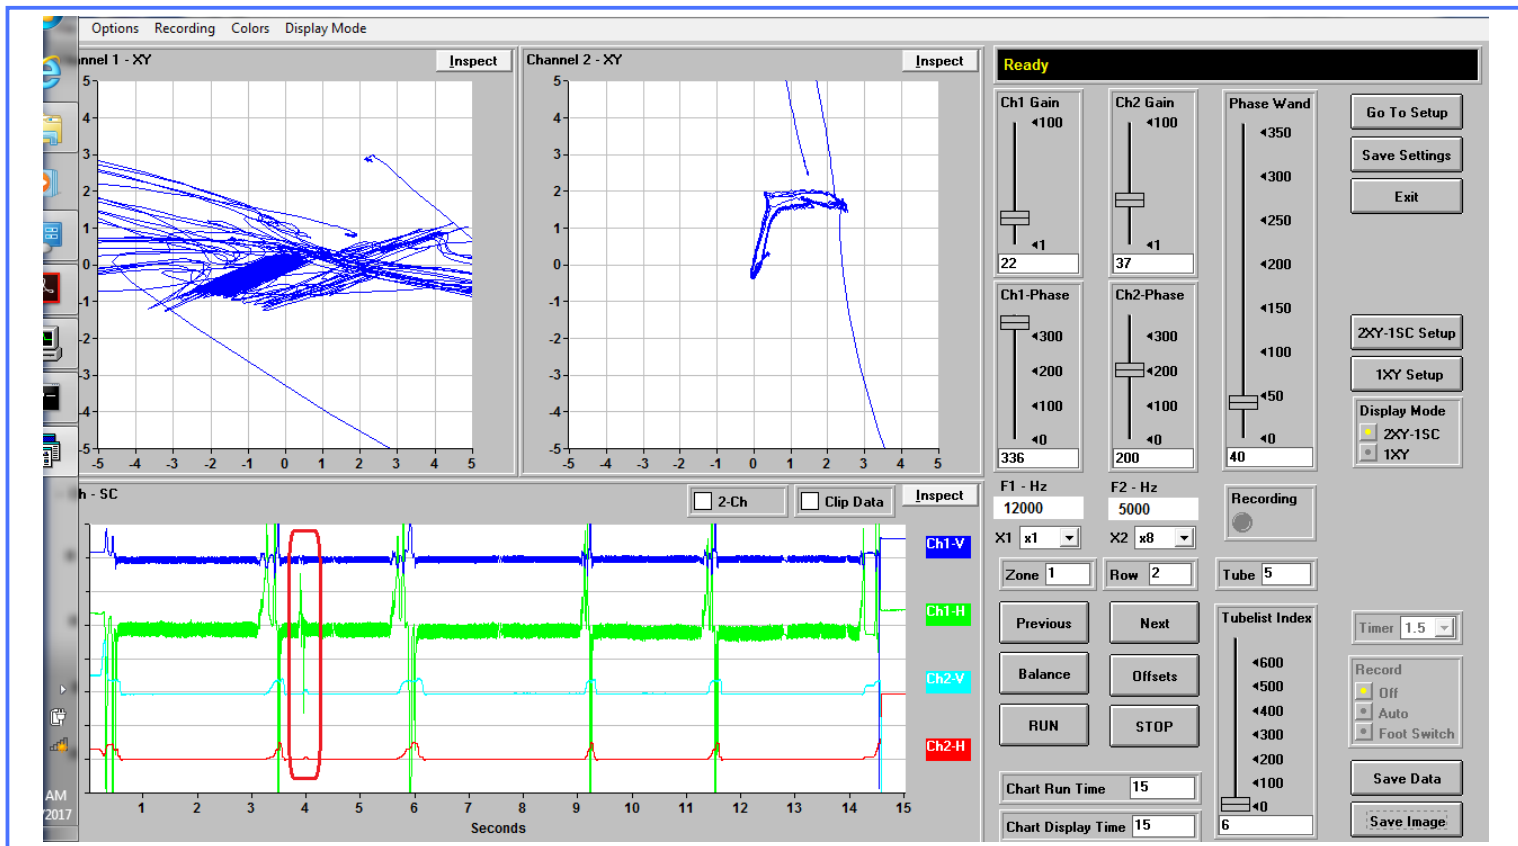
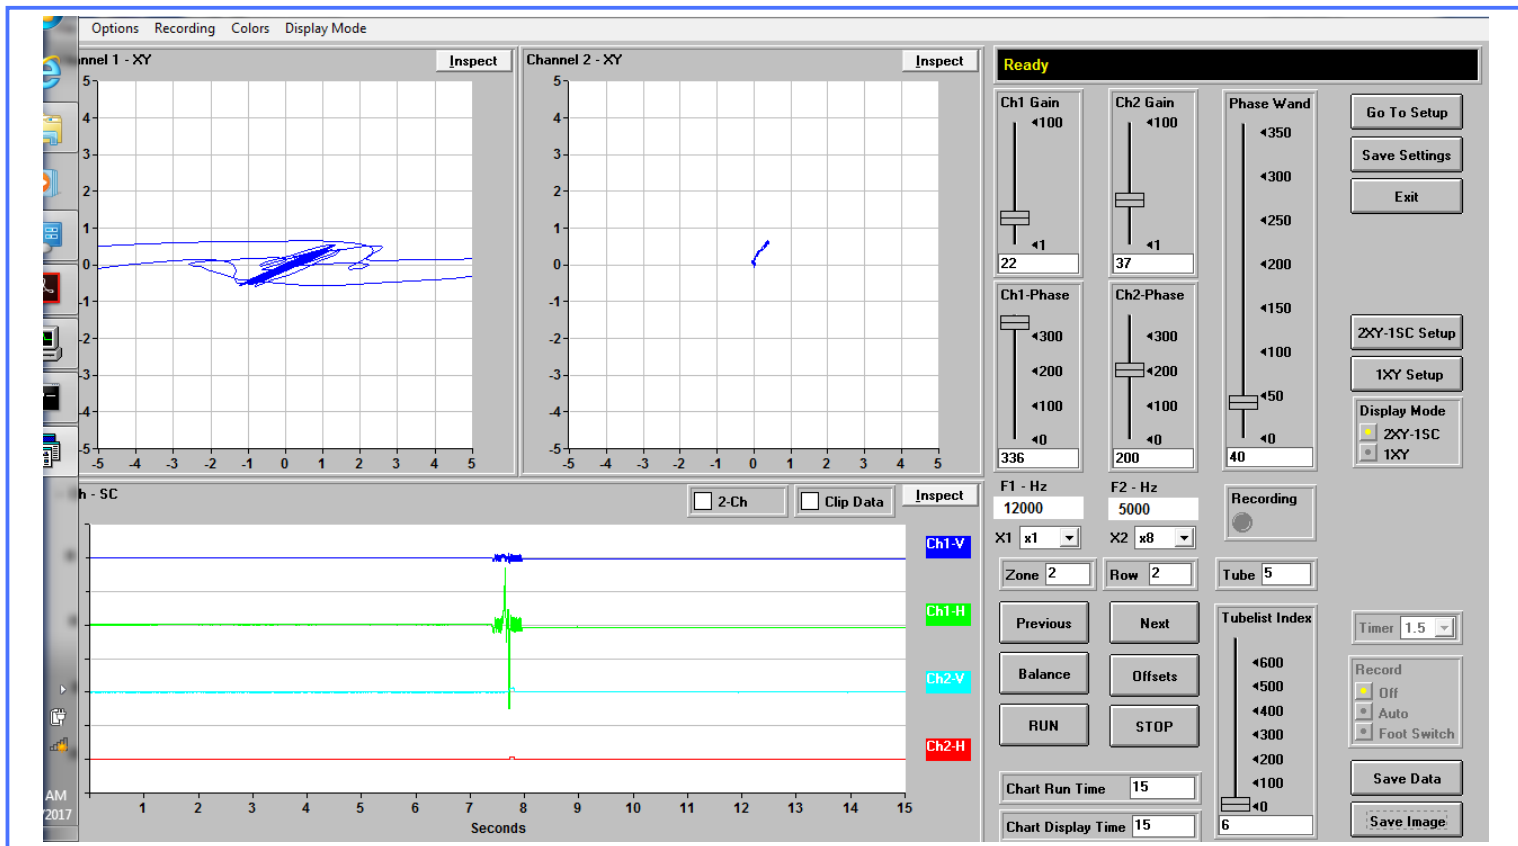
DENT, NOMINAL (Row 2 Tube 5)

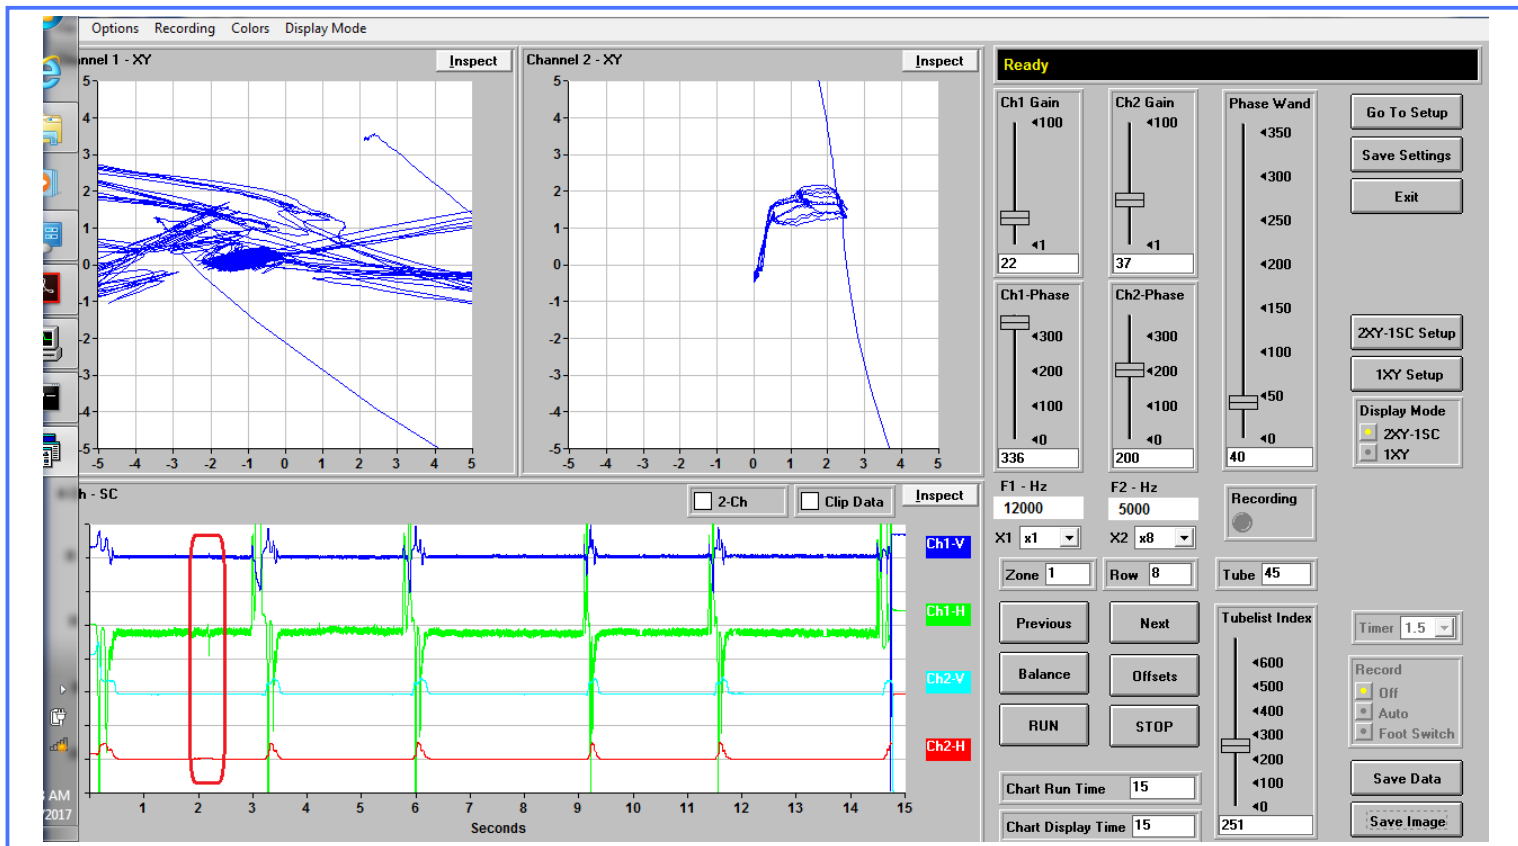
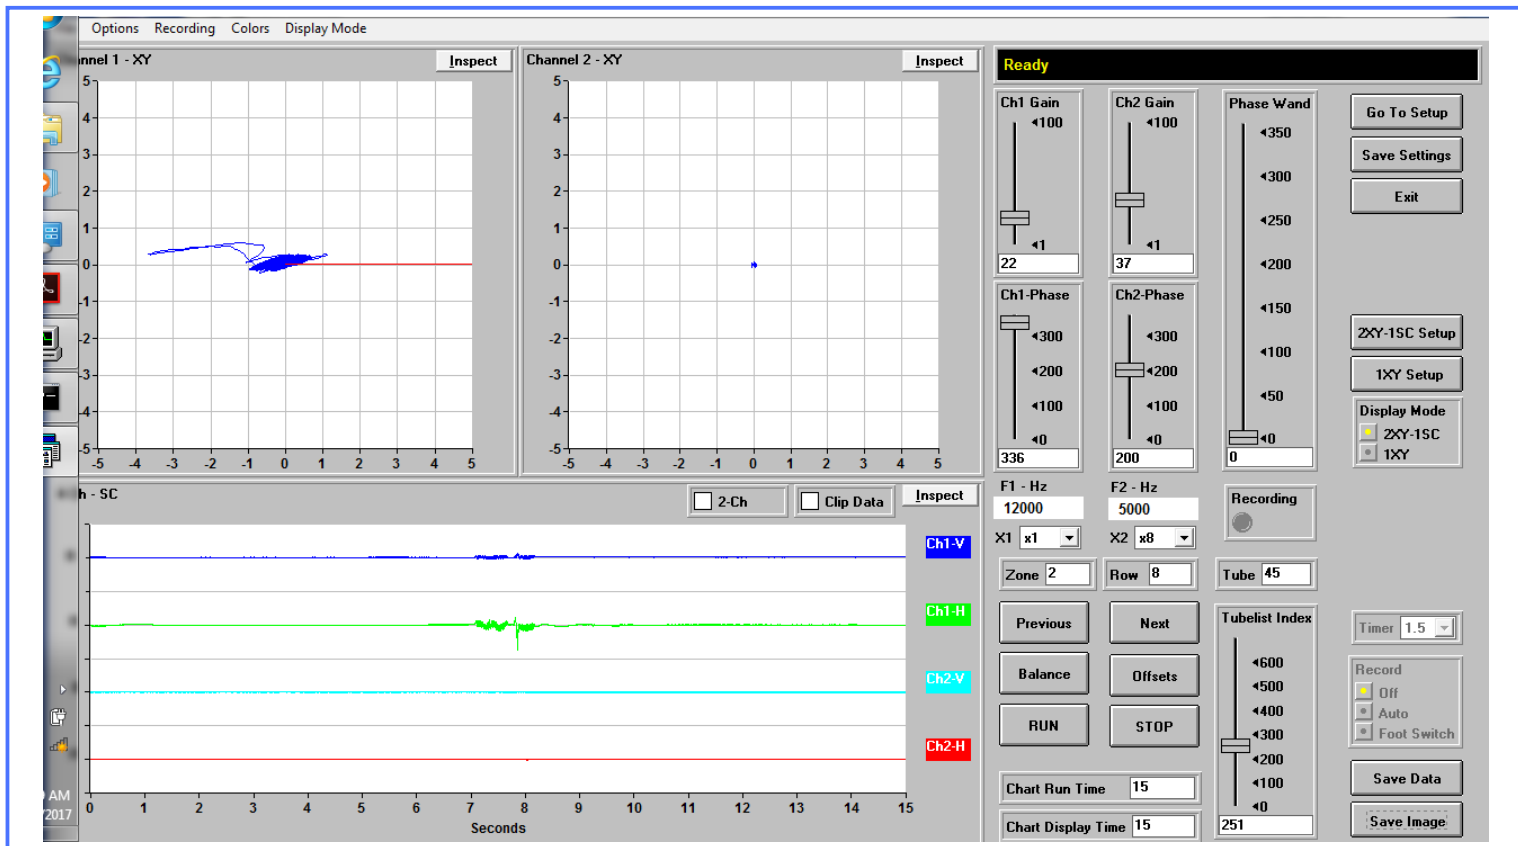
ID DEFECT < 20% (Row 8 Tube 45)

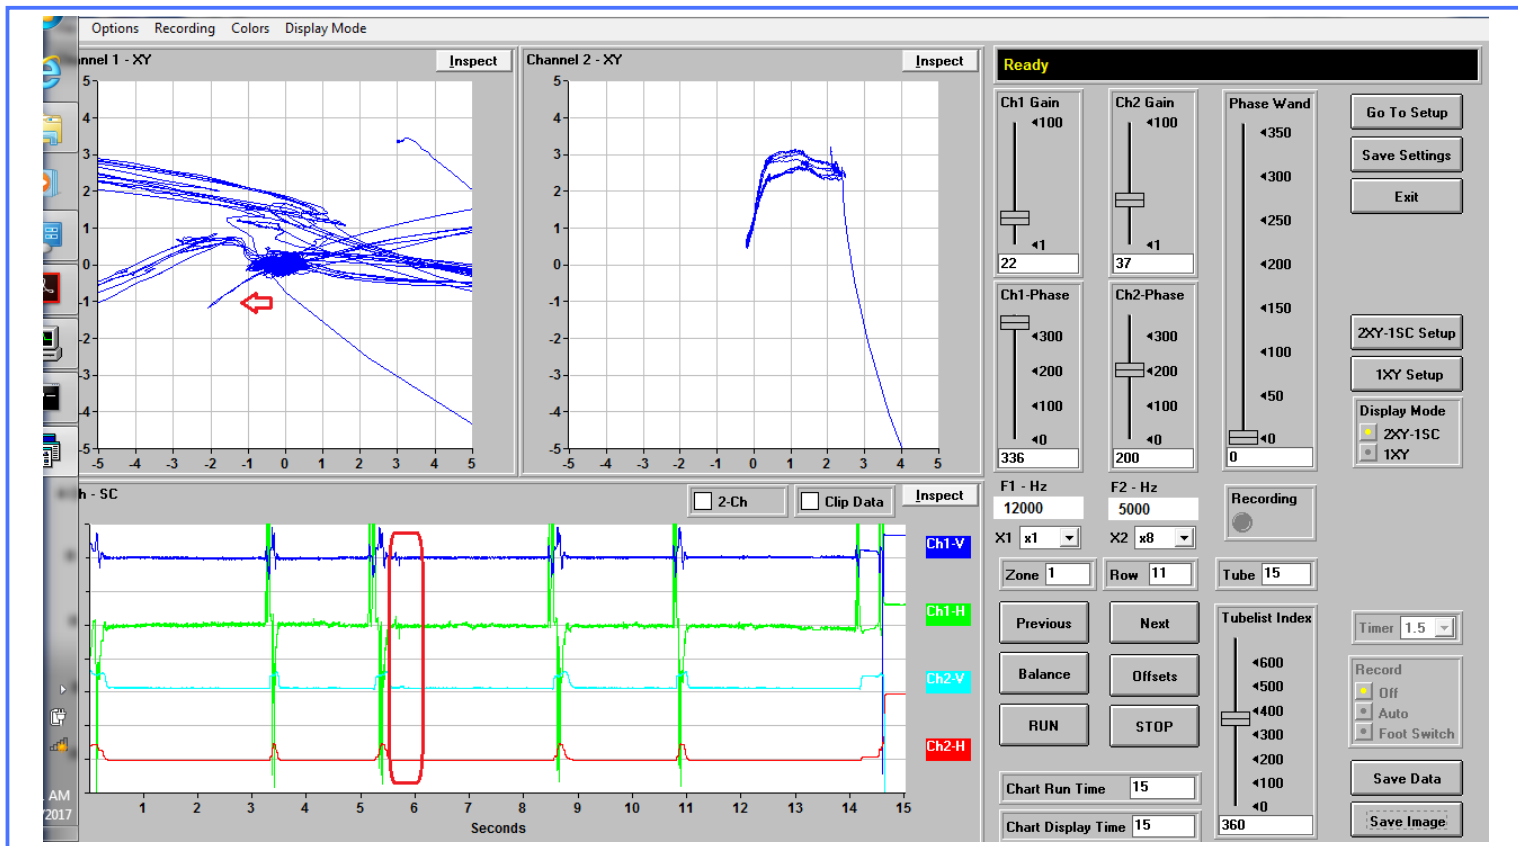
OD DEFECT < 20% (Row 11 Tube 15)
