TO	W. A. BARNES	ATLANTA	A	FROM	M. A. RIVARD	DATE	11/1/62
	P. E. ROSS	CHICAGO	A	OFFICE	DIRECT SERVICE ENGINEERING, SYRACUSE		
	C. R. STEELE	CLEVELAND	A	SUBJECT	FIELD EXPERIENCE REPORT #16 6-2-7		
	C. D. TERRELL	DALLAS	A		OIL LOSS		
	H. A. JOHNSON	LOS ANGELES	A		<u>19C CENTRIFUGAL</u>		
	E. M. TANGEL	NEW YORK	A				
	J. B. CHIOLINO	PHILADELPHIA	A				
	H. A. ADAM	TORONTO	A				
	R. W. VAN DERPOOL	CIL-NEW YORK	A				
	J. MOSES	ATLANTA	B				
	W. H. GUNTHER	CHICAGO	B		W. GROTH	G.S.	C
	R. T. MITCHELL	CLEVELAND	B		C. D. MILLER	TR-7	C
	L. N. FRICK	DALLAS	B		R. S. MUSSEY	G.S.	C
	H. GRIFFIN	LOS ANGELES	B		H. W. SIBLEY	TR-7	C
	R. B. BARNES	NEW YORK	B		M. A. SCICCHITANO	TR-7	C
	J. R. SOISSON	PHILADELPHIA	B		J. S. STYRON	TR-1	C
	J. JAMIESON	TORONTO	B		W. J. WREN	TR-7	C
	F. E. DUNN	CIL-NEW YORK	B

The purpose of this letter is to review the oil loss problem and forward recommended field corrections when oil loss is experienced on field machines.

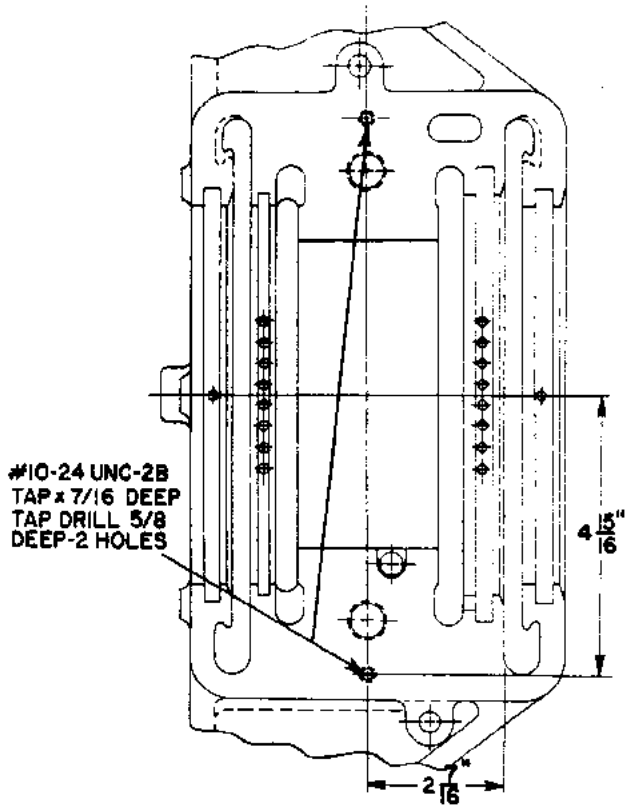
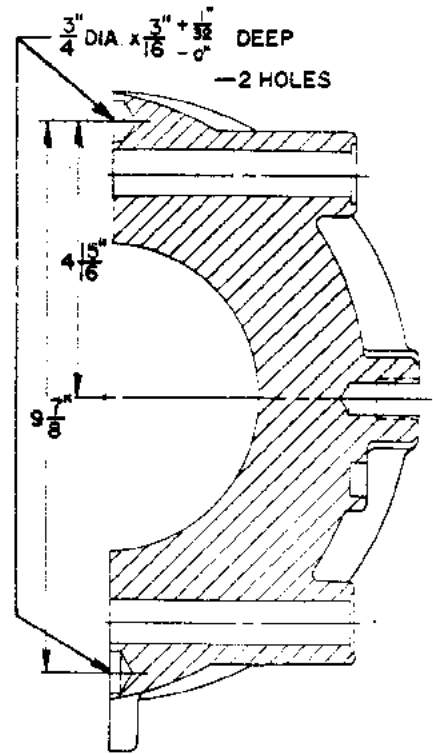
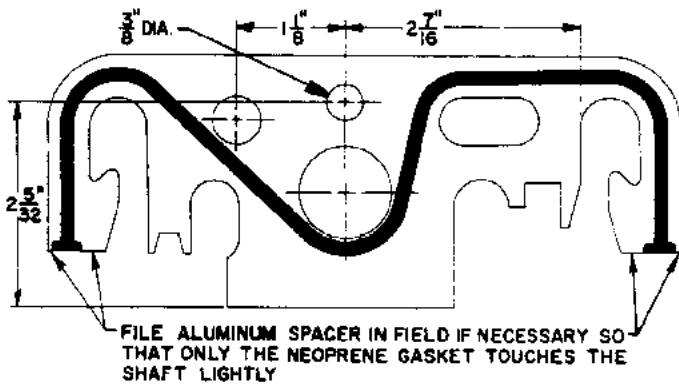
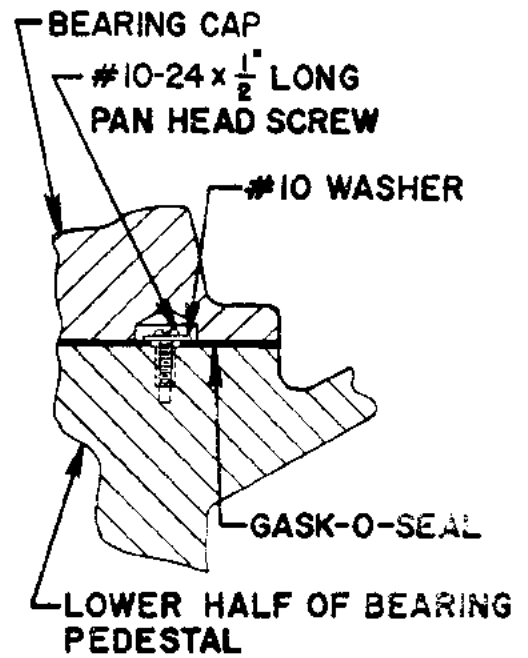
SKETCH NO. 1
HOLDING THE GASK-O-SEAL IN PLACE

Field reports last year indicated that under certain conditions, oil is lost at the main bearing felt rings. Since the drain has been removed between motor shell and oil reservoir, your first evidence of excessive oil loss will be oil accumulation in the bottom of the motor shell.

1. Sudden oil loss resulted at the main bearing felt ring on machine recycle with the oil pump running.
2. Oil loss resulted during machine operation at the felt rings and/or split line Gask-O-Seal if these components are fitted improperly.

- (a). A 3/16" drill thru hole on the bottom of each lower felt groove to aid in oil drainage at the felt ring.
- (b). A reducer bushing and a 3/4" NPT pipe plug in the core hole in the bottom of the pedestal on the motor end.
- (c). A #10-24 x 1/2" long pan head screw to hold the Gask-O-Seal in place at the split line.

A single pan head screw (#10-24 x 1/2" lg.) and a #10 lockwasher will be used on each Gask-O-Seal. A 3/8" drilled hole is provided on the Gask-O-Seal halves with a corresponding counter-sunk hole in the bearing cap to take the pan head. (See attached sketch).

2. Install an anti-recycle timer in the starter and wire in accordance with the schematic on the right hand side of the wiring diagram. Refer to W. Humm's letter dated 4/25/61 for recommended timers and their wiring schematics.
3. Replace the lower and upper felt sealing rings on the main bearing. Before replacing the felt rings however, examine the existing rings for proper compression against the shaft. The felt ring that is still white in color means that it was not contacting the shaft properly and it may mean that the felt ring grooves are machined too deep or that improper felt ring compression is available. Examine the felt to be sure that there is no gap at the split line that can cause oil bypass. The split line Gask-O-Seal should be examined carefully and replaced if any visual defects are found. Secure the Gask-O-Seal with a pan head screw per the attached sketch.
