INTER-OFFICE LETTER

MR. W. A. BARNES	ATLANTA	(B)	FROM	A. I. JOHNSON	DATE 8/30/68
MR. F. A. DELEHN	LOS ANGELES	(B)			
MR. A. MHI	BRANALEA	(B)	OFFICE	DIRECT SERVICE ENGINEERING	
MR. A. MINICK	DALLAS	(B)			
MR. T. C. PETERSON	CHICAGO	(B)	SUBJECT	F.E.R. 68-8	
MR. L. STURZENBERGER	NEW YORK	(B)		19R CONDENSER PURGE BAFFLE	
MR. R. VAN DERPOOL	COC ADA	(B)		<u>SEALING STRIP FAILURE</u>	
MR. H. E. GRIFFIN	LOS ANGELES	(C)			
MR. W. H. GUNTHER	NEW YORK	(C)			
MR. H. A. JOHNSON	DALLAS	(C)			
MR. R. T. MITCHELL	CHICAGO	(C)			
MR. J. MOSES	ATLANTA	(C)			
MR. R. VAN DERPOOL	COC ADA	(C)			
MR. R. JOHNSTON	TR-20	(C)

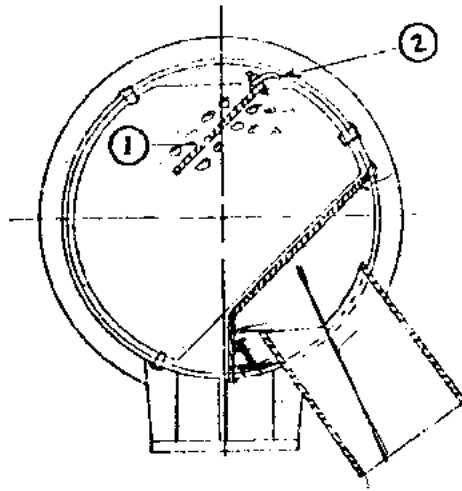
FIGURE 1

Background - From approximately 9/62 until 1/68 the purge baffle sealing strip used on 19R condensers was constructed as in Figure 1 below. Experience has shown that it is possible for the purge baffle to flex and warp enough to shear the 1/4" bolts holding the assembly together. These sheared bolts usually end up in the condenser float valve chamber. Several problems may result from the broken bolts:

- 1) The bolts may jam the float valve open leading to machine hunting and other problems.
- 2) Vibration of a loose back up bar may cause noise in the condenser.
- 3) Sheared bolts and nuts may lodge between tubes leading to tube leaks.

Field procedure - on condensers with purge baffle as in Figure 1.

Remove the float box cover. If bolts are found in the float box remove them and operate the machine.

If the noise level is no longer acceptable or there is a tube leak in the area where a sheared bolt or nut might fall, the sealing strip assembly must be repaired.

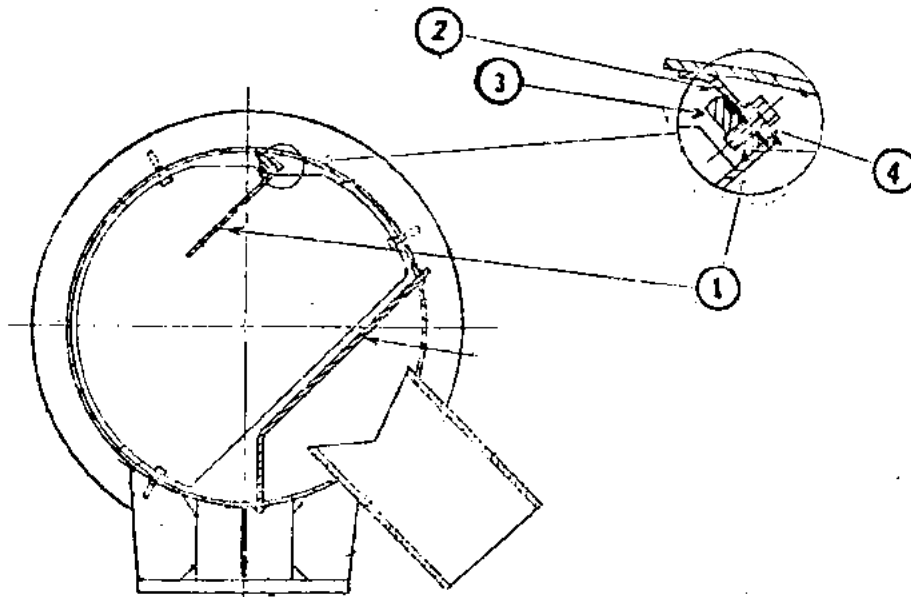
FIGURE 2

*Modified*  
 Condensers serial number 11141 and higher have an improved sealing strip arrangement. The neoprene strip is now bolted with 3/8 high strength bolts to a perpendicular support bar that stiffens the purge baffle. This arrangement is shown in Figure 2.
