SUBJECT 19EA IMPELLER DISPLACEMENT SWITCH WIRING

FIELD EXPERIENCE REPORT 73-6

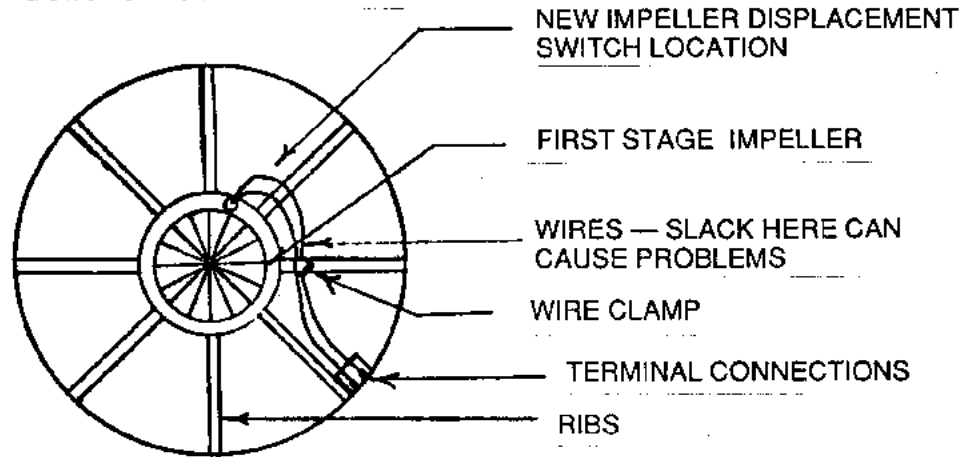
Fig. 1
Before Modification

A recent compressor redesign has relocated the impeller displacement switch on 19EA(1&5) compressors to an approximate 12:30 position. Due to the length of wires, the slack formed allows wires to possibly be drawn into the impeller causing an open circuit and resulting in compressor shutdown (see Fig. I).
