17 & 19 SERIES SERVICE ENGINEERS

Subject: 19DG MOTOR COOLING PROBLEM

FIELD EXPERIENCE REPORT 74-3 REVISION
Supersedes FER 74-3 dated 6/5/74

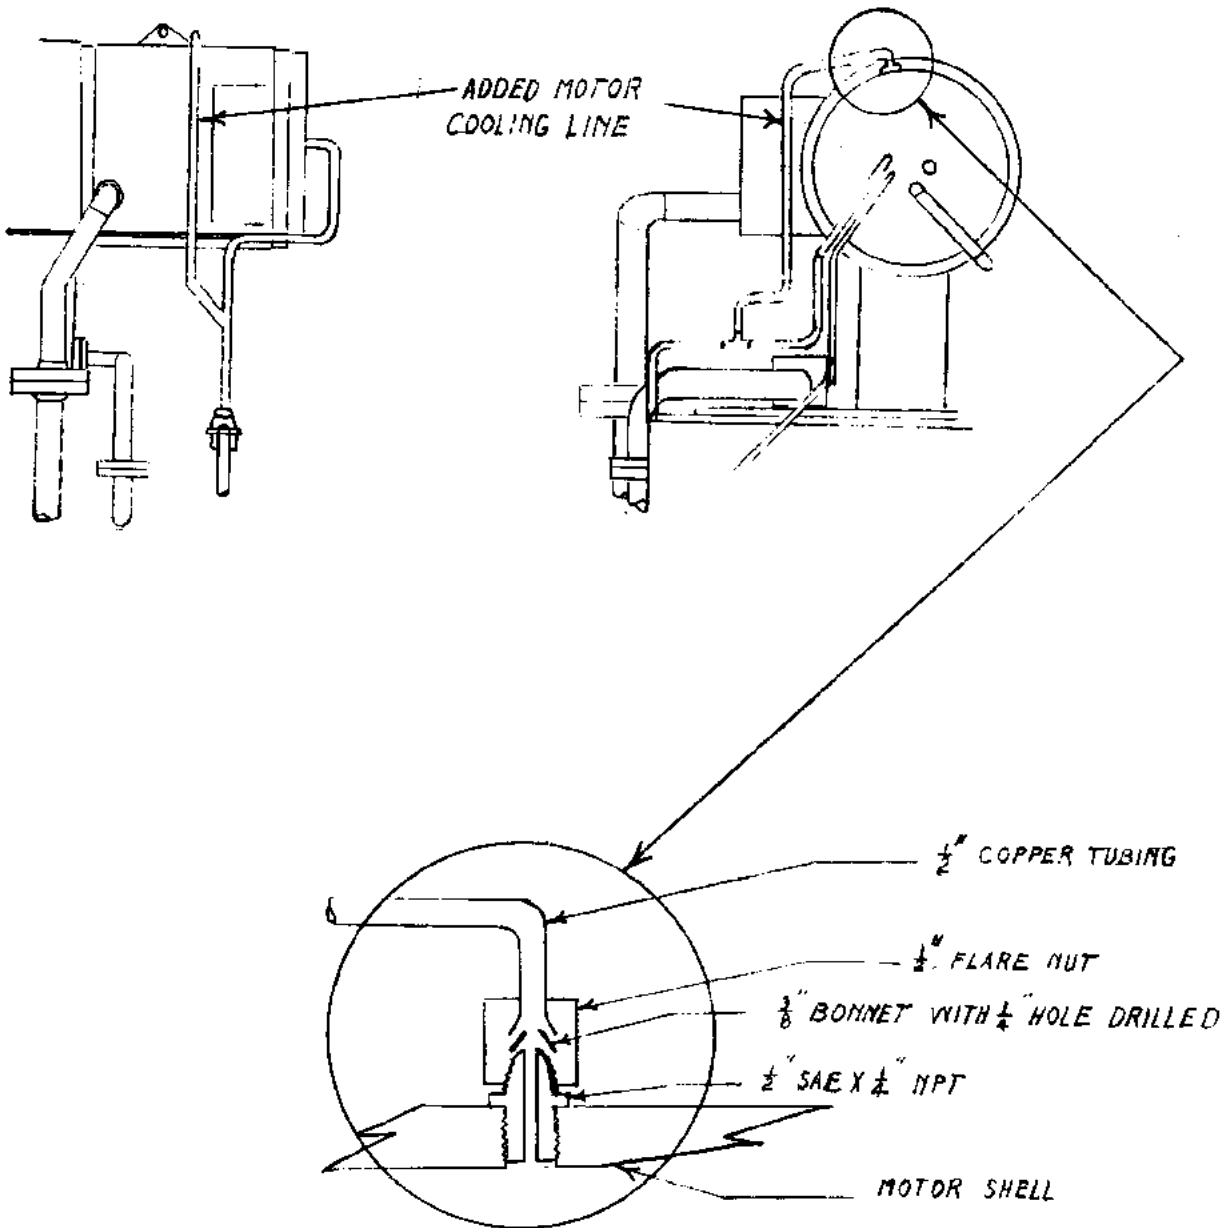
Fig. 1

Some larger 19DG machines have been experiencing nuisance tripouts due to motor over temperature. Engineering tests on these motors have prompted a factory modification to all C8 - C10 motors. This modification is the addition of another spray on top of the motor shell. (See figure 1.) This change is effective as of November 1974. If a 19DG machine is experiencing nuisance tripouts due to motor over temperature, it is recommended the following checks be made in addition to the installation of the factory fix:

Install a 1/2" line from the refrigerant supply line, after the filter, to the top of the motor shell. The 1/4" M.P.T. plugged hole on the terminal side of the shell will be utilized for additional cooling. The refrigerant should be metered through a 1/4" orifice (figure 1).
