Date: 8/23/76
From: CHARLES D. MILLER
Office: MSD SERVICE ENGINEERING, SYRACUSE
Subject: SADDLE DAMAGE TO COOLER TUBES
FIELD EXPERIENCE REPORT 76-5

"Saddle Damage of Cooler Tubes"

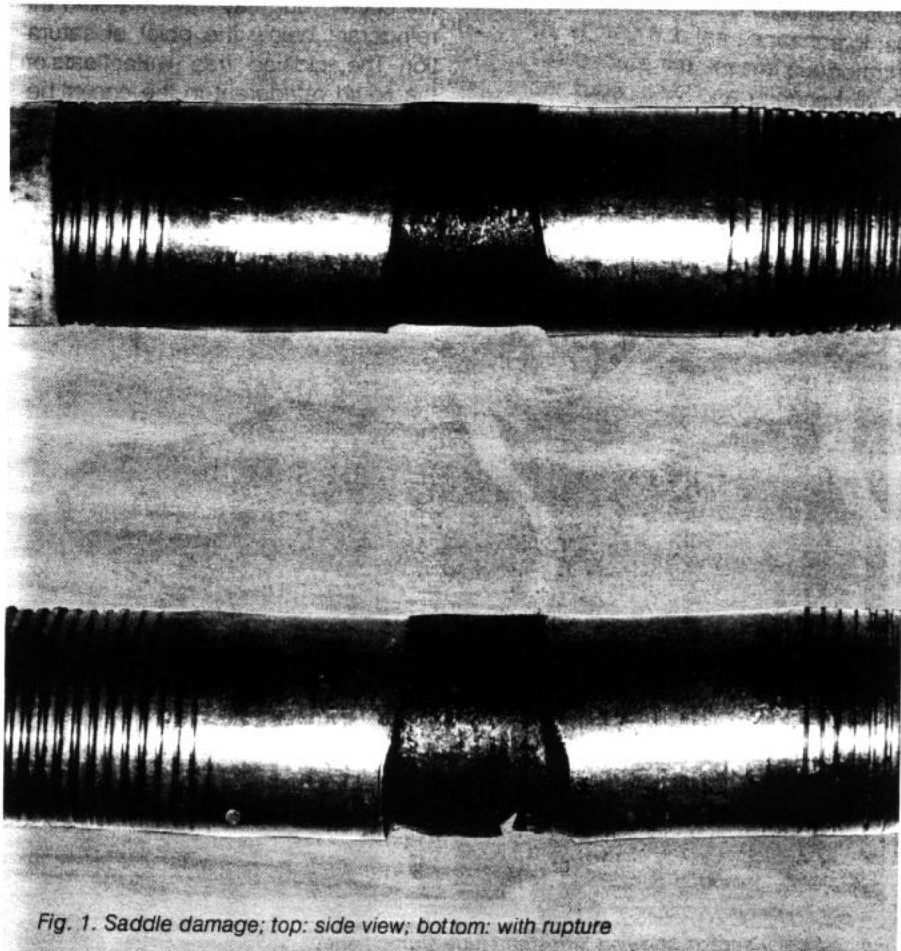
fatigue failure; the magnitude of vibration in these failures may be evidenced by tube-to-tube abrasive wear (See Figs. 1a and 1b);

Fig. 1. Saddle damage; top: side view; bottom: with rupture

Ultimate failure of the tube occurs when the tube cross-section can no longer support the load imposed by the forces due to vibration or hydrostatic pressure. (Fig. 1b).

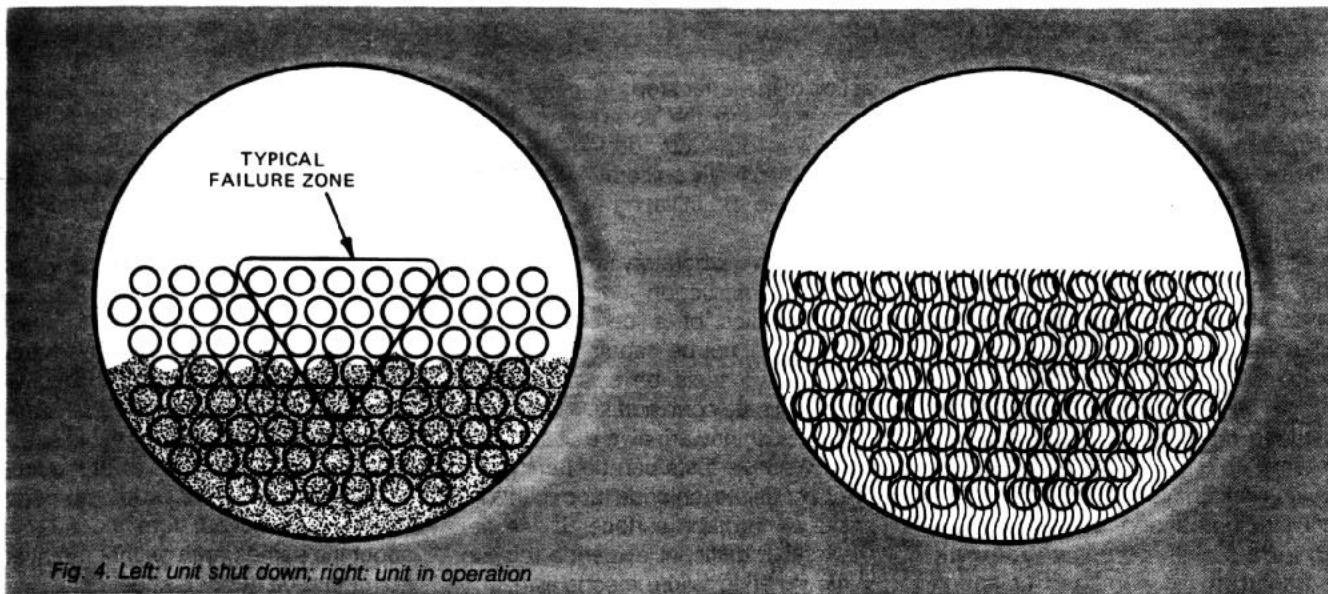
Fig. 4. Left: unit shut down, right: unit in operation

perience this type of failure. Another fact is that the tubes that actually fail from this cause are confined to the center of the bundle, not to the sides (Fig. 4a). This is believed to be due to the increased boiling that takes place in this area due to the greater tube depth in the bundle at the center. The greater the tube depth, the greater the amount of heat transferred causing boiling. Once the tubes become excessively loose, the primary failure mechanism is mechanical wear, and it is in this center portion of the tube bundle where wear will be most active due to the greater boiling activity than found at the cooler sides. Hence, the failed tube and the most severely damaged tubes will be in that portion of the bundle experiencing the most boiling after initial loosening caused by corrosion of the tube support sheet.

Typically, tubes from the top few rows near the center region of the bundle horizontally will show evidence of saddle damage of step 4 (See Failure Zone, Fig. 4a). The visual appearance of the saddle area is typically of a matte, dull finish showing surface roughness and possibly pits. There may also be imbedded particles. The tubes in the top rows at the sides of the bundle will usually not show a saddle pattern and will be at a stage of step 3 in the sequence of failure. The visual evidence at this step is a black surface deposit of iron oxide on the tube from the tube support sheet.

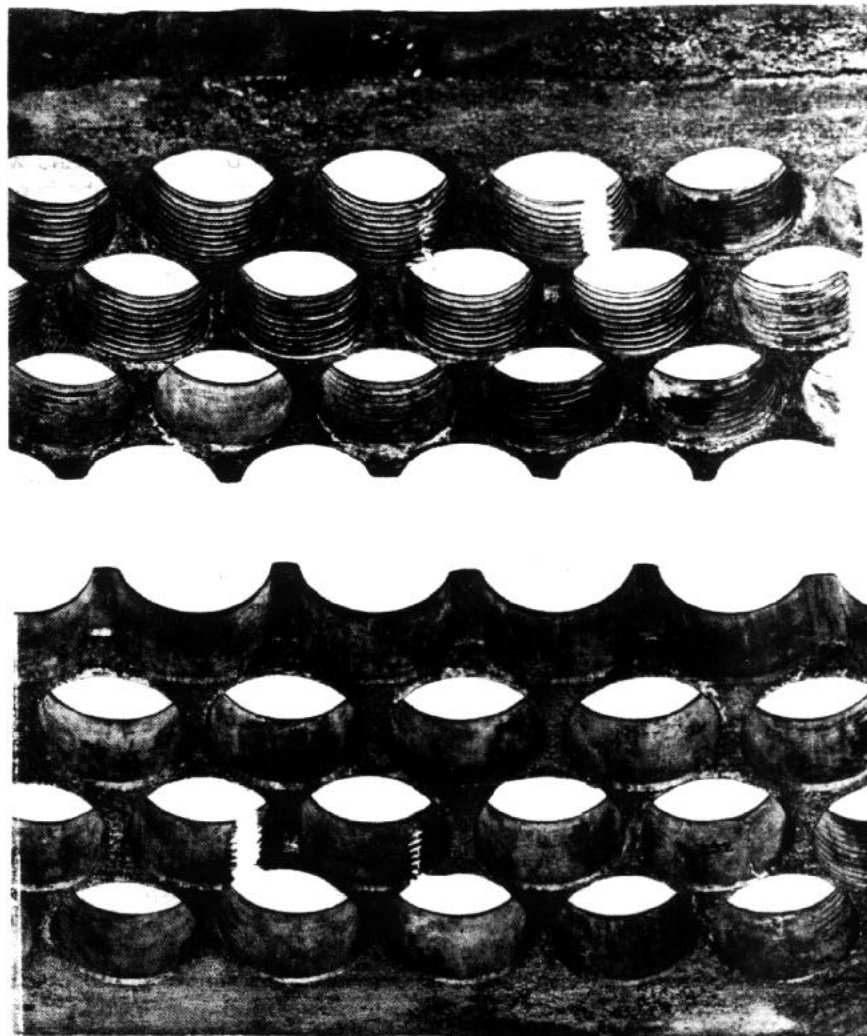
- Corrosion proceeds at this interface destroying any of the mechanical bond and resulting in excessive looseness between the tube support sheet and the tube. In this phase, corrosion is occurring primarily in the steel tube support sheet. This corrosion process is primarily that of galvanic corrosion in which steel is attacked preferentially to copper. Fretting corrosion and cavitation may also contribute to the initial loosening process. The tube support sheet holes become enlarged and elliptical (Fig. 5a and 5b).

rection and is most pronounced on the bottom half of the hole (Fig. 5a). Often, the original machining marks are in evidence on the upper portion of the hole. (Fig. 5b). This hole enlargement has occasionally been reported to be the result of a wear mechanism. It is difficult to reconcile the wear of a relatively hard steel hole from abrasion by a relatively soft copper tube. In extreme cases, tube support sheet holes will have elongated over 0.100". By comparison, the total tube wall thickness is about 0.050". More usually, at the time of tube rupture due to saddle damage, the metal removed from the tube is about the same depth as that removed from the tube support sheet hole.

Fig. 5. Grooved tube support sheet; top: anterior view; bottom: posterior view

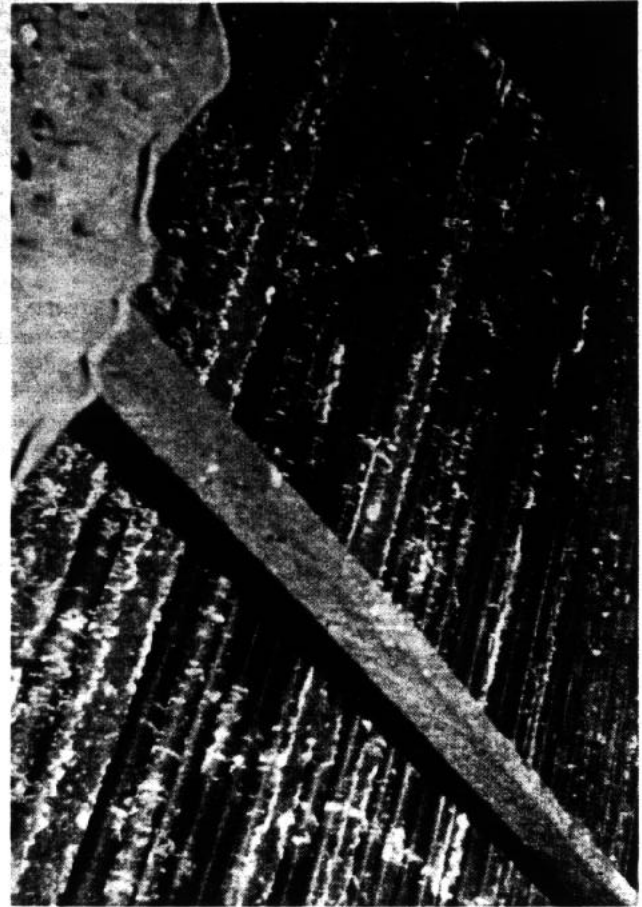
Fig. 7. Scale encrusted tubes from rust flaking off "wet" cooler shell

Acidified water can cause extensive and severe corrosion to the inside of the cooler shell. The scale formed can and does flake and fall off, clogging tube fins, areas between tubes (Fig. 7), and the eliminators. These deposits become hard and reduce heat transfer and restrict the flow of refrigerant gas. The upper rows of tubes, subject to the periodic wetting from the change in level of the floating acidified water, are sometimes corroded and covered with a green corrosion deposit of copper chloride. Such a deposit obviously reduces the heat transfer surface area and heat transfer rate. Since these deposits are hygroscopic, this factor makes total water removal more difficult.
