• SUBJECT: 19EA OIL LOSS

F.E.R. 77-5

19EA OIL LOSS

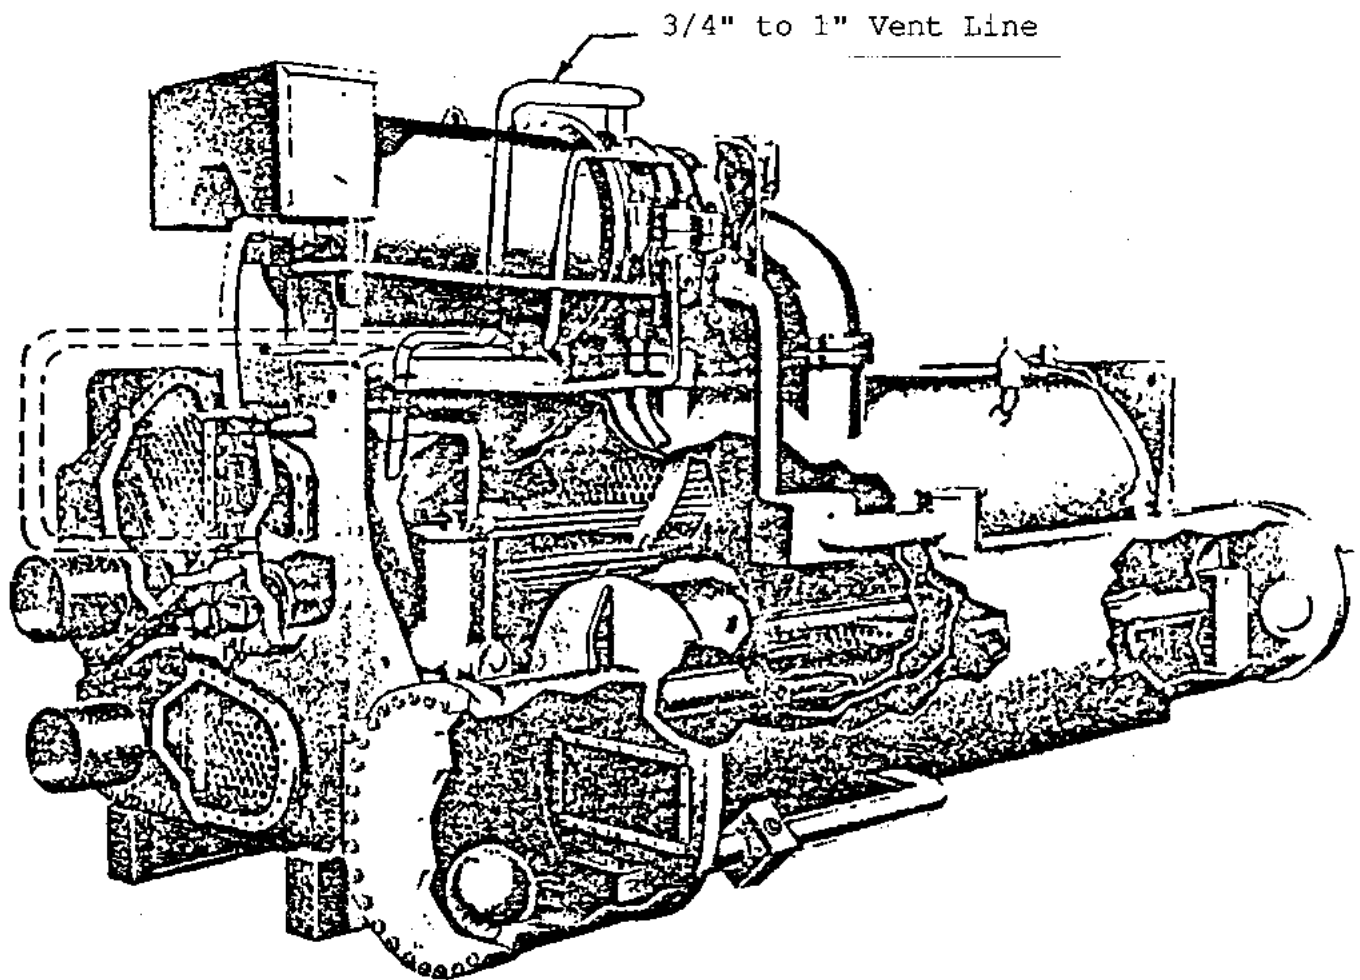
Fig. 1

- 1.2 At Start-Up, refrigerant flashes out of the oil in the reservoir, holding the reservoir pressure higher than the cooler, motor shell, and transmission cavity. This condition may cause oil to stack up in the transmission area. Oil will drop out of the sightglass and may or may not return during operation. However, if machine is shutdown shortly after start-up, oil should return to reservoir.

ADDITIONAL VENT LINE

From Transmission Inspection Cover to Either Oil Reservoir Cover
or Through the Side of the Shell

- 1.2.1 Raise oil temperature to 155^o F. If problem persists, proceed to STEP 1.2.2.
 - 1.2.2 Add an additional vent line between the transmission inspection cover and either the oil reservoir cover or thru the side of the shell into the oil reservoir. Use 3/4" to 1" pipe. SEE FIGURE 1.

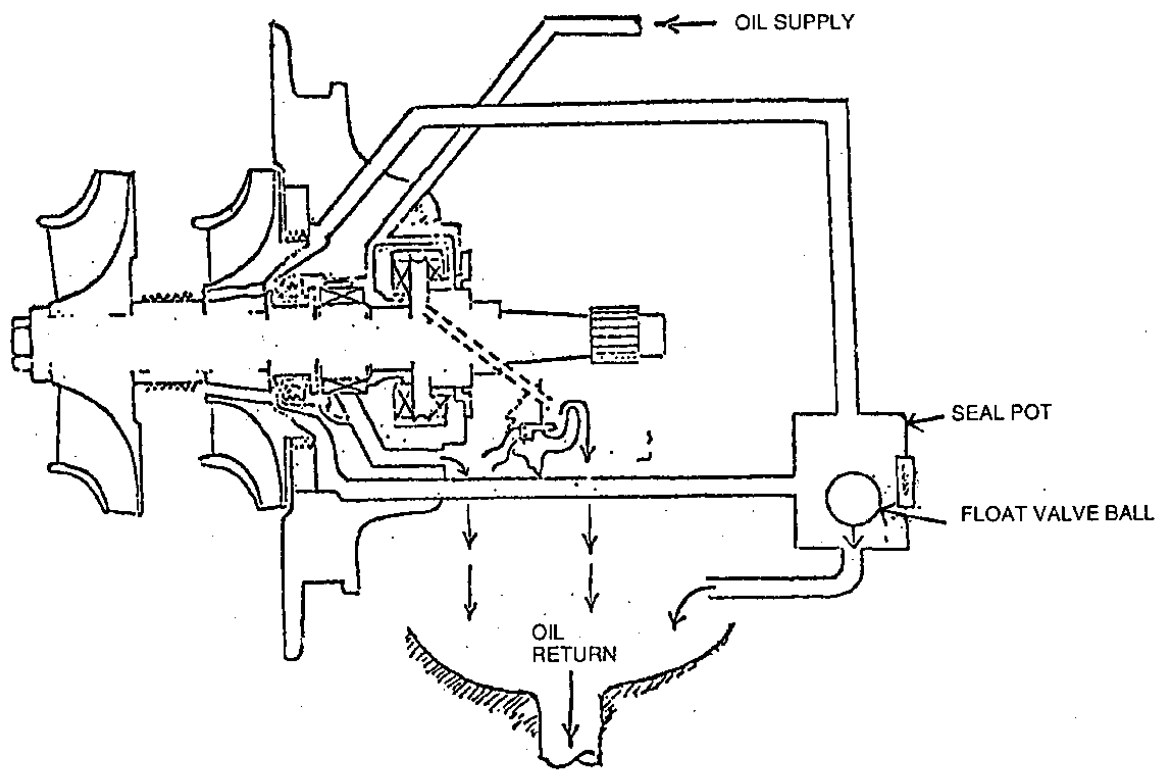
Compressor Lubrication System
Fig. 2

- 2.1 Early machines have a seal pot and float system (FIGURE 2). If the seal pot system is working, it is recommended that it be retained. The original design copper float ball has collapsed on occasion. This will be indicated by a full sightglass of oil. If a collapsed ball is found, and the assembly is to remain in use, replace it with a stainless steel ball, P/N EC28QZ-030.

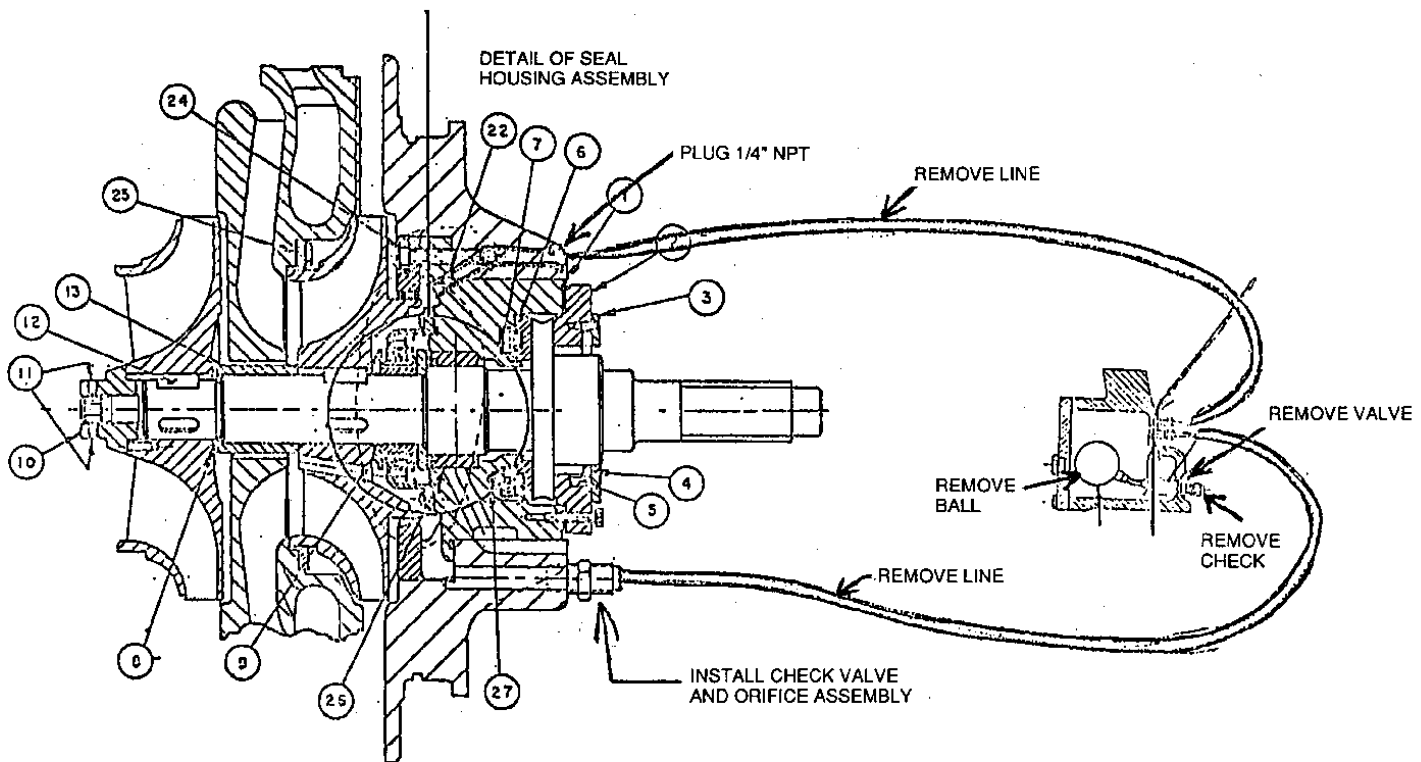
Rotor and Bearing Assembly

ASSEMBLE CHECK VALVE
FILL BORE WITH SOLDER

- 2.2.2 Remove the two lines between the float chamber and the discharge and bearing housing. SEE FIGURE 3. Plug the gas vent hole at the top of the discharge bearing housing.

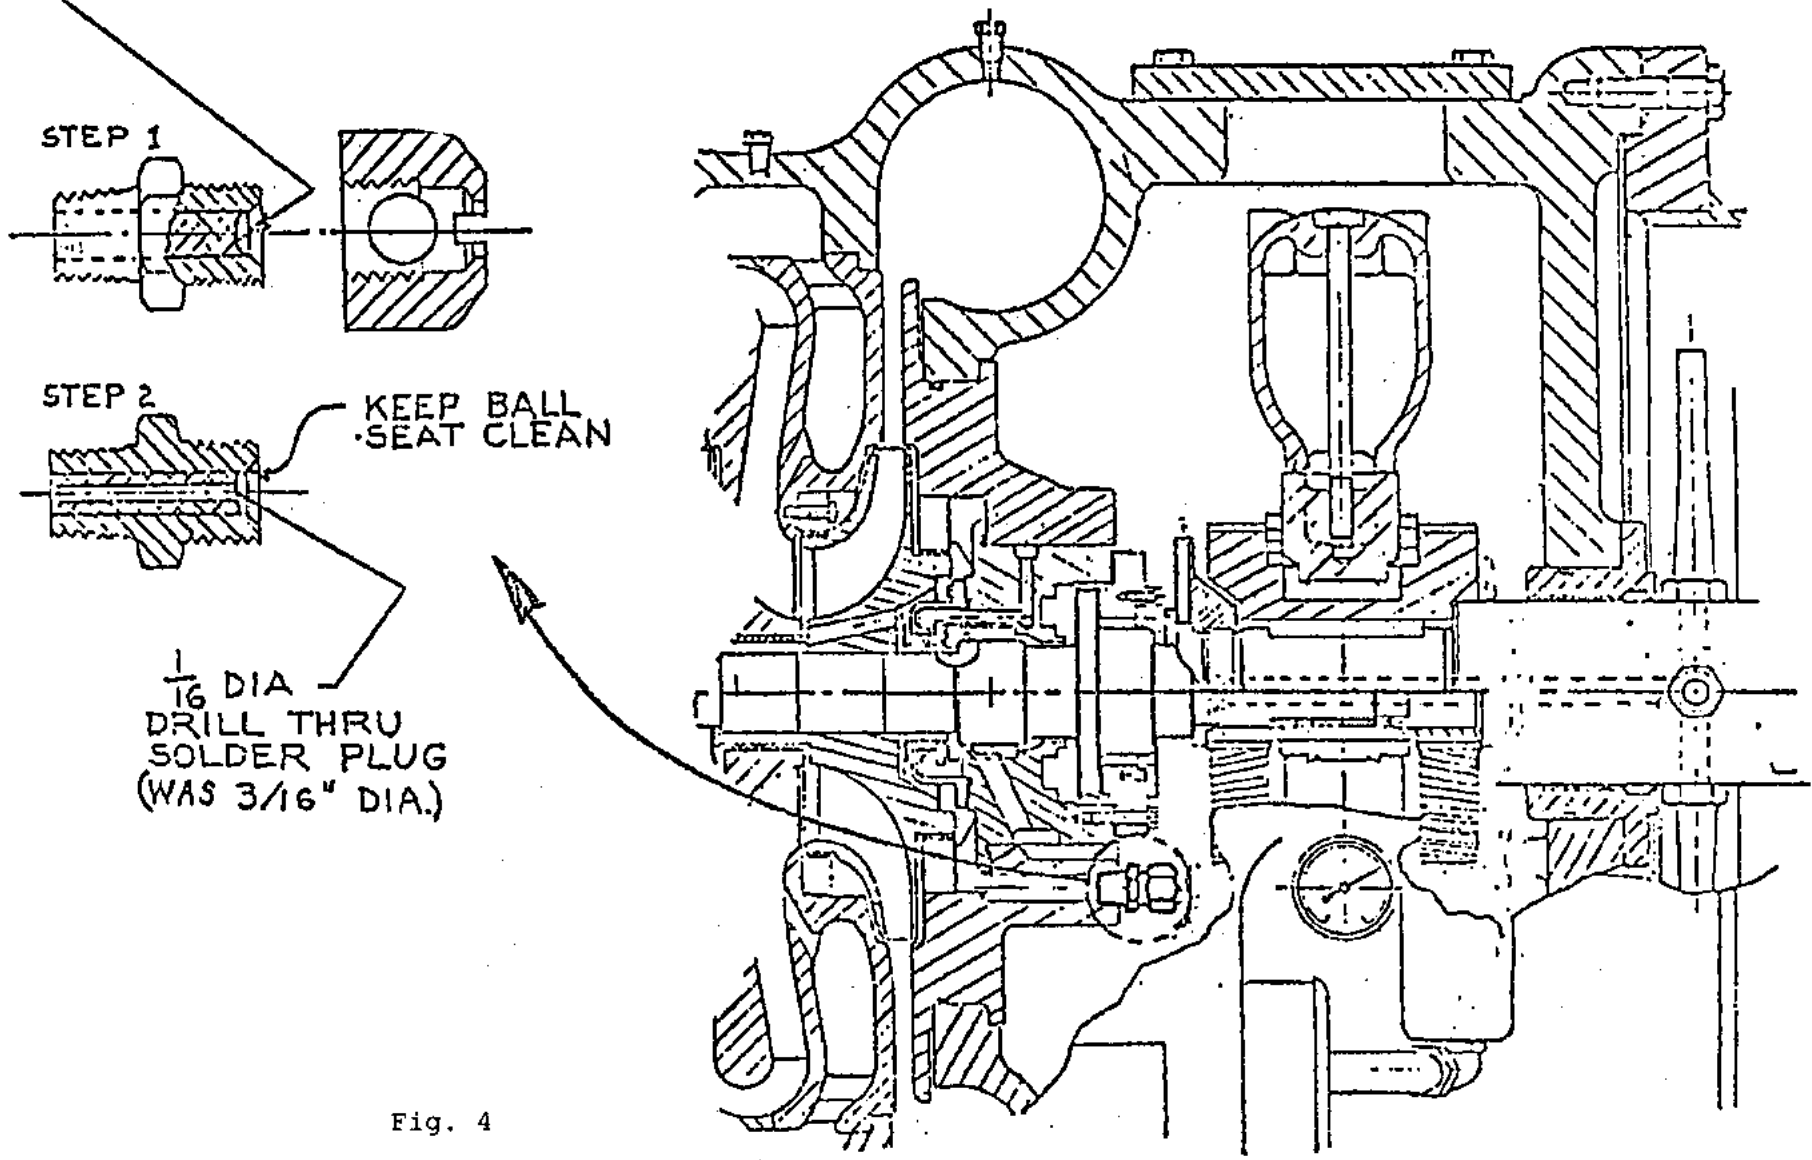
Fig. 4

1/16" Check Valve Orifices. (In Lieu of Seal Pot and System)

- 2.2.3 Install the new check valve/orifice assembly, P/N19EA41-262, in the oil drain at the bottom of the discharge and bearing housing. The check valve/orifice assembly has a 3/8" male NPT connection which fits into a 3/8" hole in the discharge bearing housing.

- 2.3 Later machines have a 3/16" orifice blowing refrigerant gas and seal leakage oil from behind the second stage wheel into the transmission cavity. Experience has shown that the centrifugal demistor can not handle the volume of gas from this size orifice (especially if any other leakage is present). These orifices should be modified to a 1/16" orifice. New machines have this modification.
- 2.3.1 Remove check valve. It is extremely difficult to do this modification thru the transmission inspection cover. The compressor cap may have to be lifted. SEE FIGURE 4.
- 2.3.2 Solder 3/16" orifice closed on threaded end.
- 2.3.3 Drill thru solder with 1/16" twist drill.
- 2.3.4 Replace check valve in compressor.
- 2.4 The following chart outlines the seal system that may be on a machine by compressor serial number.

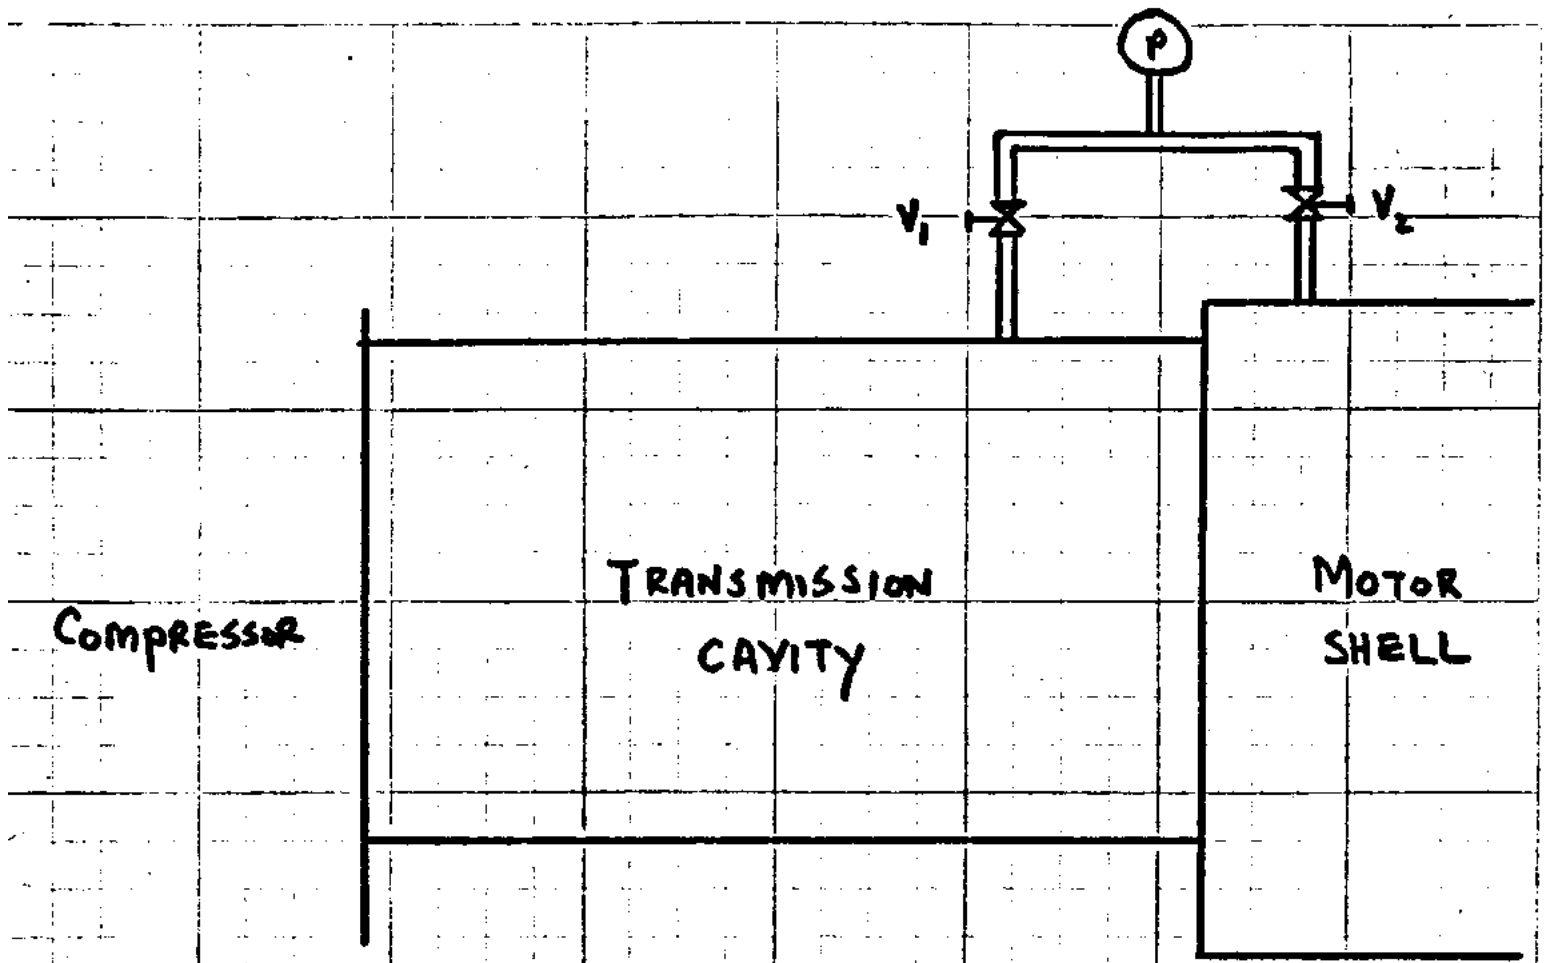
Method to Check Pressure Differential
Fig. 5

If gas leakage into the transmission area is excessive the demistor system is overloaded and the result is continual oil loss of 1 to 5 gallons per week across the motor shaft labyrinth.

To test for this reversal of pressures, a pressure gage should be installed to measure the pressures in the transmission cavity and in the motor shell. SEE FIGURE 5 for a suggested hook-up. If the transmission cavity pressure is the greater of the two, a gas leak exists.

To MEASURE TRANSMISSION CAVITY PRESSURE :

V1 - OPEN
V2 - CLOSED

To MEASURE MOTOR SHELL PRESSURE :

V1 - CLOSED
V2 - OPEN

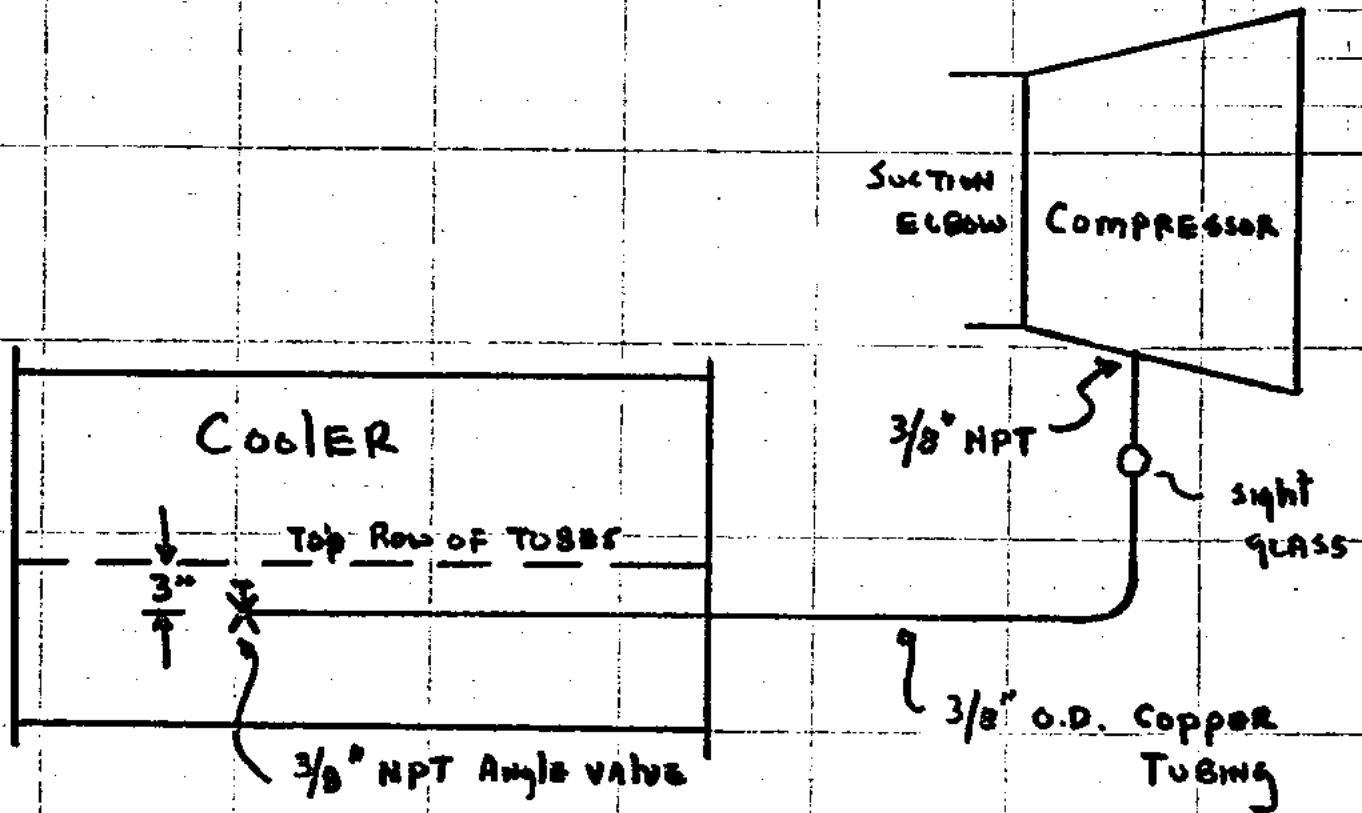
Fig. 8

6.1 With the inlet guide vanes closed, the oil return system can become less effective on some machines. The oil that is usually carried with the refrigerant gas into the compressor suction remains in the cooler.

6.2.1 Drill and tap a 3/8" hole approximately three rows down from the top row of tubes in the cooler. This location is approximately four (4) inches down from the filter-drier return connection. Consult BULLETIN 19SB-76-8E for dimensions.

6.2.2 Drill and tap a 3/8" hole in the downstream side of the inlet guide vanes. This connection is located at the suction of the first stage impeller. CONTACT ZONE SERVICE ENGINEERING for the exact location for this connection since the dimensions between vanes and the impeller differ for different impeller combinations.

6.2.3 Connect these two holes with 3/8" copper tubing. Install a 3/8" angle valve and sightglass in the line so the flow can be controlled. SEE FIGURE 8.

Angle valve : CARRIER P/N EP23LA155
 3/8" NPT x 1/2" SAE FLARE
