Carrier
Machinery
and Systems
Division

SUBJECT: 19EA,FA SENSORS

F.E.R. 78-4

PURPOSE: To provide a procedure for troubleshooting bearing and motor sensors.

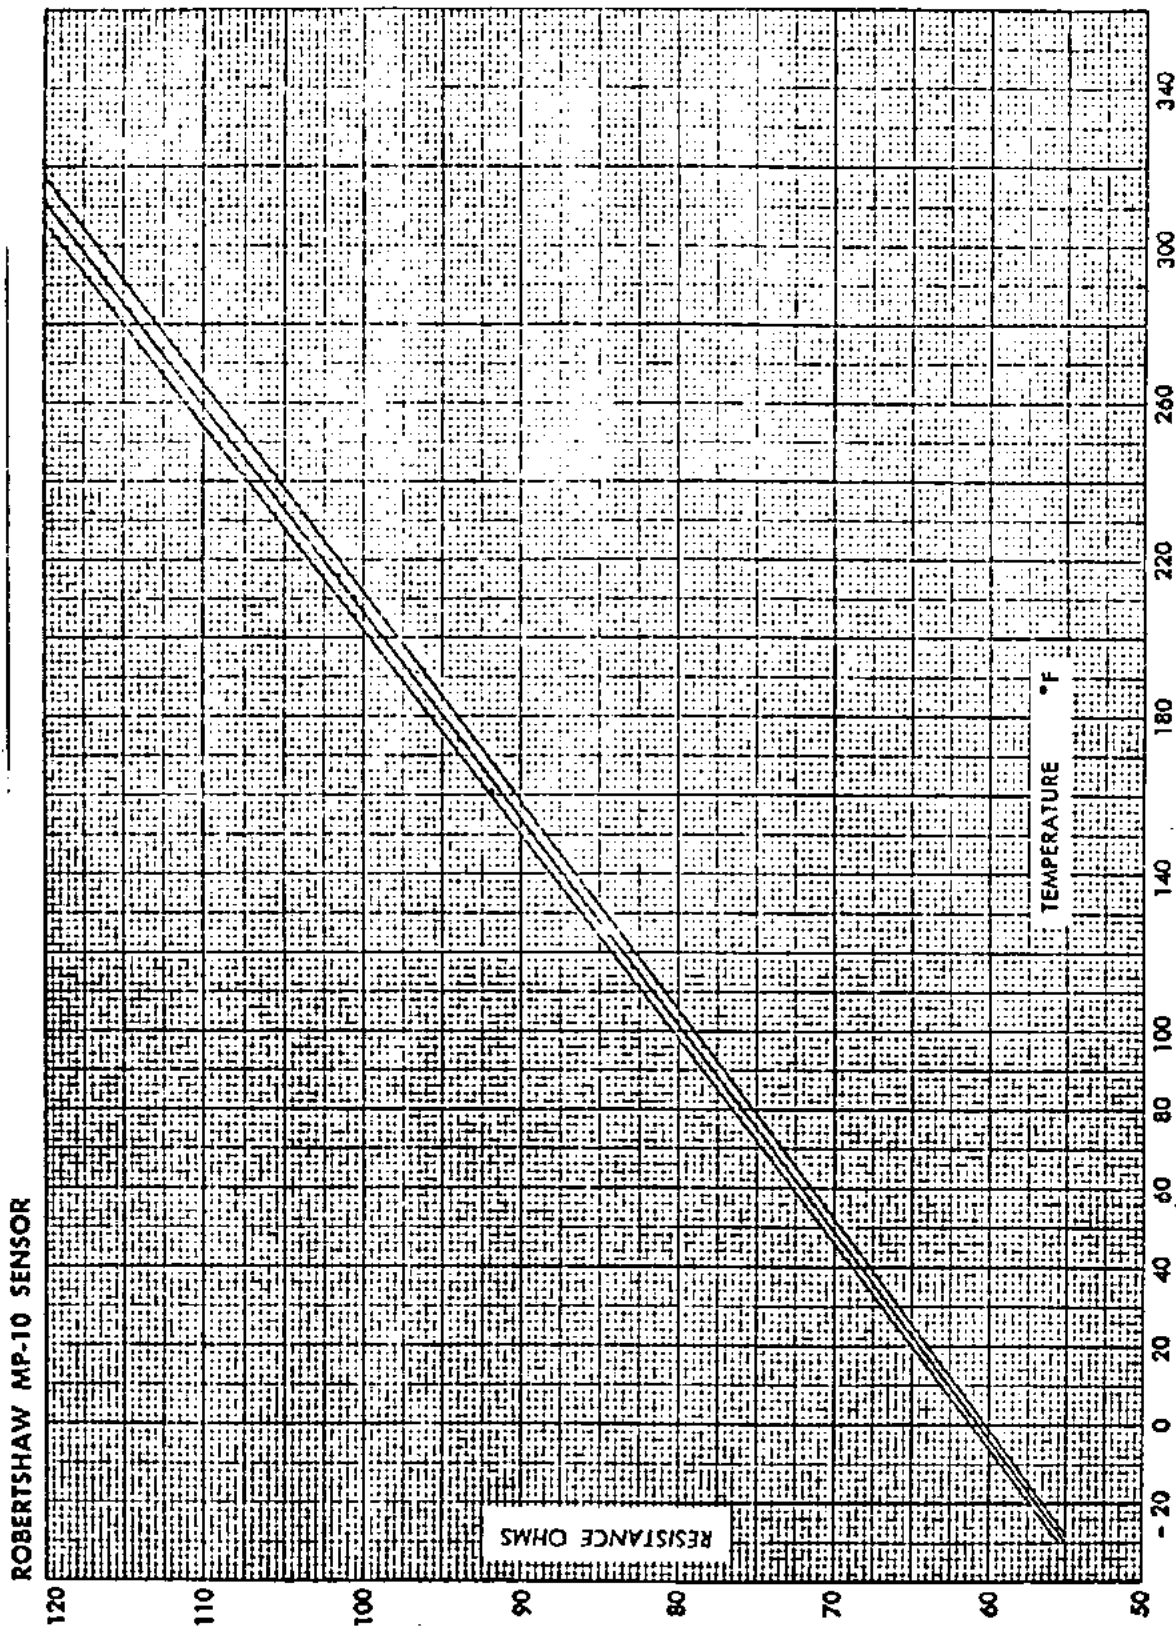
19EA BEARING, DISCHARGE, AND MOTOR SENSORS

2.1.1. Defective Sensors - Check the resistance reading across the sensor. The resistance - temperature relationship shown in Sketch #1 should be evident if the sensor is functioning properly. The bearing, motor, and discharge sensors (if applicable) should be checked.

Sensor Resistance versus
Sensor Temperature (Linear).
Chart 904810
