# Interoffice Letter

Date: AUGUST 24, 1982  
From: FRANK A. BAGILEO, JR.  
Office: SERVICE ENGINEERING-CRANFORD  
Subject: HERMETIC/CENTRIFUGAL  
MOTOR SENSOR REPLACEMENT/REPAIR

F.E.R. 81-4

PURPOSE: To advise field personnel of recommended repair procedures concerning motor sensor replacement.

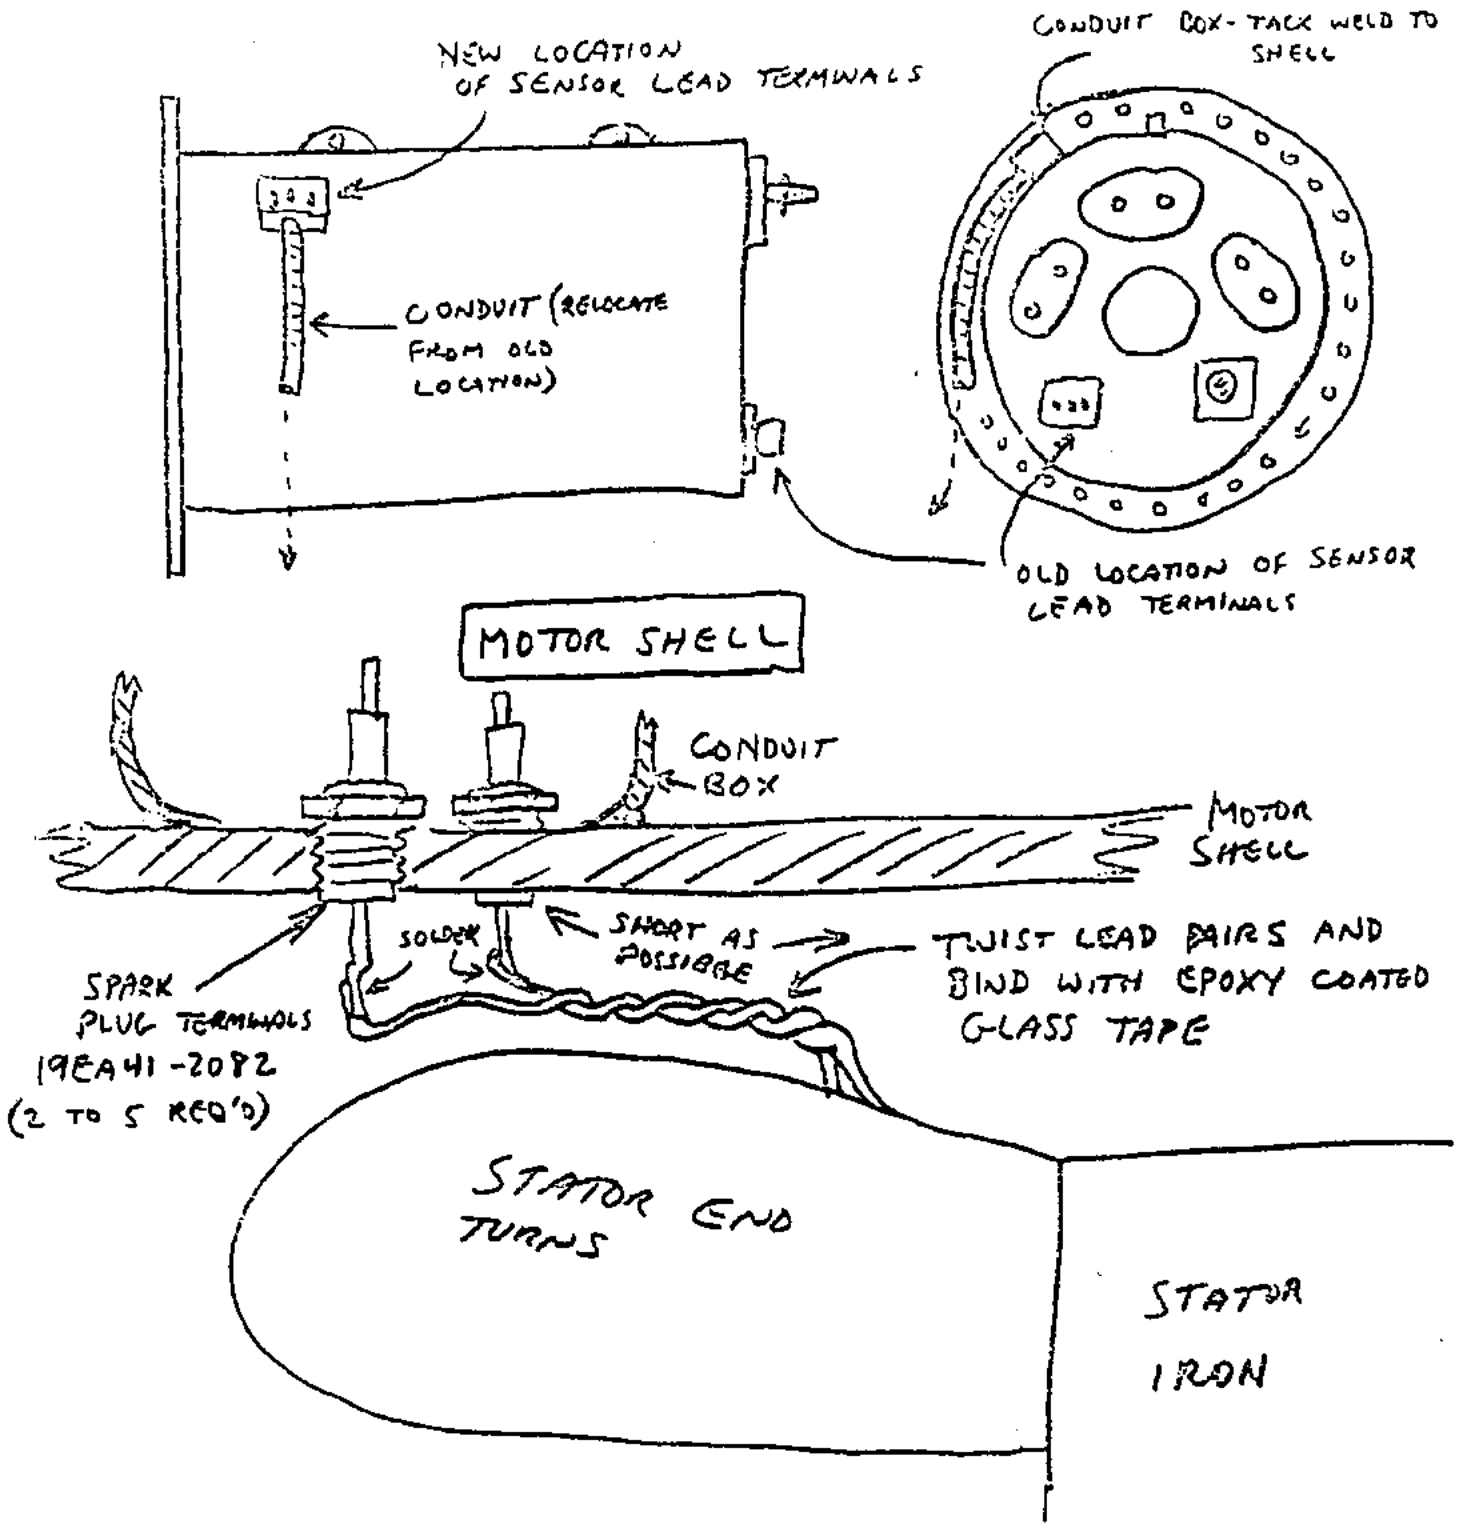
2.0 Method for bringing leads out of motor shell: See Figure 1. It is important that individual lead pairs be twisted together to prevent stray voltage pickup and securely bound to form a rigid assembly. To provide added security, the spade terminals and mating connectors can be soldered together (with rosin core solder; not acid core - use soldering iron and do not overheat spark plug terminals).

SENSOR may blow before fuse -  
a low vol. will raise set  
point = 10°F

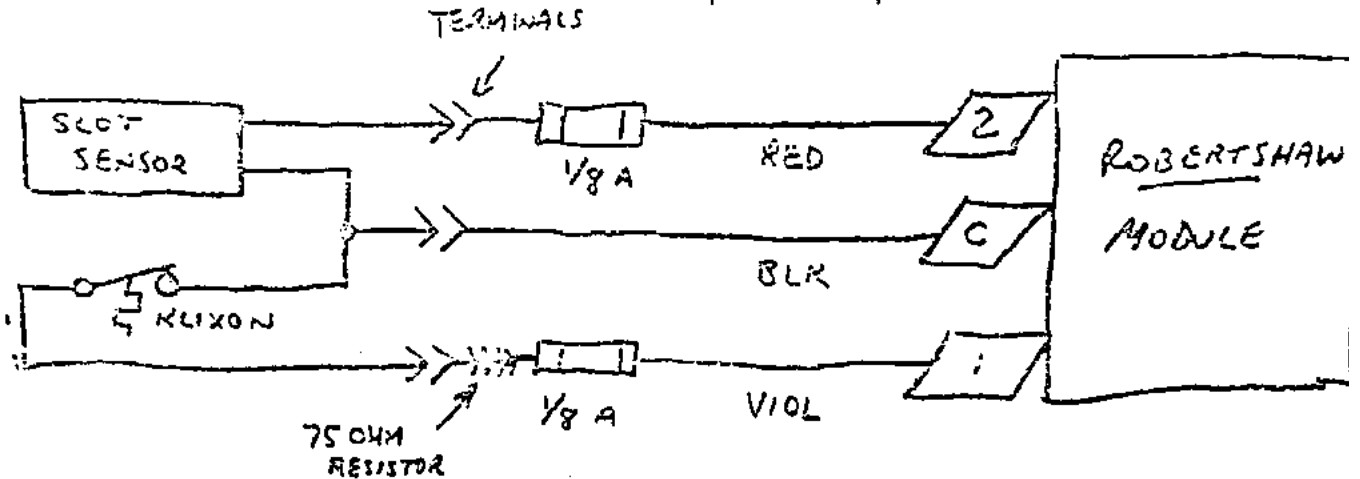
FIGURE 2 - WIRING WITH ONE SENSOR, ONE KLIXON

2.1 If end turn sensor is not usable but slot sensor is, a Klixon in series with a 75 ohm resistor can be used with the remaining sensor. A wiring diagram is shown in Figure 2. The Klixon (HH12HA105) should be attached as near as possible to the location of the end turn sensor and tied down with glass tape epoxied in place.

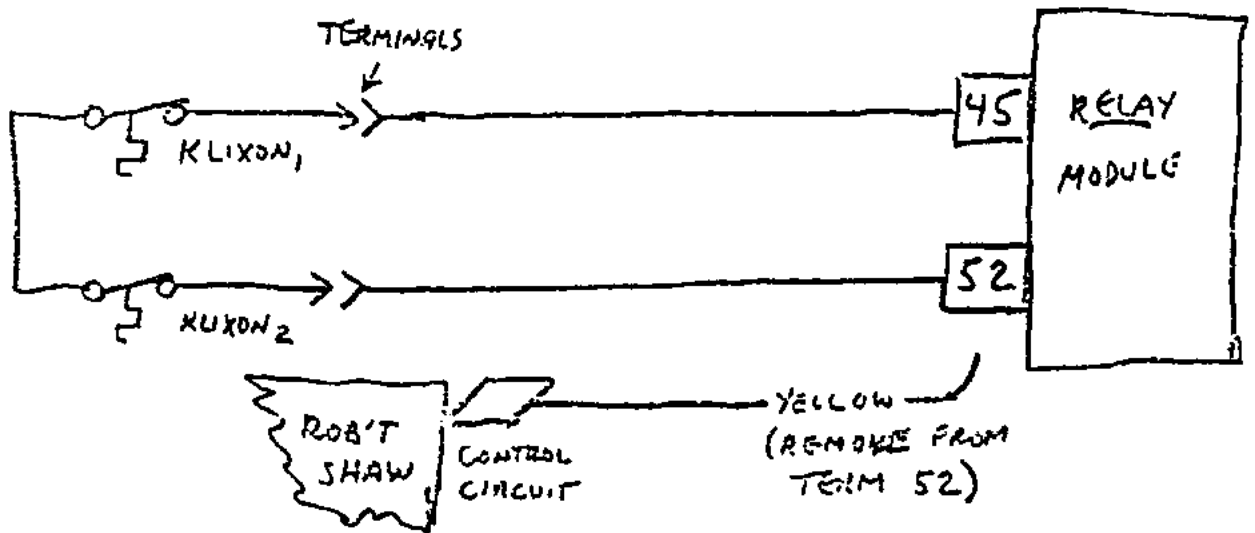
FIGURE 3 - WIRING WITH KLIXONS ONLY

2.2 If all sensors are unusable a Klixon (or two-in series) should be attached as in step 2 above, but can be wired into the circuit bypassing the Robertshaw module. See wiring diagram, Figure 3.

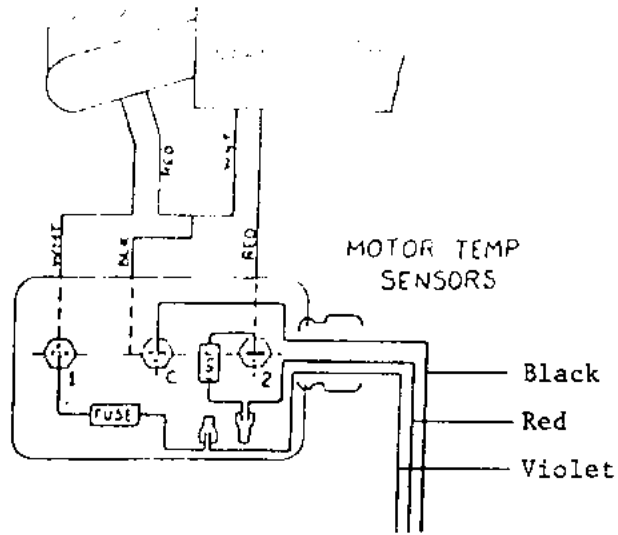
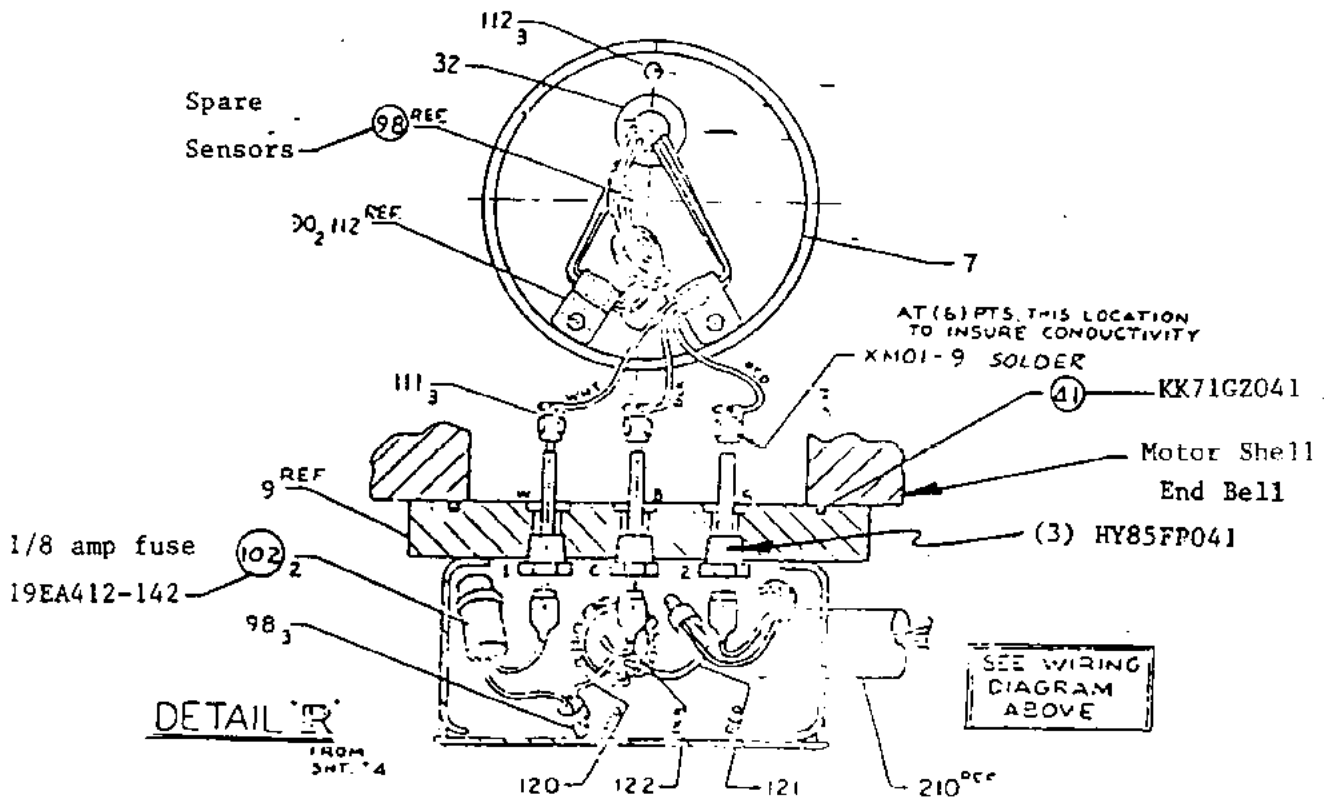
FIGURE 4

1.0 19EA, EB, FA's have a spare set of sensors embedded in the motor end turns and motor slots. In the event that a motor sensor should go bad, consult Fig. 4 for location of the spare sensors.

19EA-EB-FA  
SPARE SENSOR LOCATIONS
