Subject: 19E SERIES COASTDOWN RESERVOIR
Reference:

Cent. FER 82-2

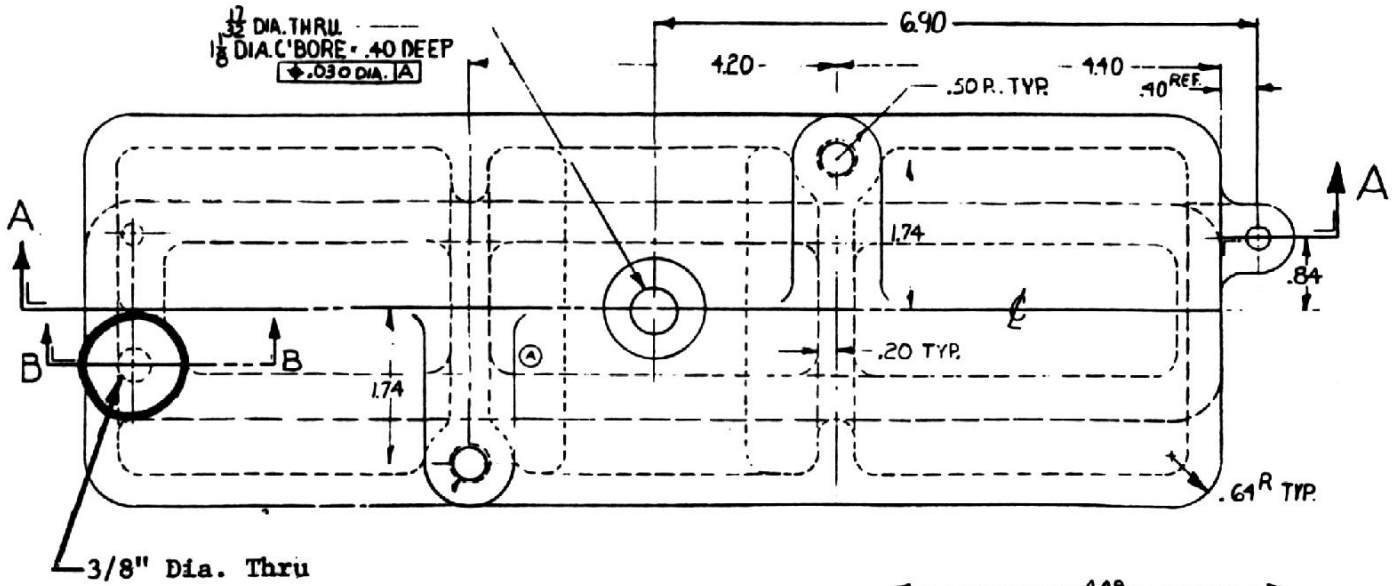
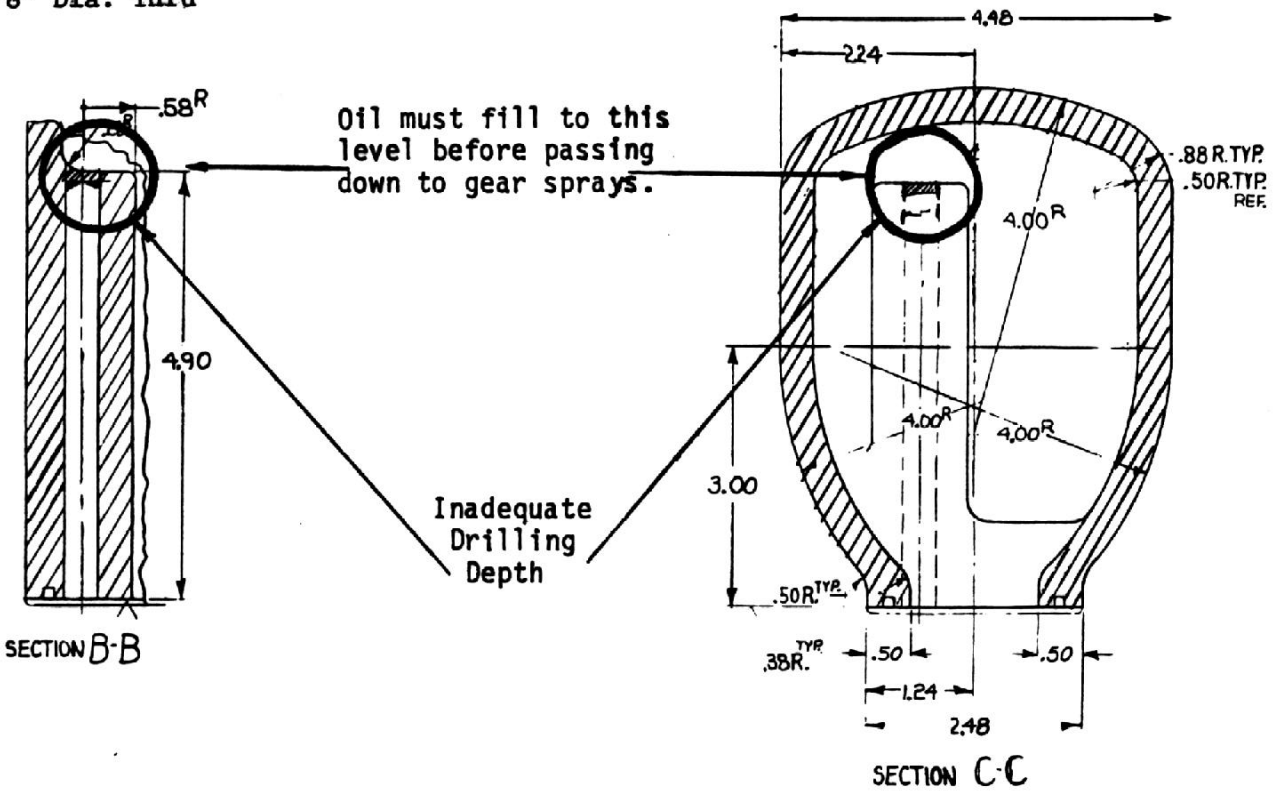
It is possible that the oil passage in the coastdown reservoir (Part No. 19EA51-1094 and 19EA41-1094) has not been drilled to a sufficient depth to provide a hole at the level through which oil is supplied to the bearing cap and into the gear spray headers.

3/8" Dia. Thru

When a machine is pumped down and the compressor opened for any reason, it is recommended that the reservoir be checked by manually running the oil pump for at least one minute. If there is insufficient oil being supplied to the gear spray headers, remove the reservoir and redrill the oil passage as shown in the attached sketches.
