**UNITED
TECHNOLOGIES
CARRIER**

BULLETIN: CA-SB-19-C-59-6
DATE: 8/4/59
PAGE: 1 OF: 9

SERVICE BULLETIN

INTERNAL VANE SHAFT SEAL

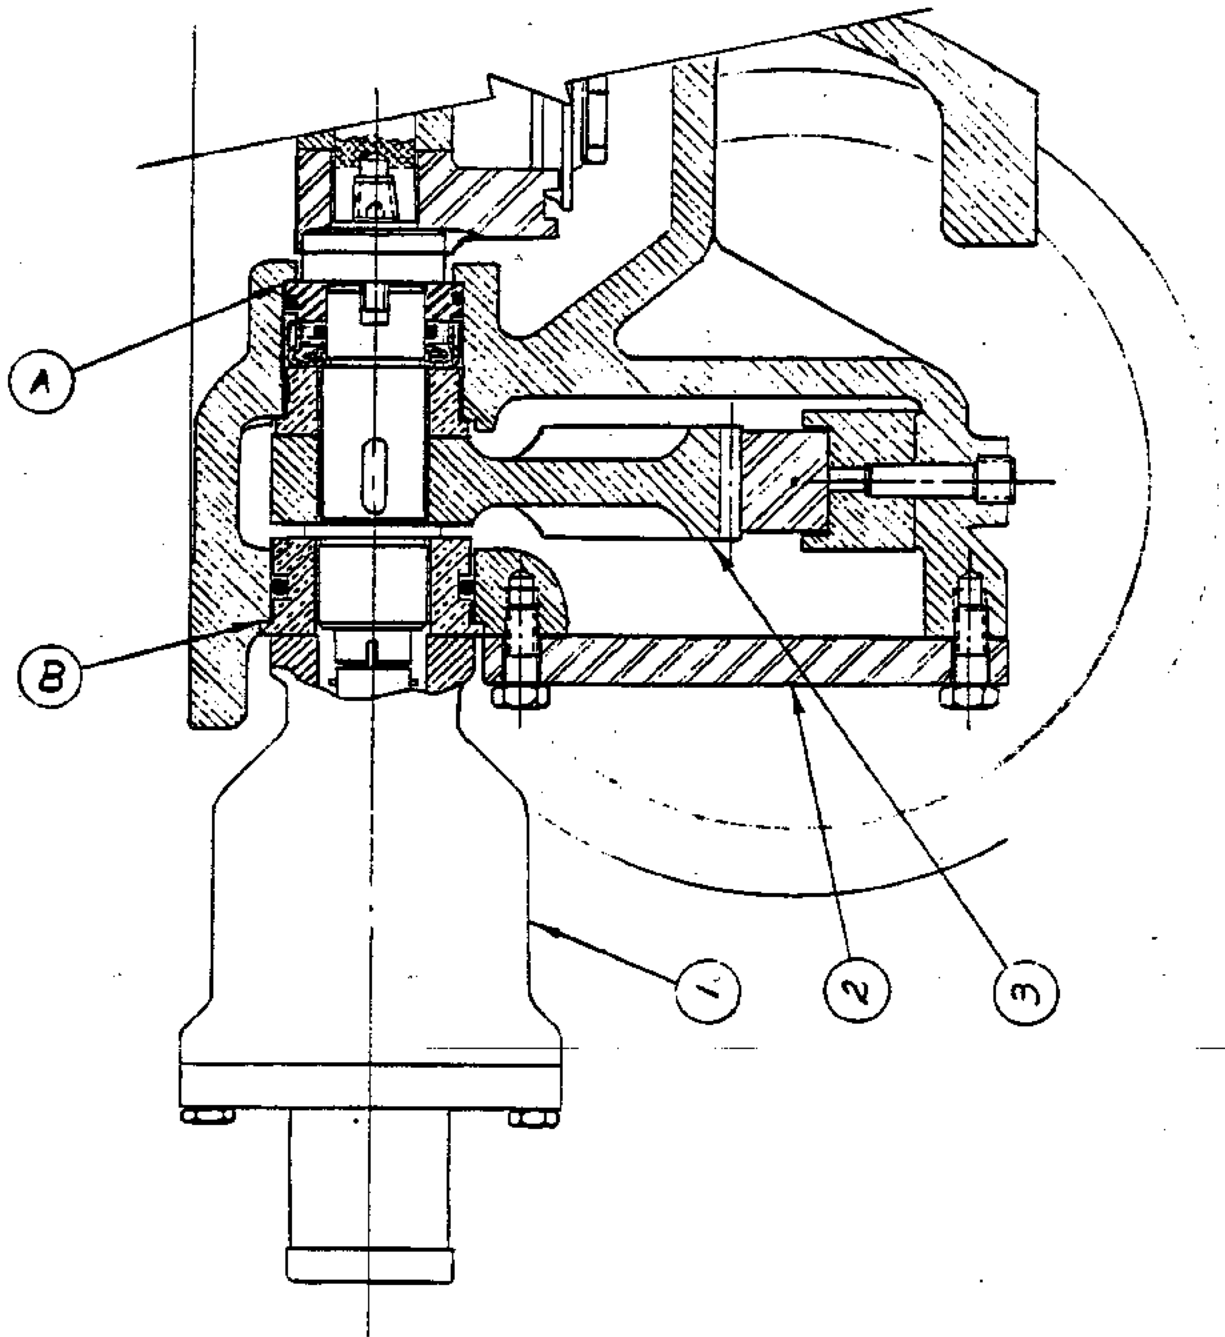
1. Remove vane follow-up potentiometer, item 1, Fig. 1.
2. Remove oil piston inspection cover, item 2, Fig. 1.
3. Using a puller as shown in Figs. 2 and 3, jack the shaft out of the assembly. To prevent binding the gear segment, item 3, Fig. 1, should be held in position by reaching through the piston inspection opening. The jacking plate should not bear against the outside bushing, item 1, Fig. 2, as this part will move out with the shaft.
4. Using puller as shown in Fig. 3, pull shaft coupling, item 2. The shaft seal, item 3, and internal bushing, item 1, will be forced out ahead of the coupling.

3. The seal spring has a maximum movement of 1/8". Minimum compression on this spring is 1/32" and maximum is 3/32". The above measurement should put it within this range. If too little spring compression is indicated, then shims should be inserted at point A, Fig. 1. If too much spring compression is indicated, shims should be inserted at point B, Fig. 1.

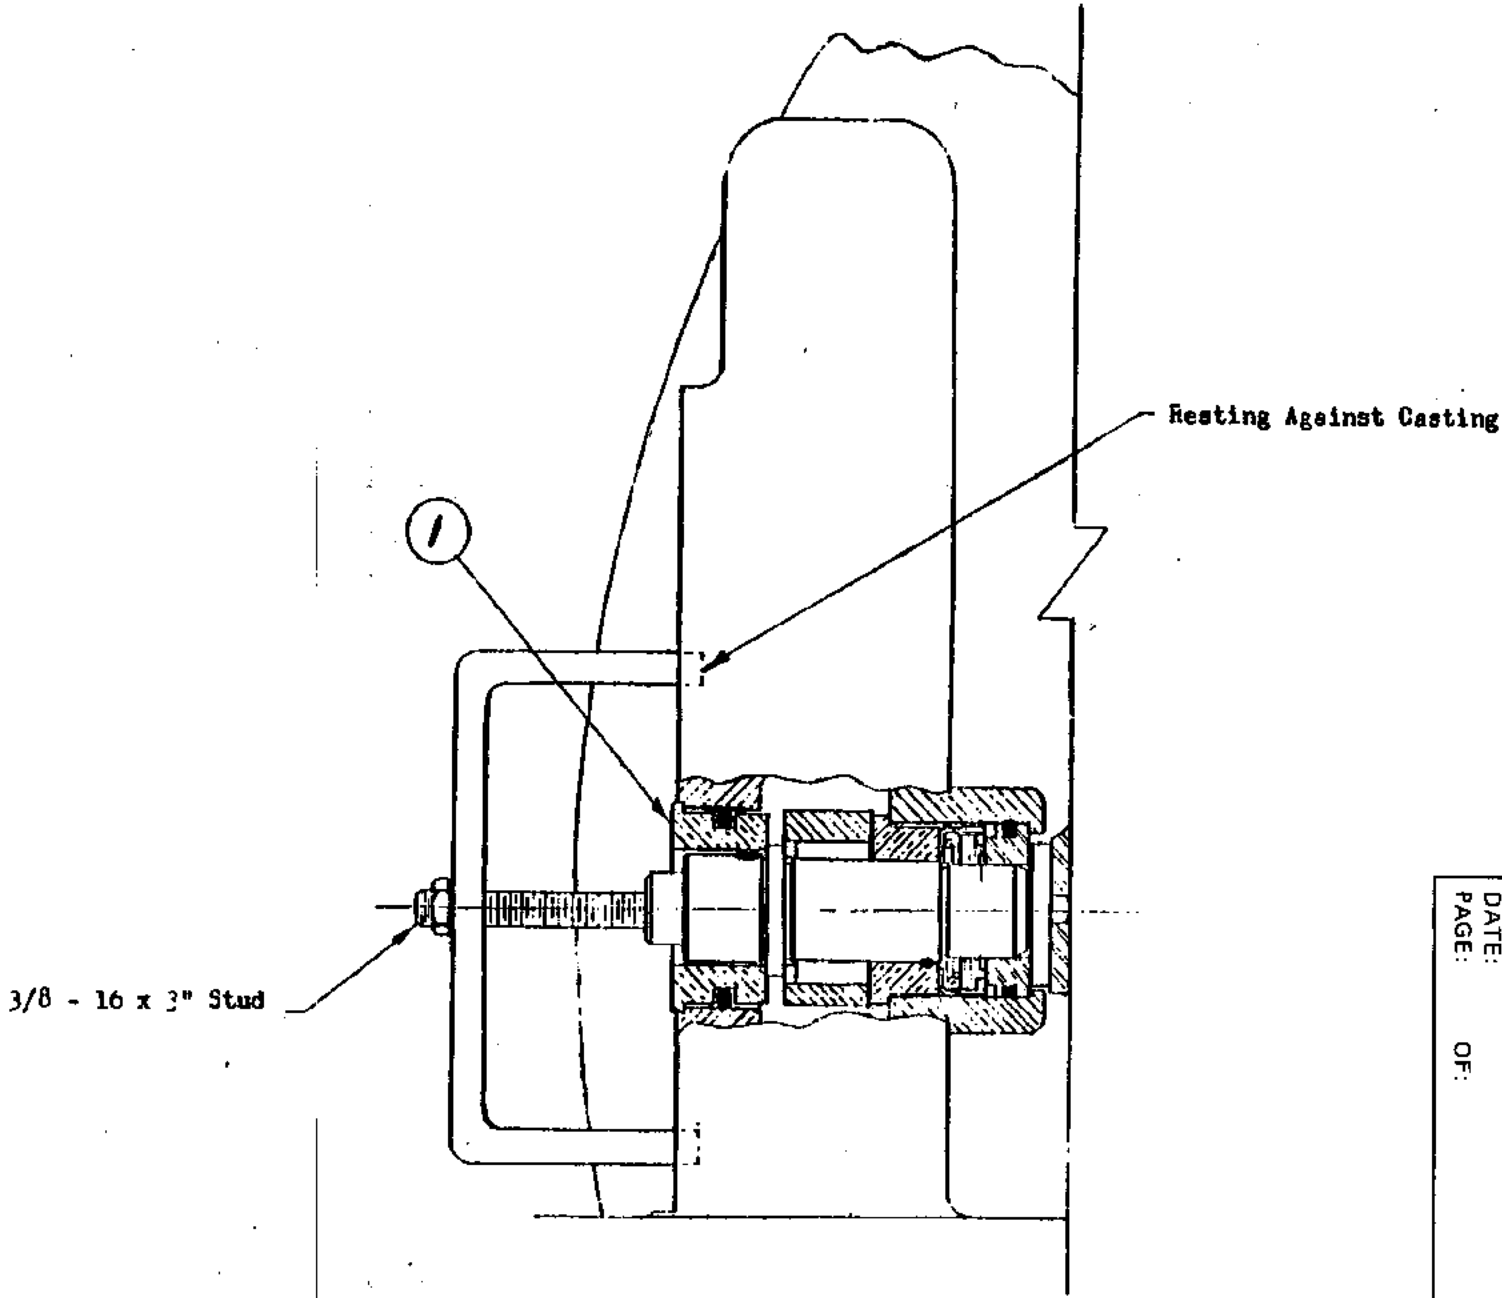
Fig. 2

1. Using a 6" depth gauge, check the distance between point A and B, in Fig. 4.
2. Place the outside bushing, item 1, Fig. 2, in the normal position over the shaft and also place the shaft seal, both rotating and stationary parts, item 3, Fig. 3, over the other end of the shaft and with all of these parts out of the machine, measure the distance between points C and D, as shown on Fig. 5. This should be between 1/32" and 3/32", greater than the measurement taken in step 1, above.
