**UNITED
TECHNOLOGIES
CARRIER**

BULLETIN: CA-SB-19-C-64-22

SERVICE BULLETIN

ANTI - RECYCLE TIMER CIRCUIT

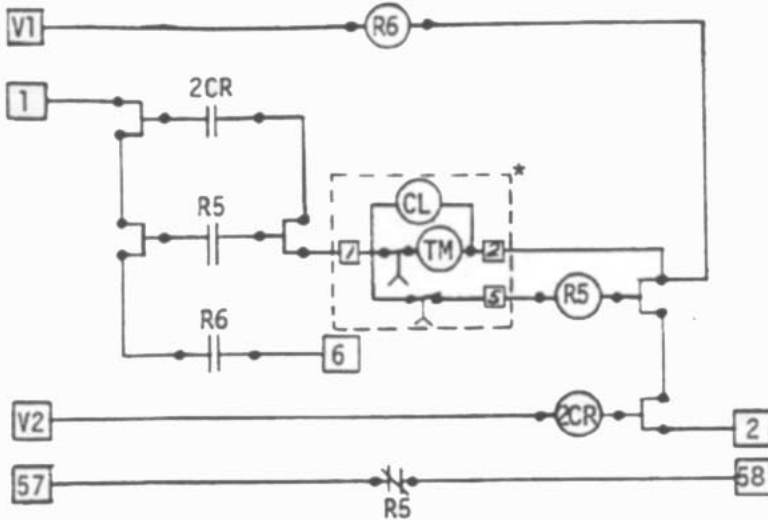
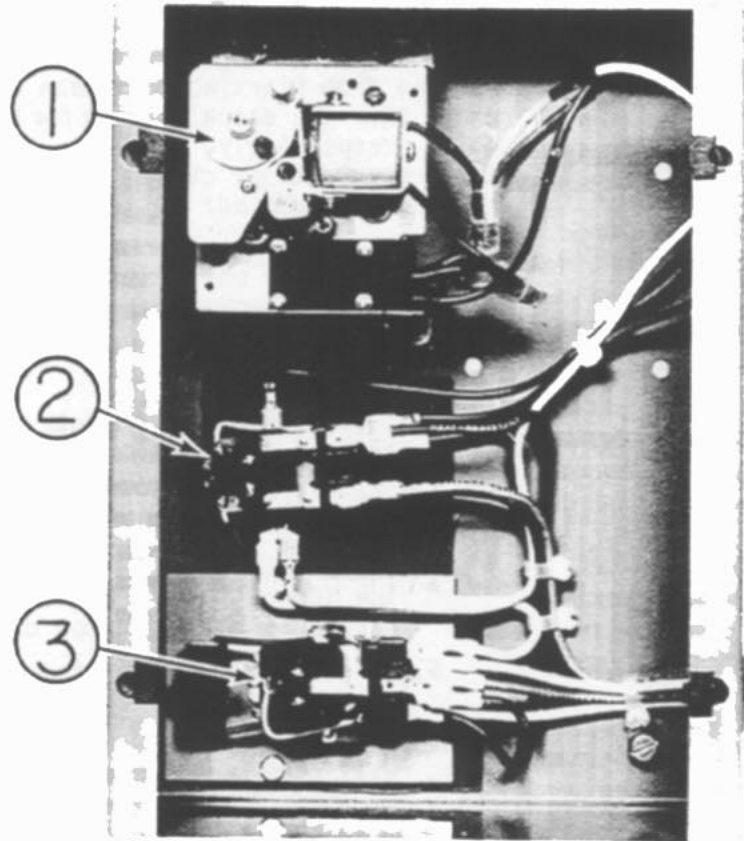
Figure 1

The function of the anti-recycle timer circuit is to prevent the machine from starting more than once every 20 minutes. Figures 1 and 2 show the actual wiring for the 19C3-C7 and 19C8 machine circuits, respectively, which can be used for troubleshooting. The anti-recycle timer circuit operates as follows when the Start button is depressed:

Anti-Recycle Circuit, 19C3-C7 Machines

Timer Relay Box, 19C3-C7 Machines

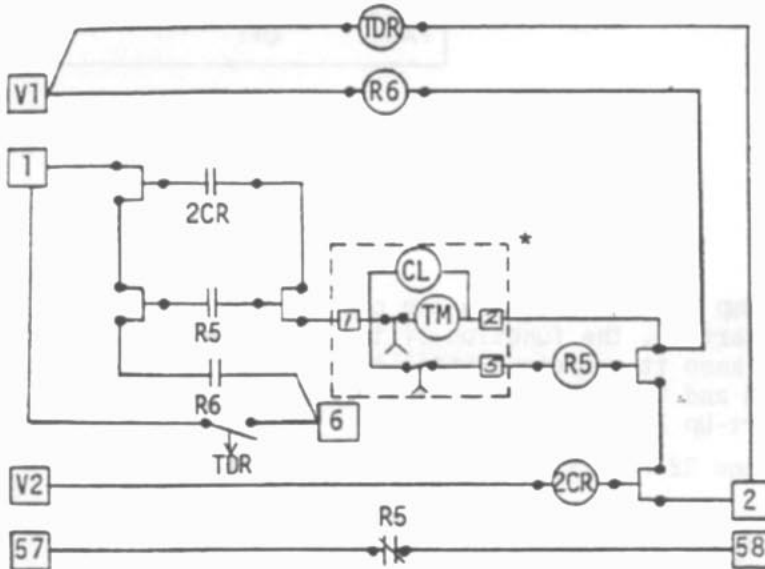
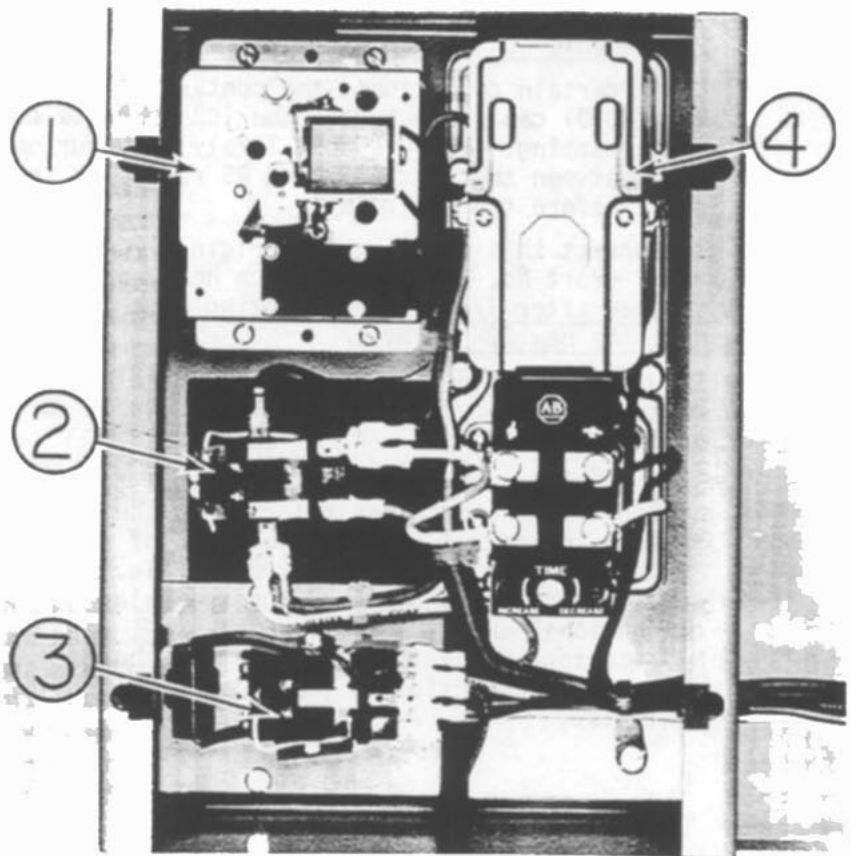
Figure 2

Anti-Recycle Circuit, 19C8 Machines

On 19C8 machines, the R6 relay has a time-delay feature which is actually a time-delay relay (TDR) wired in parallel with the R6 relay (see Fig. 2). When the Stop button is pressed, the time-delay relay remains energized for three minutes, keeping the oil pump running for that time during compressor coastdown.

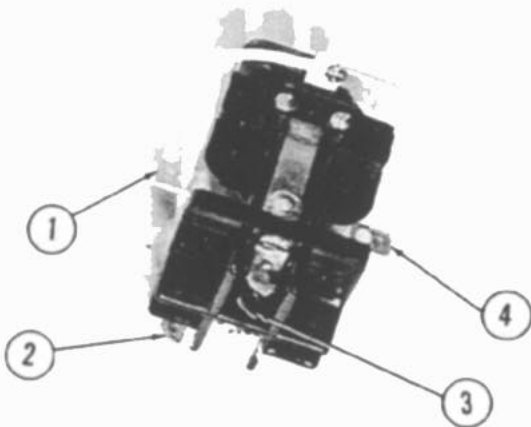
FIGURE 3

Under certain conditions, the contacts of the original 2CR relay (Part No. HN61ZJ010) can close before the ICR contacts close, preventing the machine from starting. This is most likely to occur on machines where the response time between the 2CR, ICR, and R5 relays is such that the R5 relay energizes before the ICR relay.

ORIGINAL 2CR RELAY
PART # HN61ZJ-010

It is recommended that the HN61ZJ010 relay be replaced with an HN67ZJ115 relay when start-up problems, attributable to the original 2CR relay, are experienced.

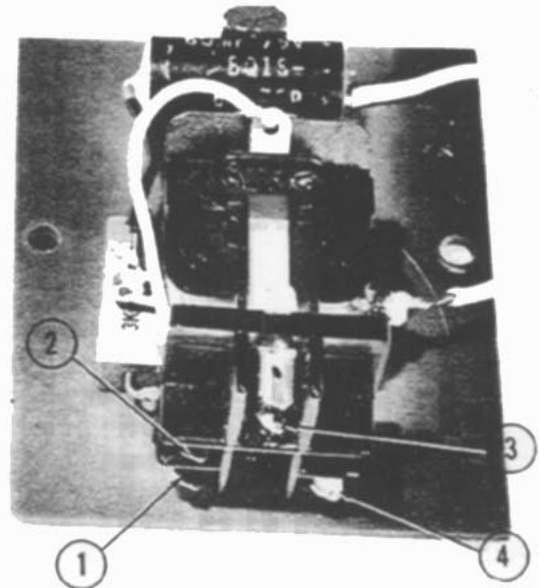
FIGURE 4

Schematically, the wiring is identical for both relays. The wires disconnected from the original relay go to their equivalent terminals on the new relay. The actual physical location of the terminals on the two relays is different. The original 2CR relay (Fig. 3) and the new 2CR relay (Fig. 4) are shown for comparison purposes. Relay connections ① and ④ (the coil connections) are wired to Terminals V₂ and 2. Relay connection ③ (the N.O. contact connection) is wired to the R5 N.O. contact and to Terminal 1. Relay connection ② (the common connection) is wired to the R5 common contacts.

NEW 2CR RELAY
PART # HN67ZJ-115

To correct this problem, the original 2CR relay has been replaced with a relay (Part No. HN67ZJ115) which has a built-in time delay. All consoles shipped after 9/30/63 and starting with Console Serial No. 70254 and higher have the new 2CR relay.
