**UNITED
TECHNOLOGIES
CARRIER**

BULLETIN: CA-SB-19-D-66-31
DATE: 7/7/66
PAGE: 1 OF 3

SERVICE BULLETIN

SUBJECT: FLOAT CHAMBER EQUALIZING VALVE AND
CHAMBER VENT; 19D11, 21, 31

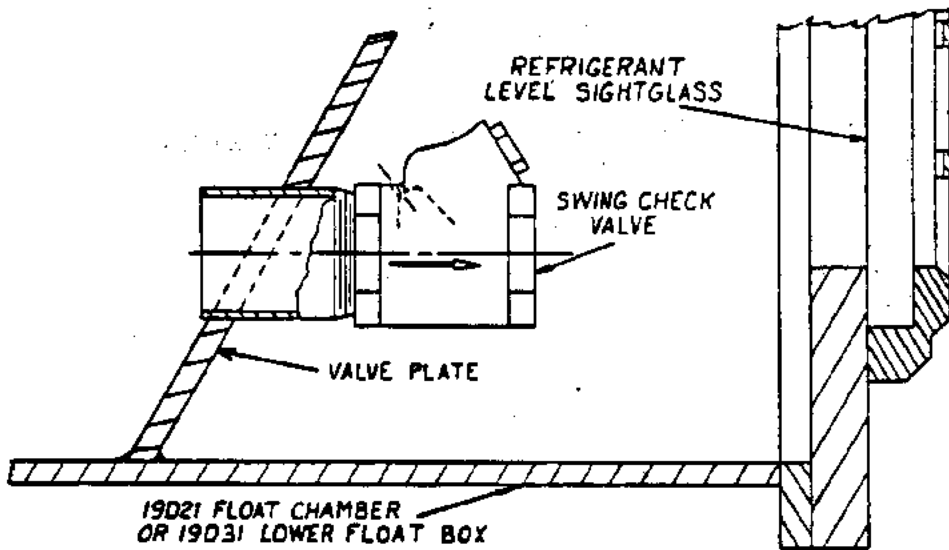
Fig. 1
Equalizing
Valve
Arrangement

- A. Equalizing Valve. Machines shipped after March 1, 1965 (approximate unishell Serial No. 25780 and higher) have a newly designed equalizing valve in the float chambers (Fig. 1.) When exposed to refrigerant, the earlier neoprene design could possibly curl, keeping the valve partially open during machine operation.

Use check valve assembly 19U21-853 on 19D21 and 19D31 machines as a field replacement for the neoprene equalizing valve (Fig. 2) whenever the machine is opened for any reason. Drilling and tapping is not required. Use the existing 1/4-20 and 1/2-13 holes to bolt on the check valve and plate assembly.

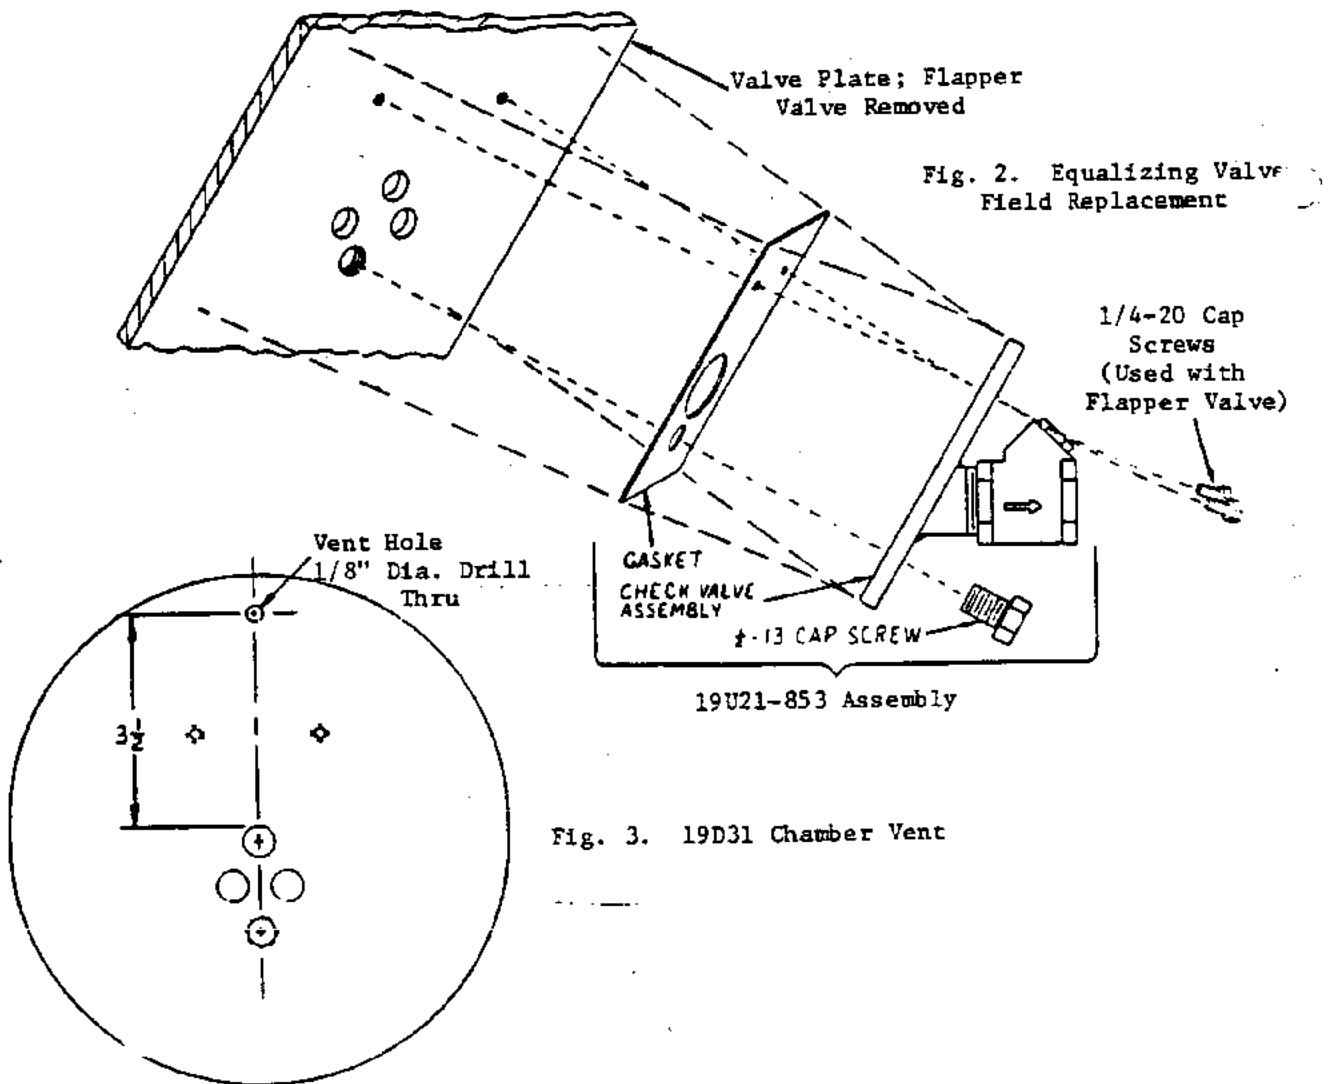
- B. 19D31 Chamber Vent. On 19D31 machines manufactured prior to October 1965, an incorrect refrigerant level can result if a gas pocket forms in the upper portion of the lower chamber. This pocket can form if the liquid level rises above the outlet of the liquid line from the upper float chamber, and may prevent a further increase in the refrigerant level.

19D31 unishells built since October 1965 have a 1/8" diameter vent hole, drilled as shown in Fig. 3, to eliminate this gas pocket.

Whenever the lower float chamber cover is removed from a 19D31 machine, drill a 1/8" vent hole in the valve plate, as shown in Fig. 3.
