BULLETIN: CA-SB-19-C-73-67

DATE: 2/9/73

SERVICE BULLETIN

GUIDE VANE GEAR RACK BLOCK

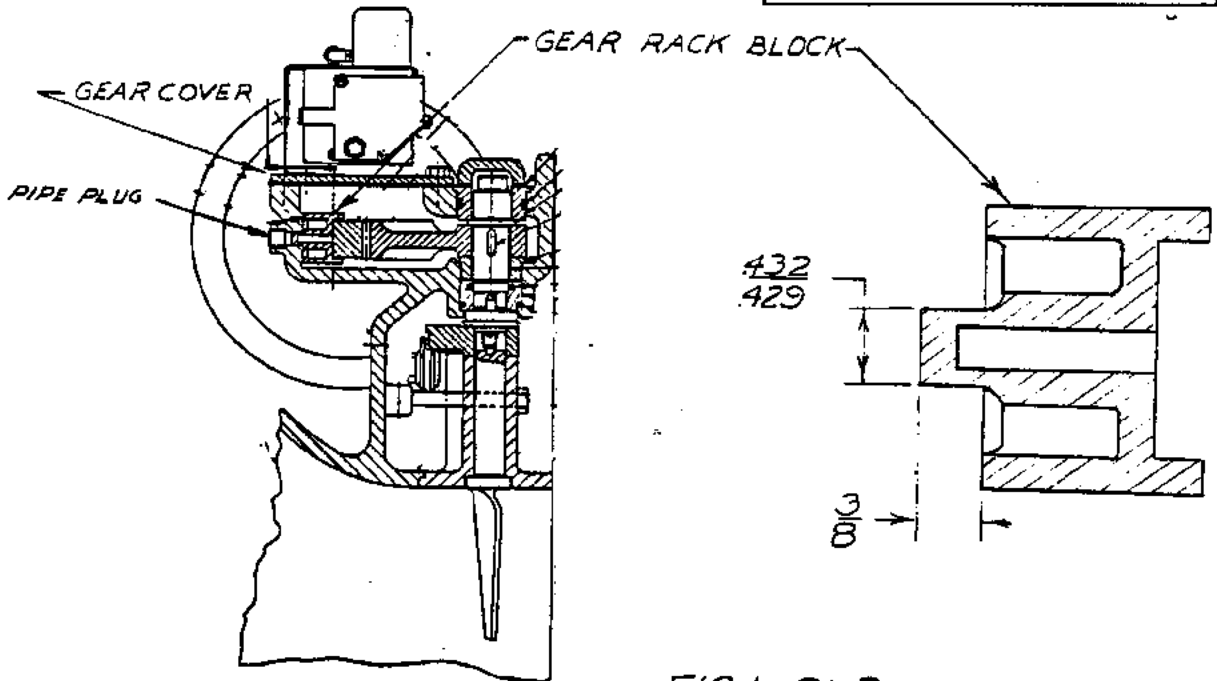
During the 1960's the gear rack block was redesigned as shown in Fig. 1. It has been suggested, however, that the original design of holding the block in place with a pin removable from outside the machine would make the guide vane operator more serviceable. Figure 2 shows the new arrangement. The new pin and block assembly part number is 19CB112-101.
