BULLETIN: CA-SB-17-74-24

DATE: 1/11/74

SERVICE BULLETIN

17DA SHAFT MOVEMENT SWITCH

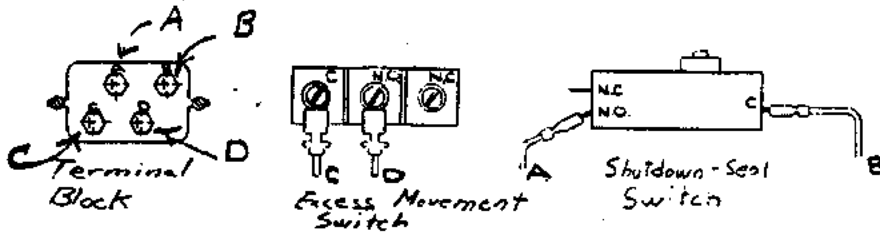
FIGURE 1

Figure 1 illustrates the terminal box and the terminal wiring.

Compressors with excess movement switch have 4 terminals. Without the switch there are only 2 terminals.

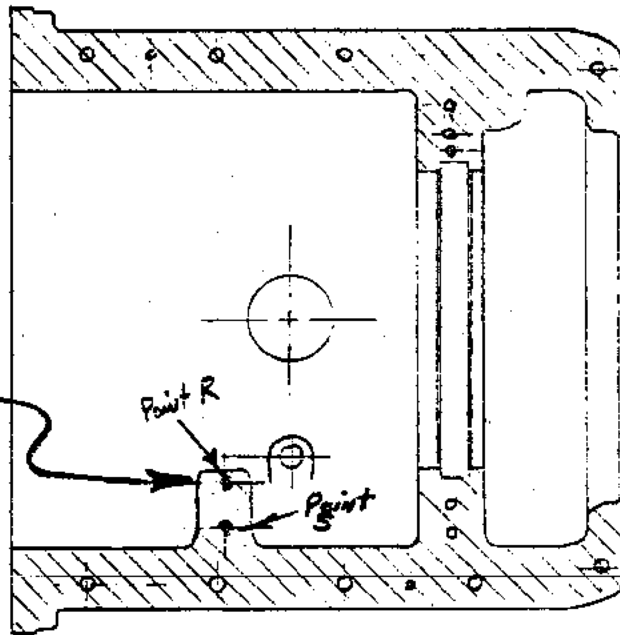
FIGURE 2

Switch bracket mounted here. See Figure 3 for point rands.

17DA Bearing Chamber Lower Half

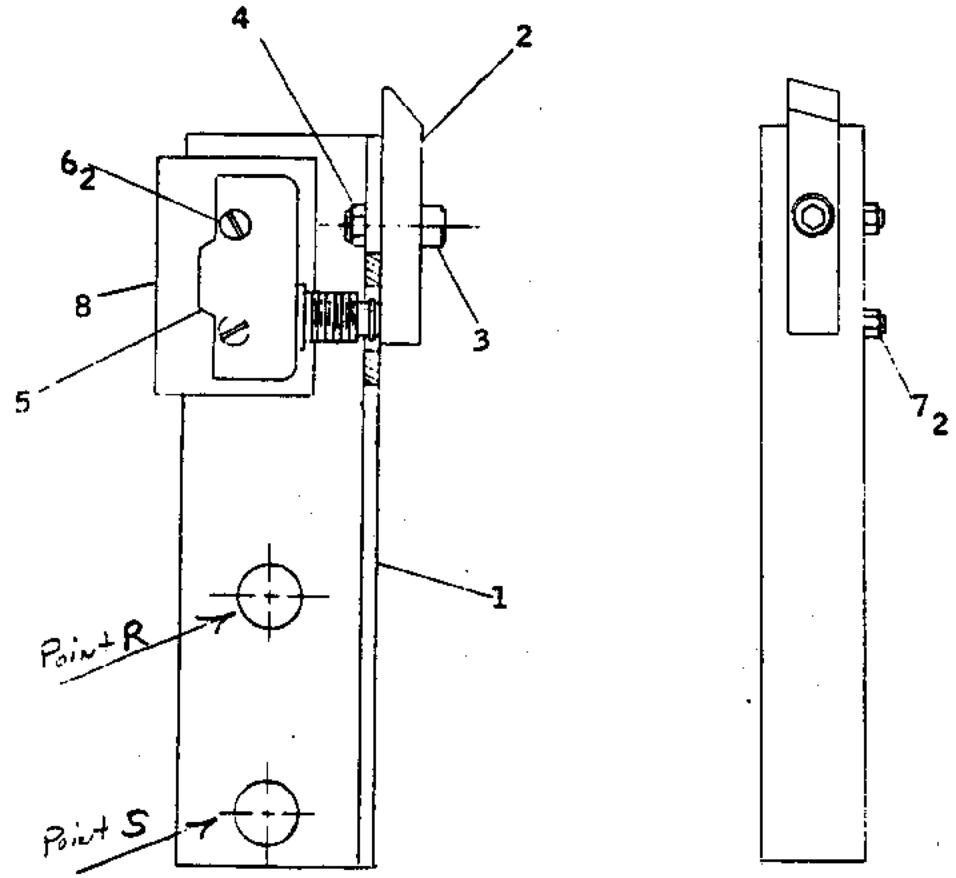
SHAFT DISPLACEMENT TRIP ASSEMBLY

The switch mechanism (See Figure 3) is located approximately midway between the journal bearings. The switch is tripped by a pin protruding from the shaft.

The trip is positioned so that it will be tripped if the shaft moves axially due to thrust failure when the shaft is rotating.

The trip pin extending from the shaft strikes the trip (2) causing it to rotate off the spring loaded switch (5) plunger. The switch then either "makes" or "breaks" the safety circuit controls to trip the machine "off the line." Resetting is accomplished by merely depressing switch (5) plunger and rotating trip (2) to hold the plunger in a depressed position.

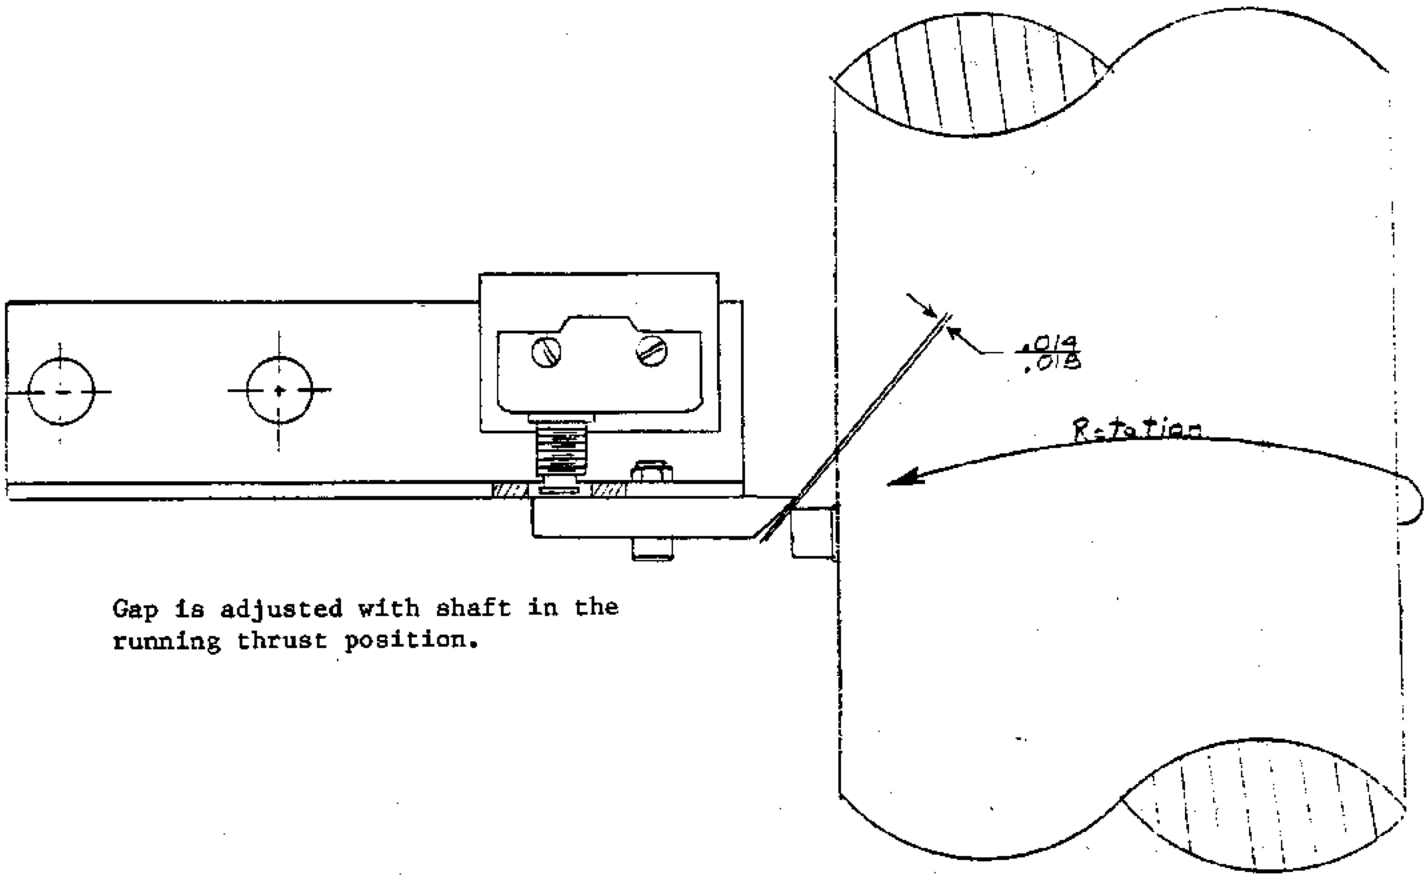
FIGURE 4

Gap is adjusted with shaft in the running thrust position.

TOP VIEW OF SHAFT AND SWITCH
