**UNITED
TECHNOLOGIES
CARRIER**

BULLETIN: CA-SB-19-E-78-91
DATE: 4/4/75
PAGE: 1 OF: 3

SERVICE BULLETIN

19 SERIES HIGH VOLTAGE TERMINAL THREAD SEALING

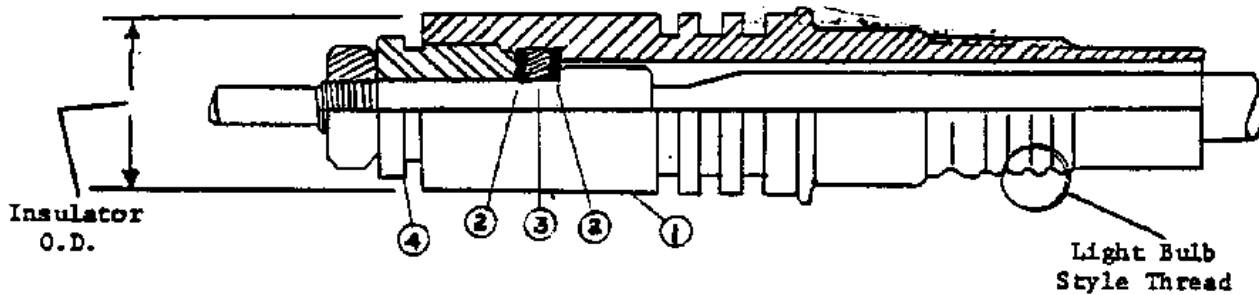
Fig. 1, 2, 3

Figure	Description		Used On	If Service is Required
1.	H	Design 1 - Rigid. Terminal with 1" NPT.	19EA machines shipped before 5/3/71.	Parts no longer available. Change to Design 3.
2.	I V O	Design 2 - Rigid terminal with 1" light bulb thread. Insulator O.D. - 1.62" Textolite terminal board.	Machines shipped from 5/3/71 (approximate comp. s/n 100434) to 3/74.	Parts are still available. Can be converted to Design 3 for greater strength and leak integrity.
3.	L T	Design 3 - Rigid terminal with 1-1/4" light bulb thread. Insulator O.D. - 1.88" molded black phenolic terminal board.	Machines shipped after 3/74.	Use Design 3.
4.	L O V	Design 1 - Flat Textolite terminal board.	Machines shipped prior to 3/74.	Parts are no longer available, change to Design 2.
5.	O L T	Design 2 - Molded black phenolic terminal board.	Machines shipped after 3/74 (approximate).	Use Design 2.

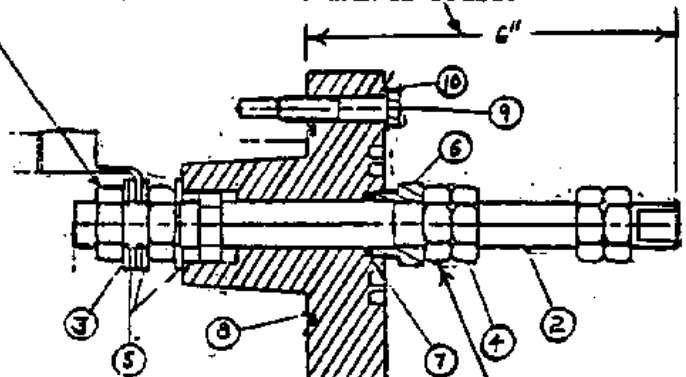
Fig. 5

This dimension to be checked at assembly. A dimension less than 6.00 indicates hex is not properly engaged into socket in terminal board.

Tighten to prevent refrigerant leakage 120 lb-in. max.
