Title: G E HIGH VOLTAGE STARTERS

Number: C8702

Models Affected: 17 AND 19

**SUBJECT- SAFETY ALERT!
LIMITAMP SHUTTER ROLLER SHAFT**

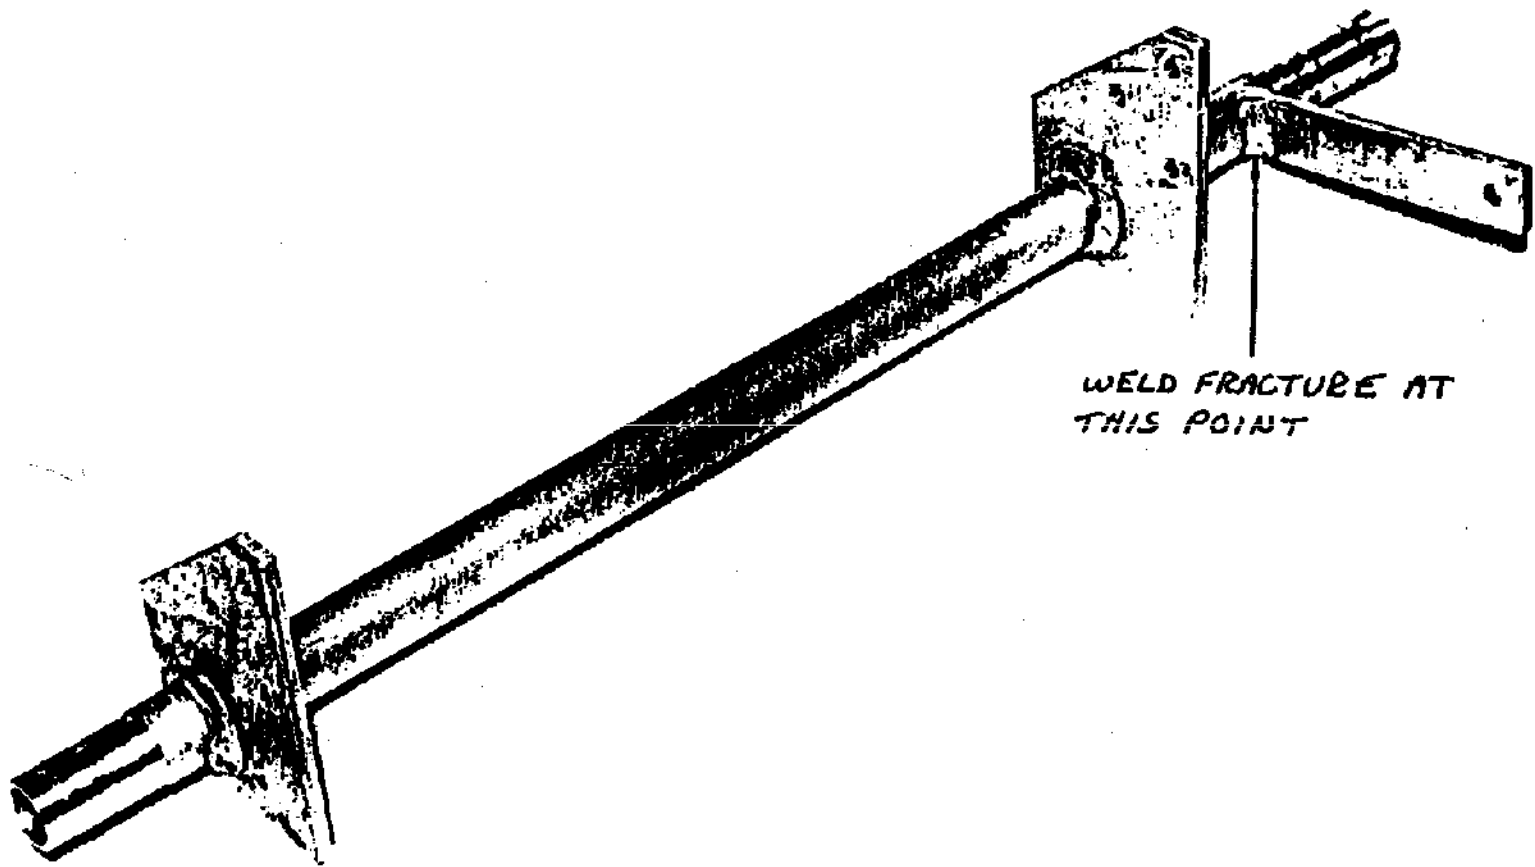
FIG. A
SHUTTER ROLLER SHAFT

We have had two isolated reports of the breakage of a mechanical interlock in Limitamp starters built during the above time period allegedly resulting in an electrical hazard to an operator when inserting a Limitamp contactor into its compartment. The attached Picture (Figure A) shows the detail of the part and the mode of breakage.

The cause of the failure in these incidences has been identified as a poor weld (cold) resulting in insufficient weld bond joining the lever arm to the shutter roller shaft. We changed our design and increased the welding area over two years ago so only units shipped prior to '83 with date codes AM to DW may be affected. Date codes can be located on a sticker inside the low voltage door.

WELD FRACTURE AT
THIS POINT

Upon notification of any significant variance we will supply new shutter roller shaft at no charge to the customer for installation.

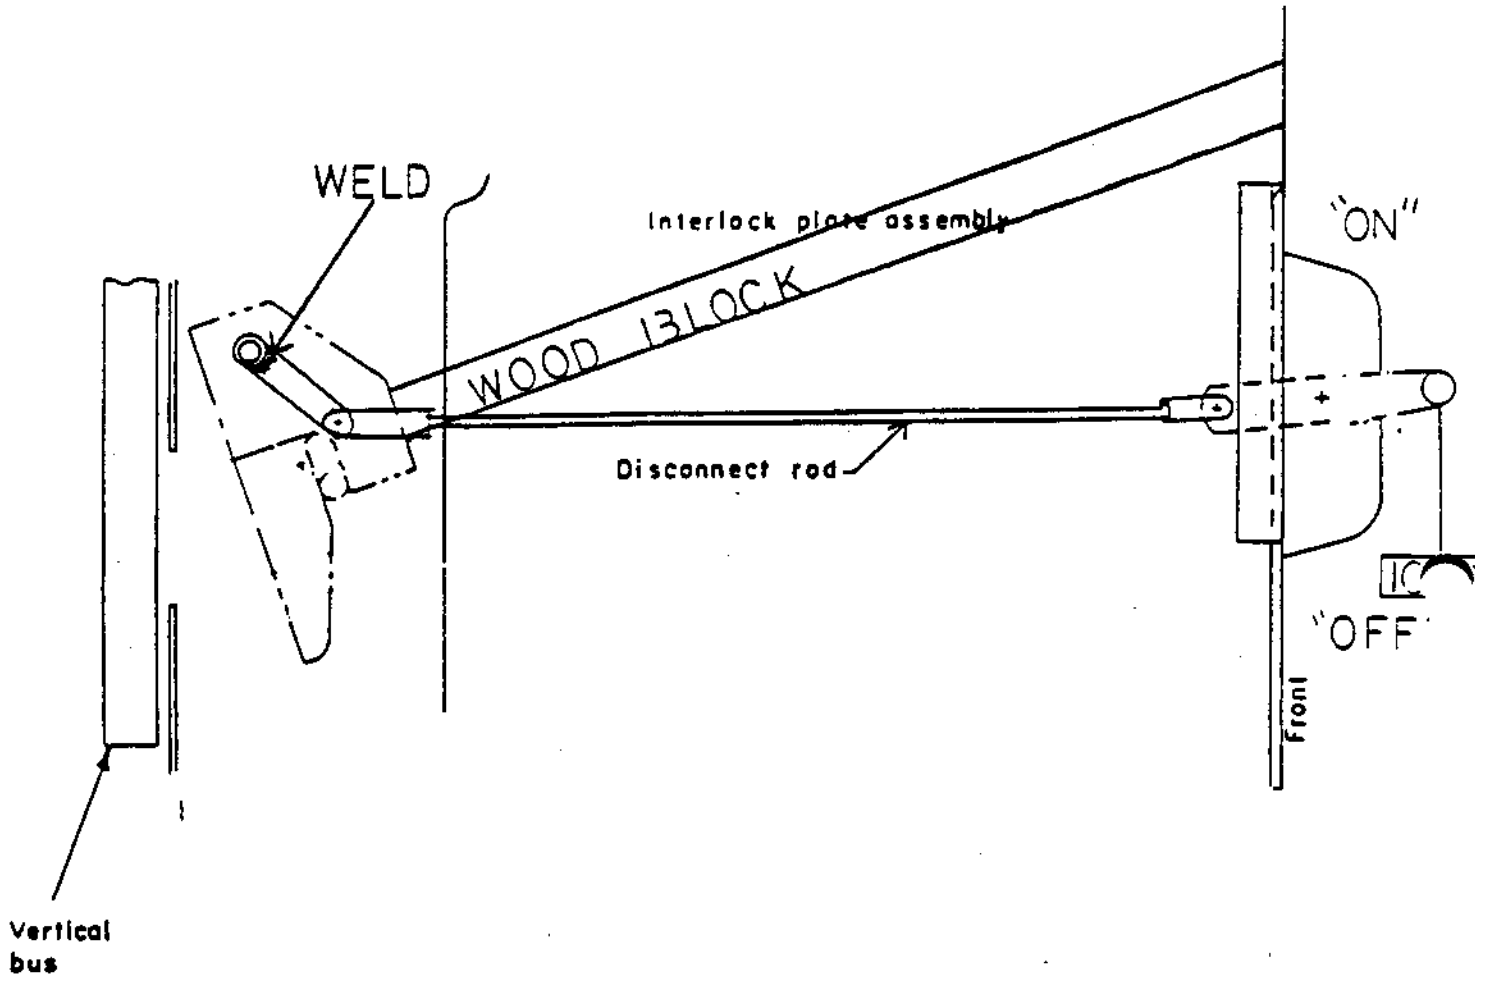
FIGURE B

- 3) Rotate the handle to a mid position; jam the mechanism by inserting a wooden brace between the cam and handle as illustrated in Fig. (B). With a small amount of pressure applied to the handle, measure the distance from the handle to the floor; then, apply a 100 pound weight to the handle; remove the weight and with a small amount of handle pressure, remeasure the handle position. Both measurements should be essentially the same.

- 4) If a significant variance is found (e.g. .25") do not reinsert the contactor and contact your G.E. Representative or the Mebane Factory Product Service, P.O. Box 489, Mebane, N.C. 27302, ATTN: R.C. Roessler, Jr., or call (919) 563-7367.
