Title: **19DK/DM BINDING VANE SHAFT**Number: **C8714A**  
Date: **12/9/87**  
Supersedes: **NEW**  
Date:Models Affected: **19DK/DM/DR CHILLERS SHIPPED APRIL, 1987 AND LATER****PURPOSE:**

This bulletin provides information on a failure mode and a field fix of the new guide vane shaft seal assembly.

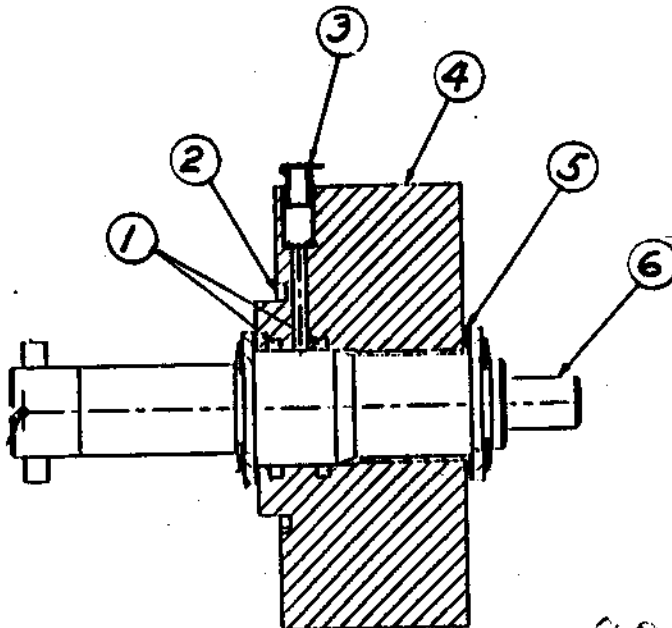
Shaft and seal assembly	19DM212-213
Includes:	
1 - Shaft Quad Ring	KK742W112 2 Req.
2 - Housing O-Ring	KK71GZ024
3 - Oil Cap (new)	CW51ZZ001
4 - Bearing Housing	19DM212-1093
5 - Flanged Nyliner	KT58BZ082
6 - Shaft	19DM212-1103

**FIELD FIX** - If the shaft is corroded replace it and the housing with plated components (see below). Also add the CW51ZZ001 oil cap discussed above for better quad-ring lubrication. The cap can be added in the field by drilling out the oil hole to a 1/4" dia. 1/2" deep and pressing in the cap. Reassemble the seal with grease around the bushing.
