Title: 19DK COMPRESSOR ASSEMBLY INTERFERENCE

Number: C8902

Models Affected: ALL 17/19 DK/DR CHILLERS WITH DK COMPRESSORS

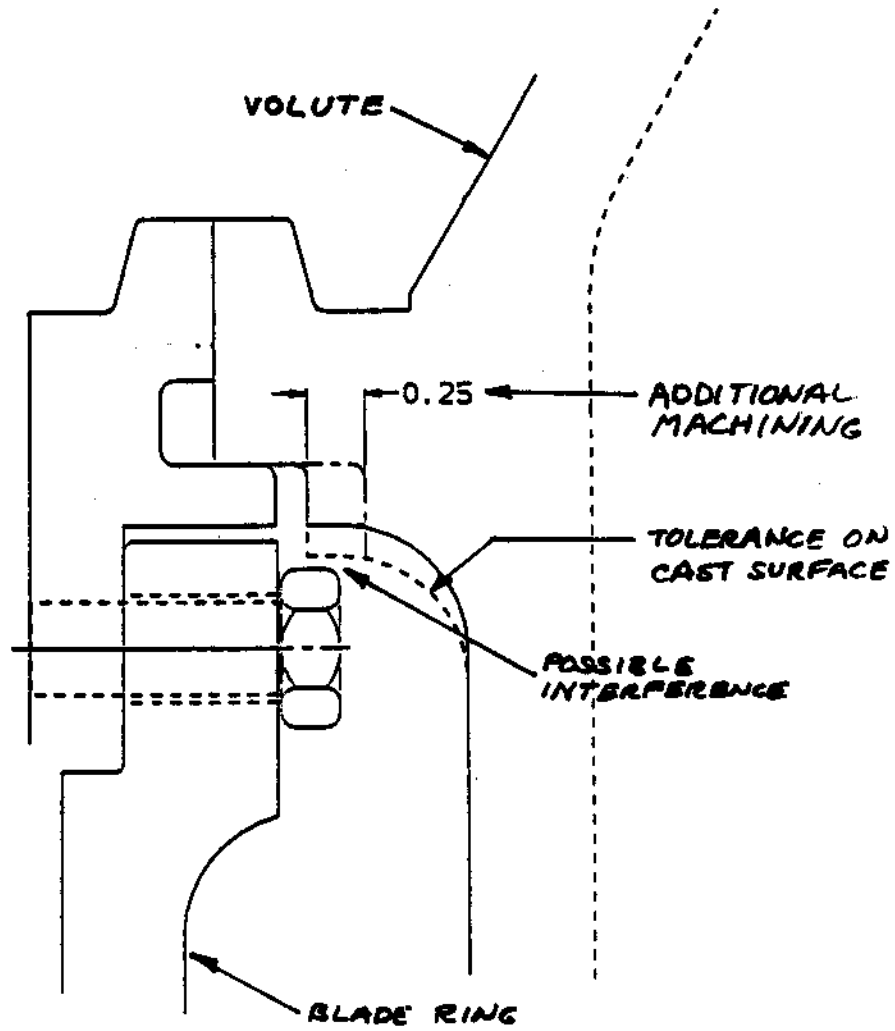
Figure 1

It has been reported that in a very few cases, the guide vane ring mounting bolts interfere with the volute casting and keep the V-band clamp flange from properly mating. See Figure 1. The joint comes together well enough to allow the clamp to be installed and the O-ring seals during the factory leak test but later the O-ring relaxes and a leak develops. It can be very difficult to diagnose this problem.

The volute machining has been revised to insure that there will be adequate bolt clearance as shown on Figure 1.

If there is a leak at the joint between the volute and the suction elbow, check for possible interference between the bolts and the volute casting. Grind the casting away locally to eliminate the interference.
