Title: **19DK/DM GROMMET SEAL**

Number: **C8906**

Models Affected: **ALL 19DK/DM MACHINES**

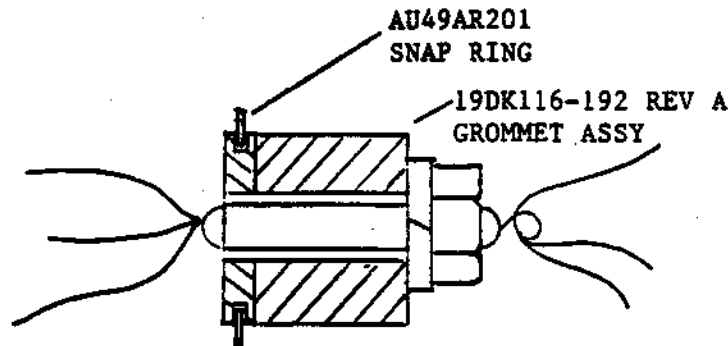
**BACKGROUND:** Due to the pressure difference between the compressor base (sump) and the motor housing on all 19 DK and DM machines it is possible to blow out the grommet that provides the sensor wire seal between these two chambers. This grommet seal is an expandable rubber plug which depends on friction to hold it in place. This can blow out if not properly tightened. Even when properly tightened there still is the possibility of blowout since there was no positive means for restraining the grommet.

All machines produced from approximately April 1, 1989 have the new design grommet which is shown in the sketch below. This new design adds a snap ring on the motor side of the seal. This provides a positive restriction against blowout.

**PROCEDURE:** This new grommet assembly is available from RCD as a non-stock item kit number 19DK660-004. In order to install this grommet it is necessary to have access to the motor side of the seal. This requires the motor to be removed.

**RECOMMENDATION:** All machines that require a motor repair or have the motor removed for any reason should have the grommet replaced at the same time.
