Title: 17/19DR TERMINAL STRIP LABEL ERROR

Number: C8909  
Date: 6/28/89  
Supersedes: NEW  
Date:

Models Affected: 17/19DR DUAL COMPRESSOR CHILLERS

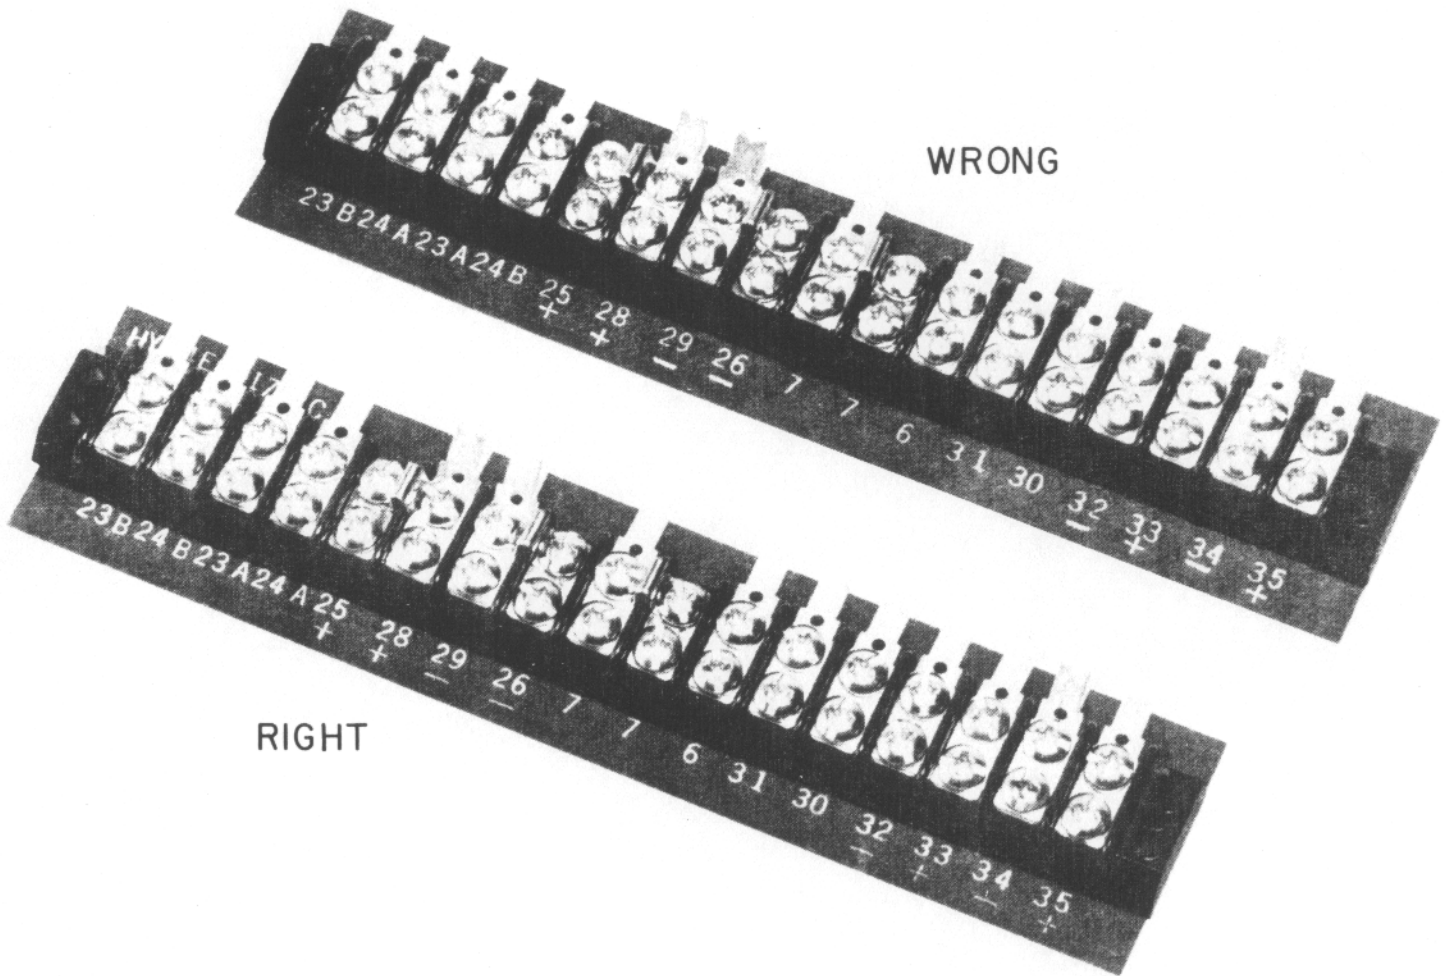
17/19 DR FIELD WIRING TERMINAL STRIP

One of the field wiring terminal strips has connections for the 0.5V motor load signal for each compressor motor. An undetermined number of labels with the terminal markings mixed up as shown below have been shipped in chiller control panels. If the field wiring is connected using the wrong labels the compressors will shutdown right after start-up because of a lack of a motor current signal since the factory wiring from the 32MP processor boards was made to the terminals as if they had been marked properly.

WRONG

RIGHT

Check for this label error during start-ups of chillers shipped prior to 6/89. Correct the wrong labels by re-marking and verify that the field wiring is right.
