**Title:** 19D Series Motor Shaft & Gear Assembly

**Models Affected:** All 19D Series

**Number:** C9208A

To inform the field that the factory is using multi-tang lockwasher's to retain bull-gear locknuts.

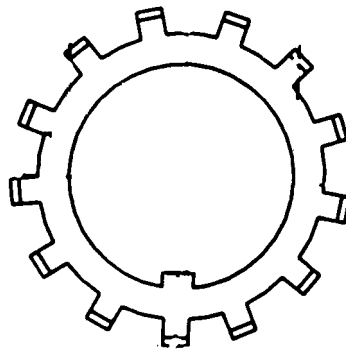
Gear locknuts have been staked in the past to keep them from loosening. The factory started using a multi-tang lockwasher that locks the nut to a keyway in the shaft in early '92. If a locknut is removed to replace the rotor or gear, it is recommended that the new lockwasher which is applicable to all 19D Series compressors be installed.

Tighten locknut to specified torque and back off just enough to align one locknut slot with a lockwasher/tang. Bend tang into slot.

Lockwasher P/N	Locknut Torque
<b>19D11 -</b>	AU 46AA 601	210 # ft.
<b>19D21 -</b>	AU 46AA 601	250 # ft.
<b>19D31 -</b>	AU 46AA 721	275 # ft.

**Hint:** Removing the original staked locknut can be difficult. It is helpful to drill into the staking impression to remove most of the displaced metal.
