SERVICE BULLETIN

Title: 19XL Continuous Improvements

Models Affected: 19XL

Number: C9403

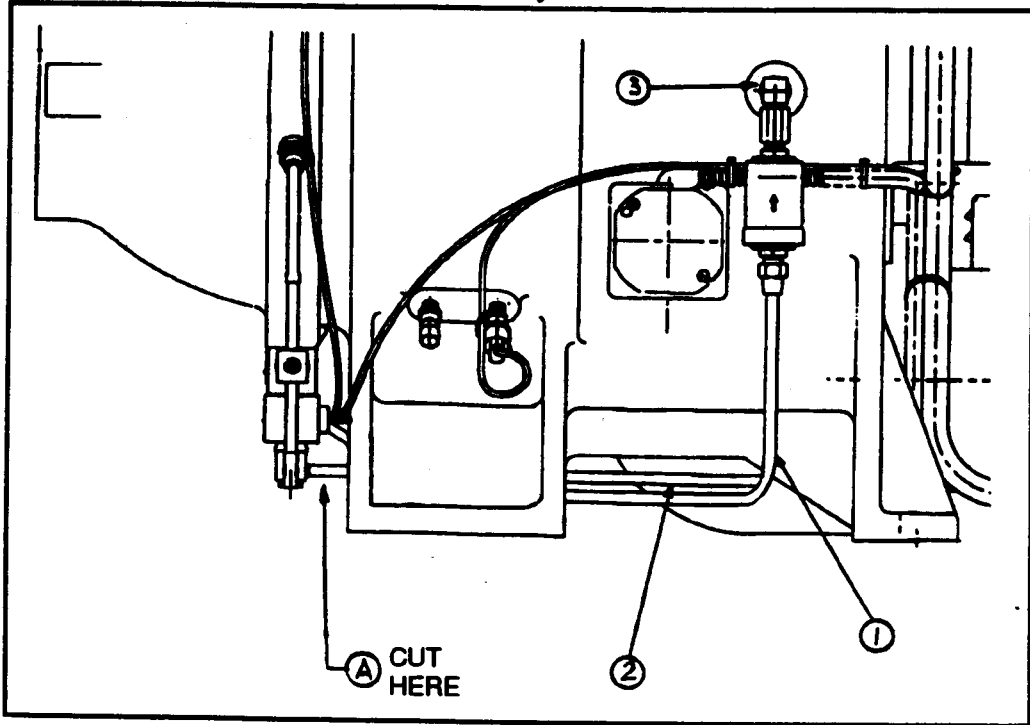
Figure 1
Old Style

Machines manufactured prior to serial number 4192JXXXXX use an ejector which is no longer available. The new ejector is not directly interchangeable, and requires kit for additional change-out.

Remove Old Fittings: (Refer To **Figure 1**)

1. Pump out refrigerant from cooler. Isolate refrigerant in the condenser, or in a separate storage vessel. Use the pumpdown lockout feature on the PIC controls test.
2. Cut the oil suction line, line 2, at point A. Leave enough tubing to braze a fitting onto this line.
3. Remove the high pressure line, line 1, by loosening the flare nuts.
4. Remove line 2, remove strainer on other high side line. It is recommended that the low side filter be changed at this time. It is located to the left of the float box. Remove connection into the compressor casting at location 3.
