## SERVICE BULLETIN

**Title:** 17/19EX Sticking Float Valves  
**Models Affected:** 17/19EX

**Number:** C9724  
**Date:** 8/8/97  
**Supersedes:** New

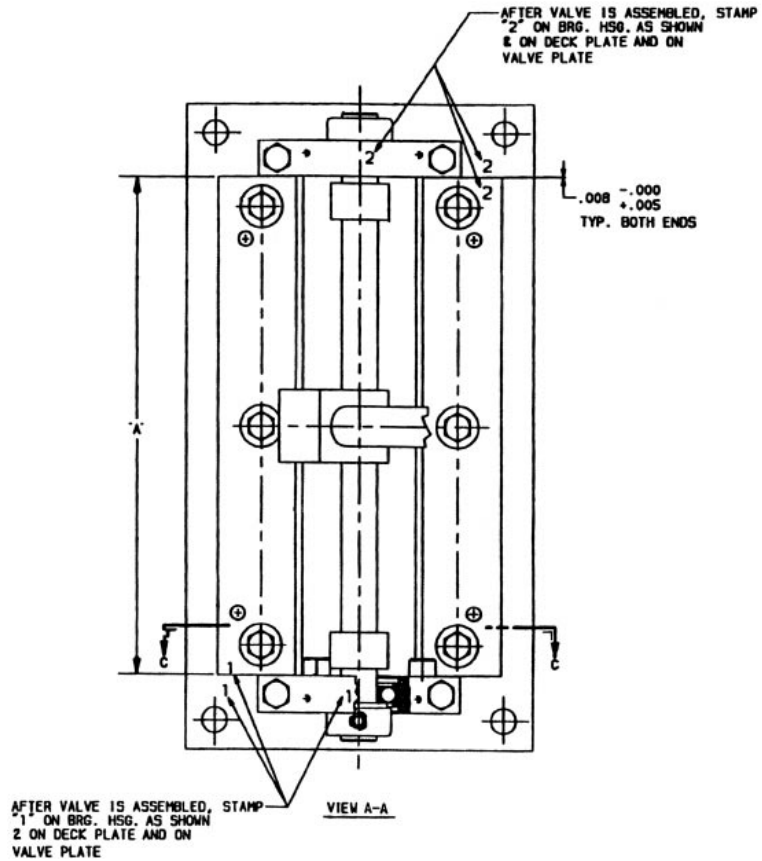
**Figure 2**  
**Float Assembly Width and End Clearance**

Float Valve	09EX44007501	09EX54001301
Float Size	1	2
Plate opening (See Figure 4)	2.24 in. (56.9 mm)	2.24 in. (56.9 mm)
Shimmed opening (See Figure 4)	1.90 in. (48.3 mm)	1.90 in. (48.3 mm)
“A” Dimension (See Figure 2)	7.025/6.995 in. (178.4/177.7 mm)	8.595/8.565 in. (218.3/217.5 mm)
Approximate Full Open, shimmed “B” Dimension (See Figure 4)	1.25 in. (31.8 mm)	1.51 in. (38.4 mm)
Approximate Full Angular Travel	45°	55°
Knife Edge Clearance (See Figure 3)	0.020 ± 0.005 in. (0.508 ± 0.127 mm)	
Blunt End Clearance (See Figure 3)	0.060 ± 0.005 in. (1.524 ± 0.127 mm)	
Shim/Block Clearance* (See Figure 2)	0.008 –0.000/+0.005 in. (0.203 –0.000/+0.127 mm)	
Float Ball	EC28HZ243	
Ball Diameter	8.0 in. (203.2 mm)	
Ball Weight	41 ± 2.5 oz (1.16 ± 0.07 kg)	
Ball Displacement	268 in. <sup>3</sup> (4.4 L)

**Note:** \* — The clearance between the shims and the bearing housings must not be less than 0.016 in. (0.406 mm) total for the two ends.

When lifted by hand, the float ball should move freely throughout its range of motion. If the float ball does not move freely, check to be sure that the float's shim plates are not binding against the float's swing plate. The recommended factory clearances are shown in Figures 2 and 3. Once assembled, the valve should rotate throughout its range of motion with a minimum clearance between the swing plate and the shim plate of  $0.060 \pm 0.005$  inches ( $1.5 \pm 0.1$  mm). It is easier to check the clearances from the under side of the float assembly.

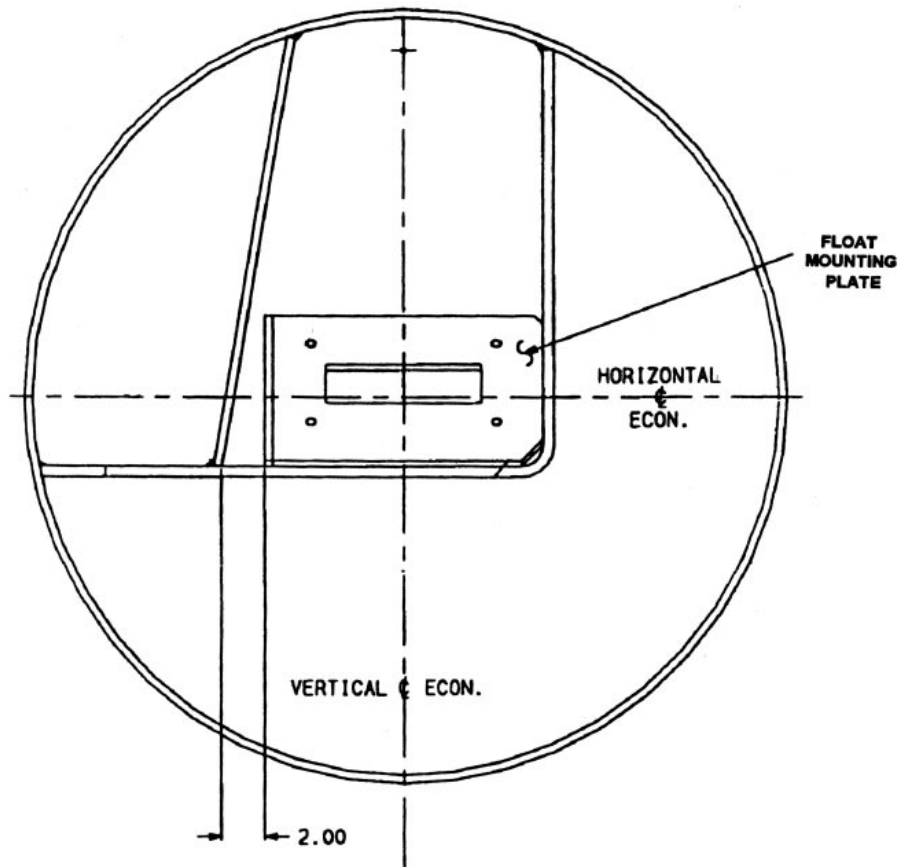
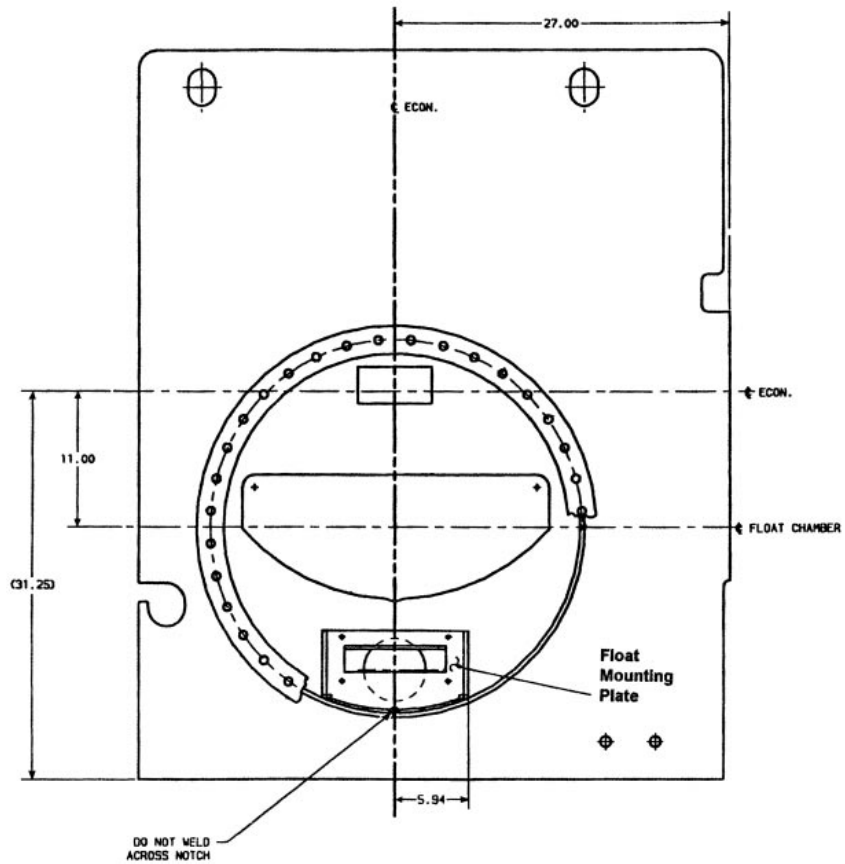
There have been several reports from the field of low cooler pressure alarms on 17/19EX machines. In most cases, this phenomenon has been traced to a stuck float valve in the economizer. The problem can be attributed to the steel plate that the float valve mounts to in the economizer warping during the welding process (See Figures 5 and 6). This causes the float's mounting plate to twist slightly, and the bearings to bind.

If this did not remedy the problem, loosen slightly one of the four mounting bolts, and re-check the operation of the float ball. If loosening one bolt did not correct the problem, re-tighten it and loosen another bolt. Repeat the procedure until the float moves freely. If the plate is warped, loosening one bolt will rectify the problem. The deformation caused by the warped mounting plate will not be transmitted to the valve's bearing blocks with three bolts anchoring the valve plate. It is recommended that the loosened bolt be re-installed with Loctite 54 to prevent it from backing out. The loosened bolt should not be tightened to the original torque. Once the bolt has been reinstalled with the Loctite, re-check the operation of the float ball.
