### **Rotating Stall**

### **Factory Preventive Action**

### **Corrective Action**

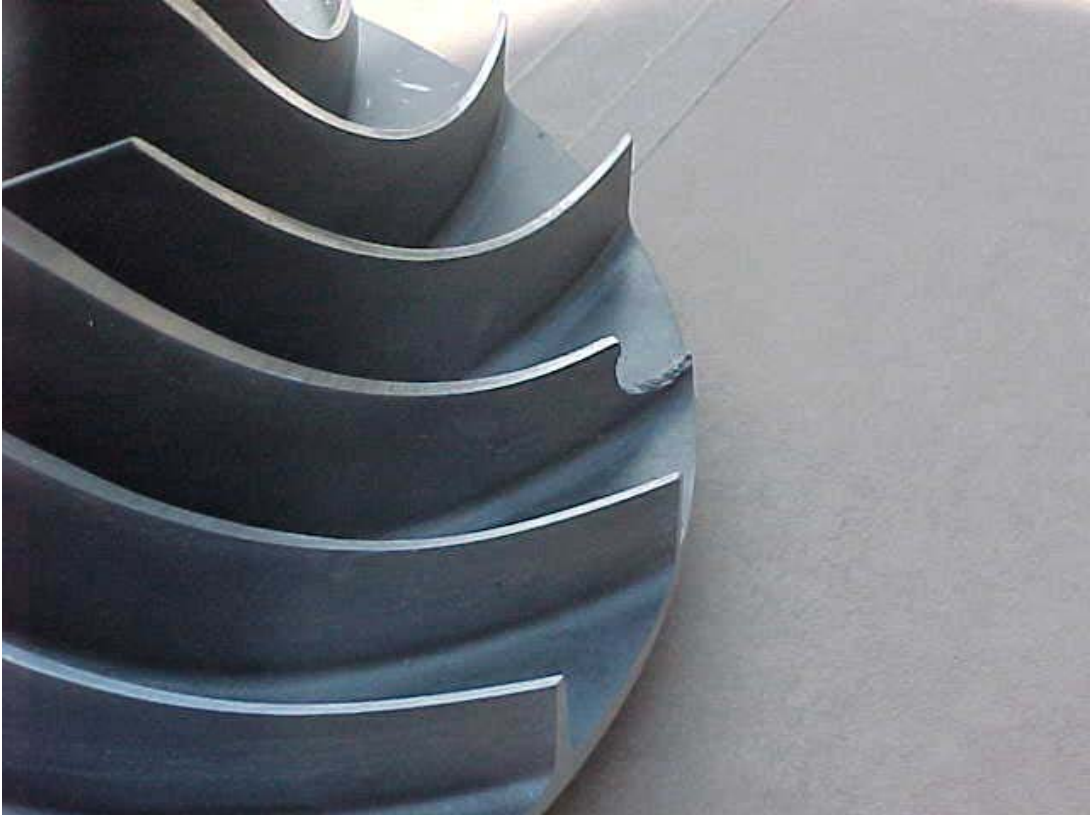
In summary, the main factors influencing the failure mode are: design strength of the individual impeller blades, job site conditions leading to rotating stall, and the material properties of the blades.

Figure 1 - picture of an impeller with a small number of broken blades

In the field, if a failure occurs, replace the impeller blade with a thick bladed design. Inspect the diffuser and bearings and replace as necessary. Check a new version of the selection program before replacement to make sure that the thick bladed impeller design can perform the duty required as small changes in performance were noted upon the redesign. Contact Service Engineering for any required support.
