Number: C0006      Date: 7/17/00      Supersedes: C9912A      Date: 6/6/99  
Title: Oil Pressure Alarms  
Category: *GENERAL*      Termination Date:  
Author: Steve Bayes  
Reviewed by: Alan M. Johnson  
Dept: CSS Service Engineering

Models: CAC: 19XR centrifugal chillers  
Affected: BDP:

## **Purpose:**

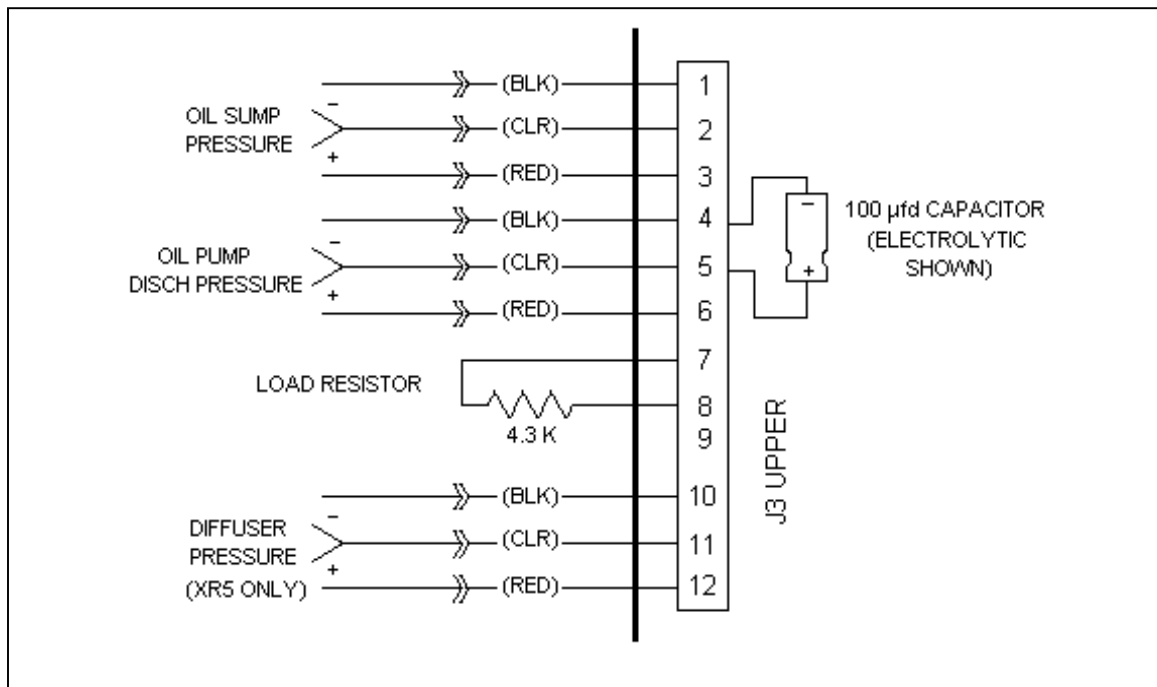
Figure 1. Wiring Diagram for Capacitor Placement  
Addressing Low Oil Pressure

There have been reports of 19XR chillers going down on a low oil pressure alarm, often soon after start up. Typically oil pressure of 24 to 28 psid is established during the pre-lube cycle. The chiller initiates a start, continues to operate through transition and then, anywhere between 30 to 90 seconds into the start, before the guide vanes start to open, it may go down on low oil pressure. The oil pressure loss has been observed in (at least) three forms:

1. The alarm is caused by a transient drop in oil pressure below the trip threshold. In some cases this may result from cavitation at the inlet of the pump. In other cases, variations in oil pump construction may result in significant high frequency pressure pulsations, the low point of which may drop below the alarm threshold, while the mean value is satisfactory. The PIC II controls are designed to recognize and respond to loss of oil pressure when the duration of the loss is a fraction of a second.
2. Gradual loss of oil pressure causes an alarm. In this case the decrease is slow enough to be observed and tracked on the CVC

display. After the chiller starts a small drop occurs down to about 21 psid, continues past the alert level of 18 psid to the alarm level of 15 psid where the chiller shuts down on low oil pressure.

3. The third form is a hybrid of the first two where after start up the pressure difference gradually decreases and then dips in a transient as described in number 1.

Corrective action is intended primarily to address the situation described in cases (1) and (3) above. On all 19XR chillers (or compressors) in which a problem with low oil pressure alarms arises, install a 100 microfarad capacitor, rated for 16 volts or higher, between terminals 4 and 5 on the upper J3 plug as shown in Figure 1 below. (If the capacitor is of the electrolytic type, with a + or - polarity indicated, attach the "-" end to J3-4.) The capacitor smoothes out the oil pump discharge pressure transducer signal without substantially affecting oil pressure sensing.

If this modification does not resolve your problem, please report the problem to Service Engineering so that other solutions can be discussed. The factory installed this capacitor on all 19XR chillers starting the first week of June, 1999.

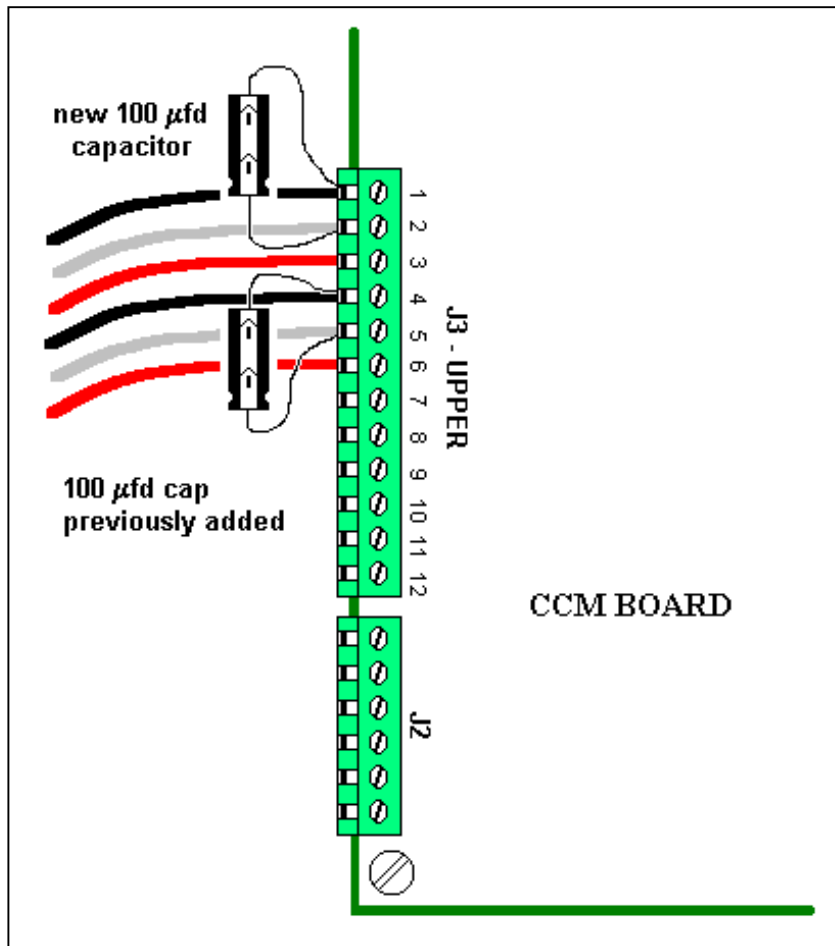
Figure 2. Wiring Diagram for Capacitor Placement  
Addressing Both Oil Pressure Issues

There have been numerous reports of 19XR chillers generating this alarm when the chiller is off. This has been linked to high frequency noise, marginal grounding of the CCM, and problems with the hardware and software filtering performed within the CCM. If you watch the oil pressure in the STATUS/COMPR screen on the CVC for several minutes, a "calm" reading (without the problem) will normally show a variation or bounce within a range of approximately 0.50 to 0.75 psi. If you have this problem you are likely to see greater variation, with a range of 2 psi or more within a span of 5 to 10 minutes.

1. Improve the grounding of the CCM, especially the sump oil pressure channel, to the chiller. Add a grounding conductor from J3-1 and/or one of the screws passing through a standoff (at any of the CCM's corners, for example) to one of the control panel's ground screws. Also assure that the control panel is well-grounded to the chiller itself.

2. Install [another] 100 microfarad capacitor, rated for 16 volts or higher, between terminals 1 and 2 on the upper J3 plug as shown in Figure 2 below (which also shows the capacitor added for the low pressure oil fault described above). If the capacitor is of the electrolytic type, with a + or - polarity indicated, attach the "-" end to J3-1. This capacitor will filter out high frequency noise (which may not necessarily be detectable with a standard voltmeter) on the input or on the CCM ground. These capacitors were installed on production units starting on or about May 1, 2000.

3. Upgrade the CVC to use Version 04 software (19XR) along with the OTP microchip Version 68 or 69. These were formally released for production in June, 2000. This software will check to see if oil pressure exceeds the 4 psi limit only for a 10-second window immediately before a startup, instead of continuously when the chiller is off.
