Number: C0003                      Date: 3/22/00                      Supersedes:                      Date:  
Title: 19XR Isolation Valve Potential Problem  
Category: *GENERAL*                      Termination Date:  
Author: Brice Auten  
Reviewed by: Alan M. Johnson  
Dept: CSS Service Engineering

Models:    CAC: 19XR centrifugal chillers  
Affected:    BDP:

To inform the field of a potential problem with the crossover isolation valve between the float chamber and the cooler on frame 2,3, & 4 chillers.

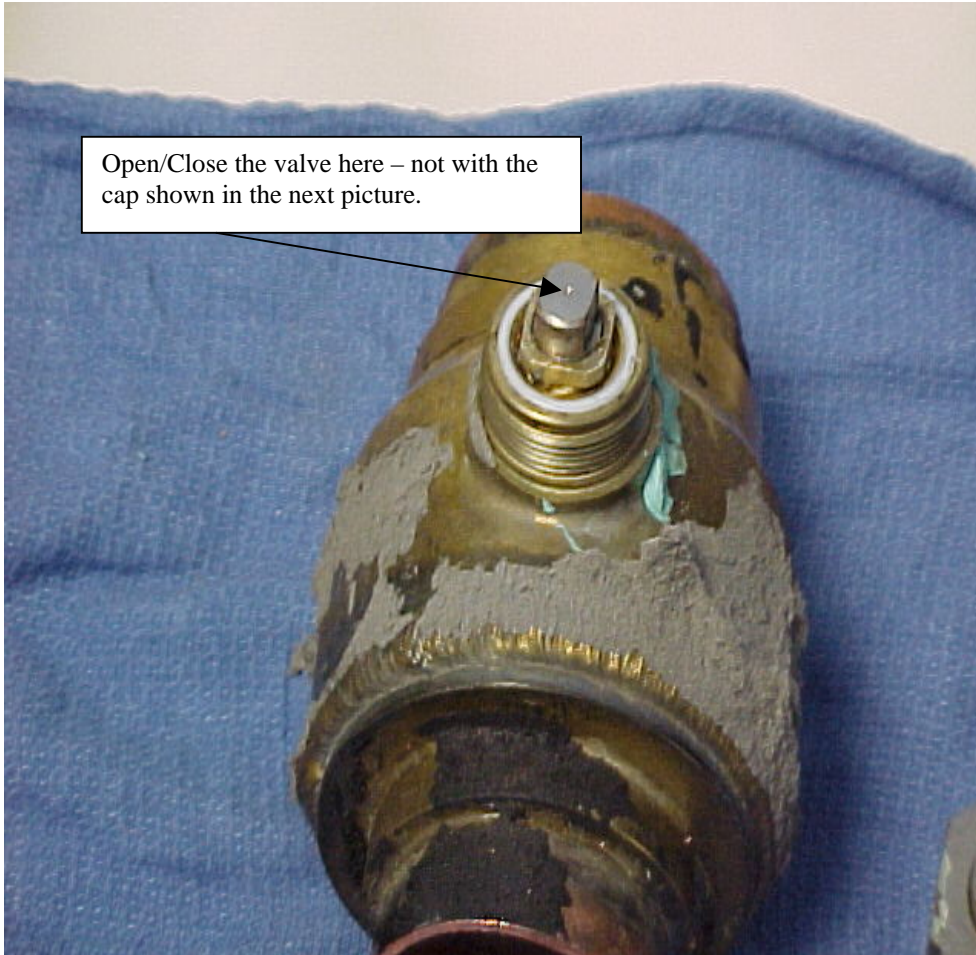
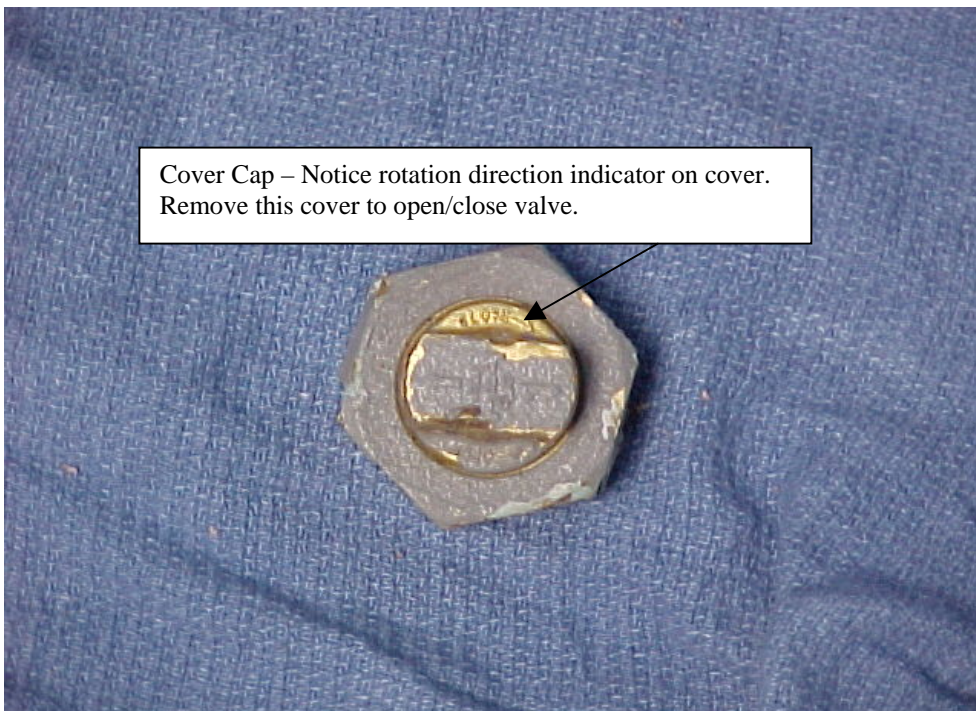
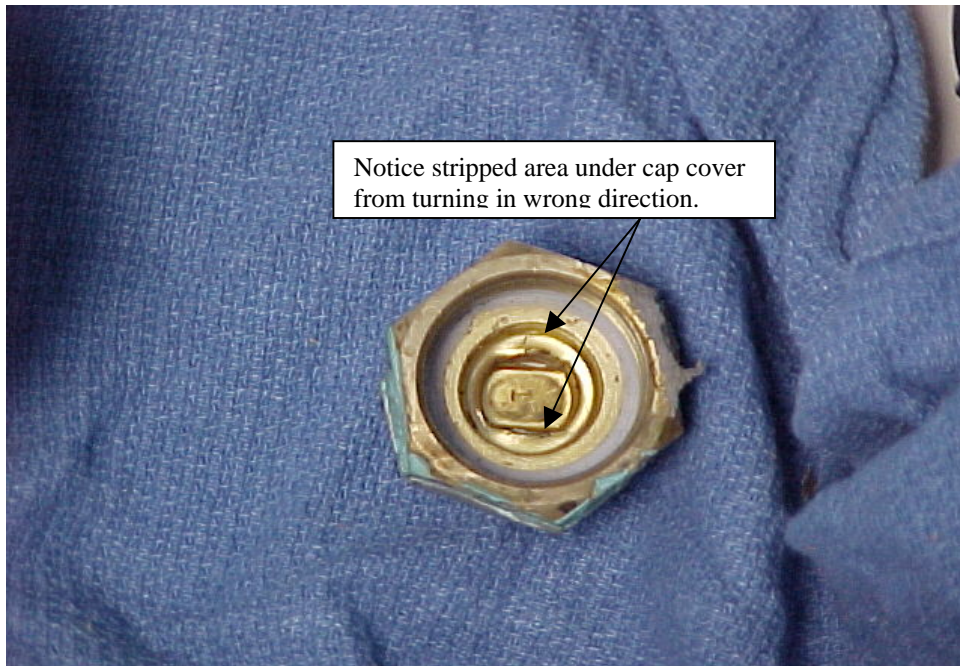
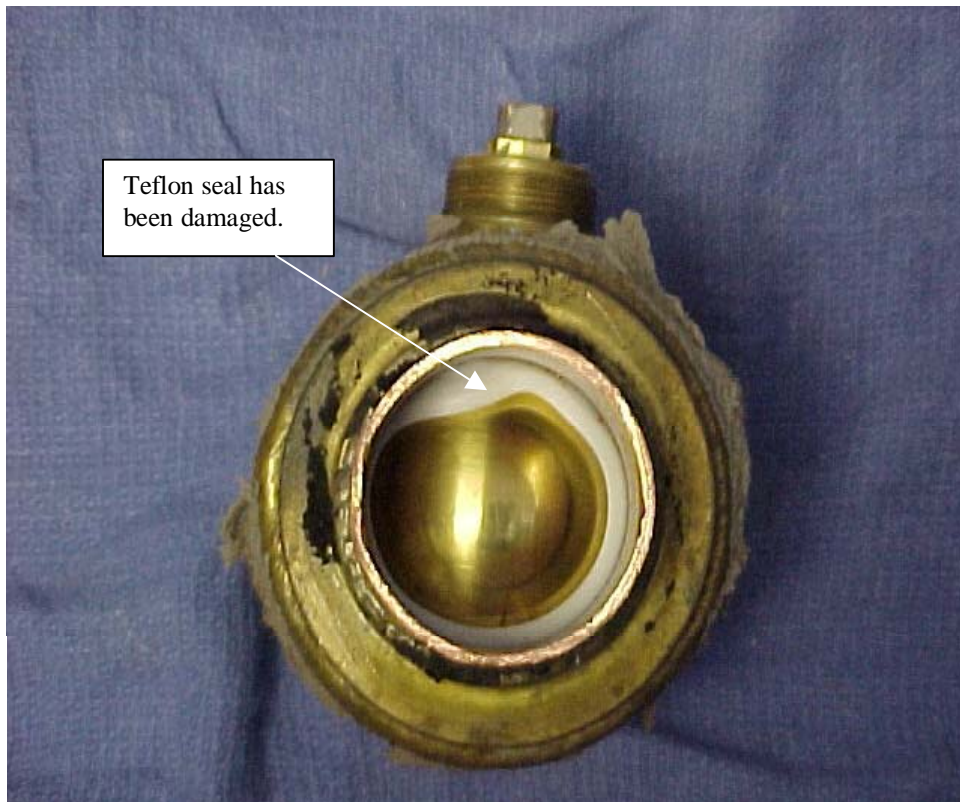
Another possibility is a closed isolation valve. The valve used (part # EP71BA-571) has a brass cap cover that fits over a steel valve stem. Rotation direction to open and close the valve is marked on the cap but is usually unreadable after painting. It is possible to turn the cover cap and have the appearance that the valve is open while in fact, the valve is still closed. Without too much effort the cover cap can be rotated and enlarge the slot that fits over the stem. There will still be a resistance when turning the cover, adding to the belief that the valve is turning with the cover. There has also been one instance where the valve stem broke allowing the cap and stem to turn without moving the valve.

If the above symptoms are encountered, first check the valve to verify that it is open by removing the cover and turning the valve stem. Pictures are attached.
