SERVICE BULLETIN

SUBJECT: 19XR Crossover Isolation Valve

NUMBER: C0003

MODELS AFFECTED: 19XR Chillers

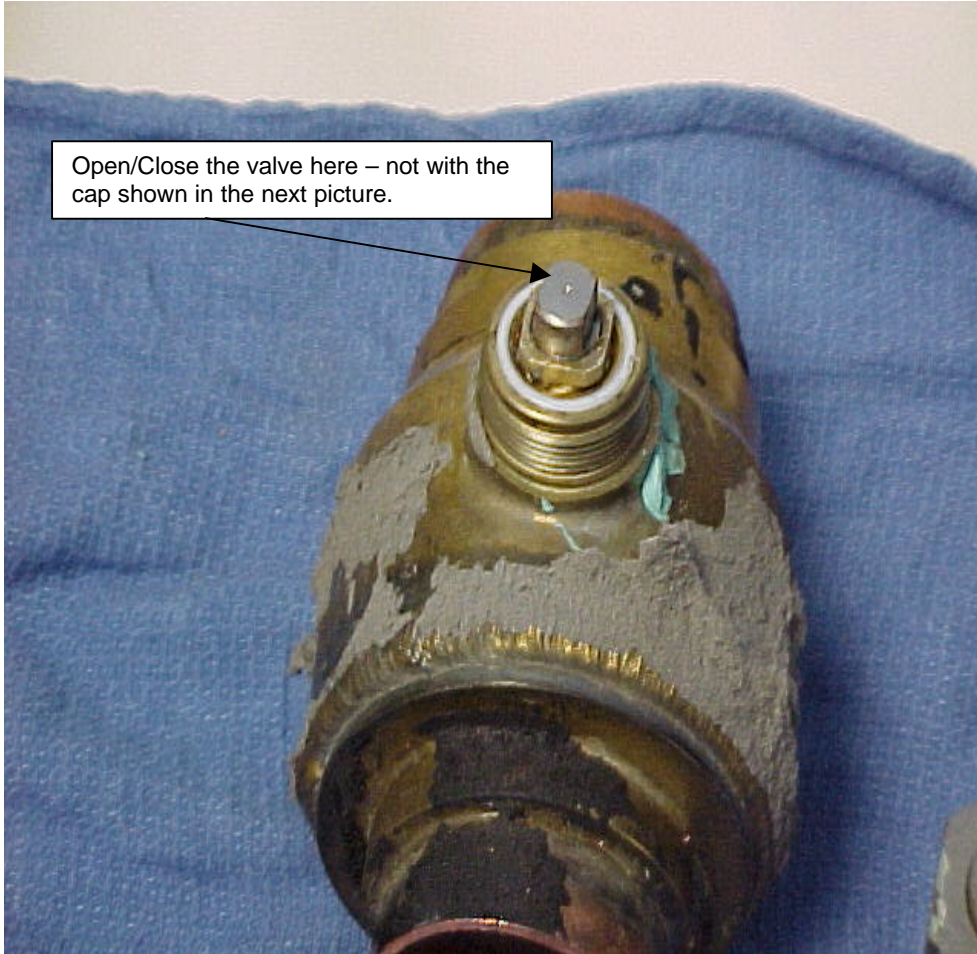
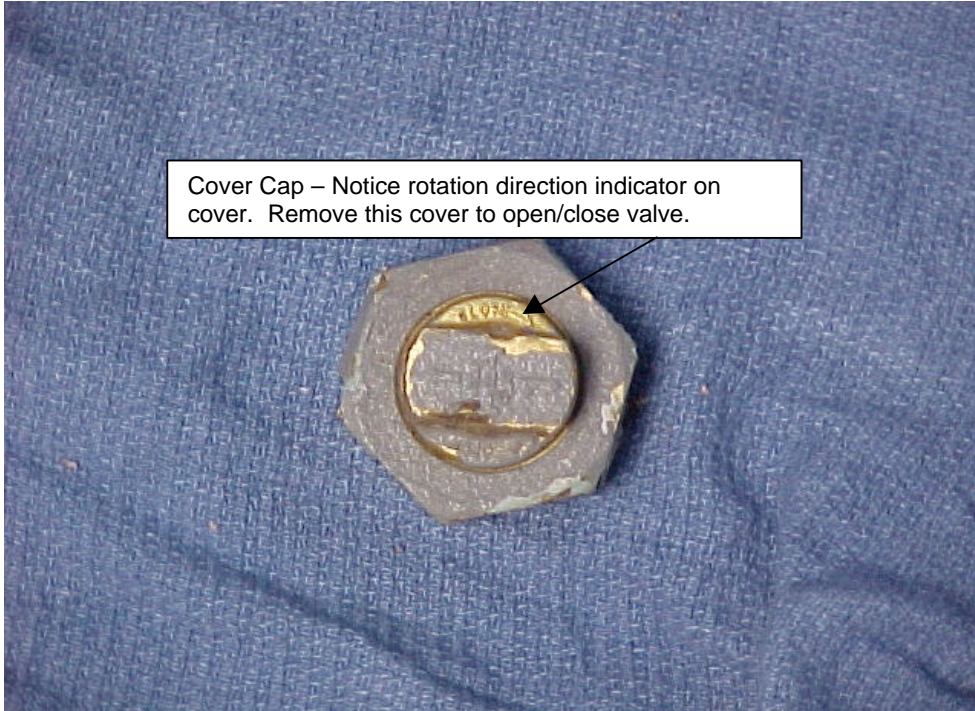
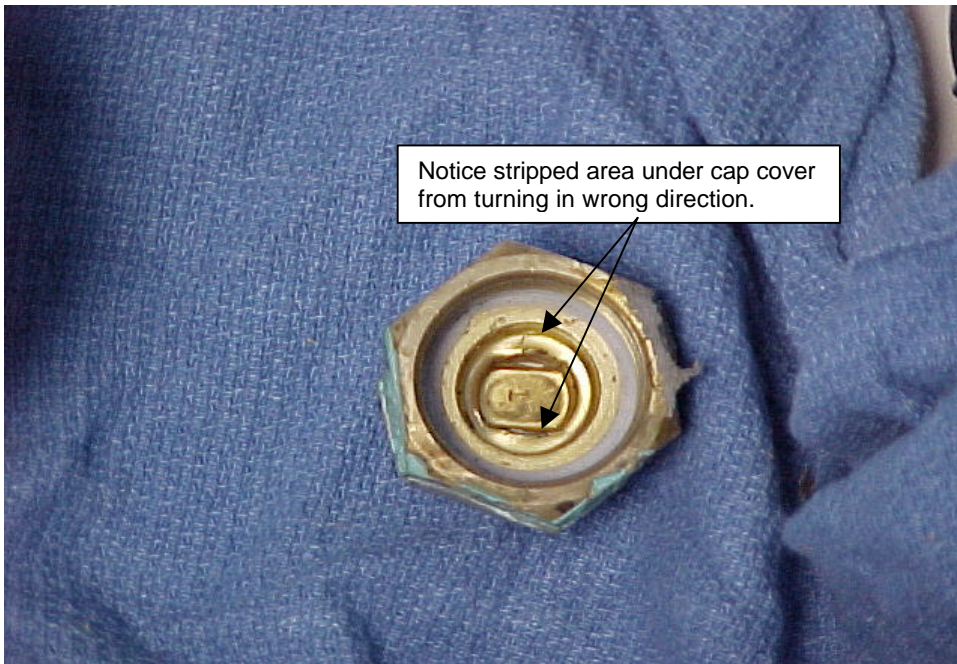
The isolation valve (part # EP-71BA-571) has a brass cap cover that fits over a steel valve stem. Rotation direction to open and close the valve is marked on the cap but may be unreadable after painting. It is possible to turn the cover cap in the wrong direction and have the appearance that the valve is open while, in fact, it is still closed. Without too much effort the cover cap can be rotated and can enlarge the slot that fits over the stem. There will still be a resistance when turning the cover, adding to the belief that the valve is turning with the cover.

If there are any symptoms that the valve is closed even though the cap indicates it is open, check the valve to verify that it is open by removing the cover and turning the valve stem. Having high discharge and low suction pressure is one indication that the valve is not open.
