# 19XRV Service Updates

Chee Nee Bong

October 2012

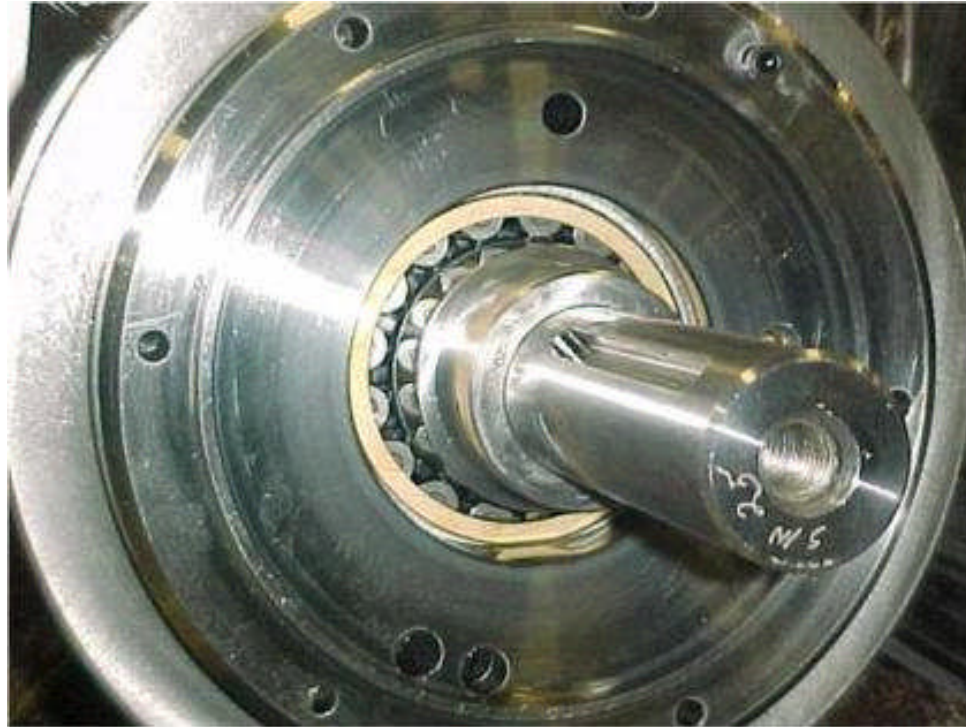
Vibration analysis should be added to annual maintenance  
Babbit bearings contains 80% tin, REB contains 0% tin  
Cleanliness is important in REB repair

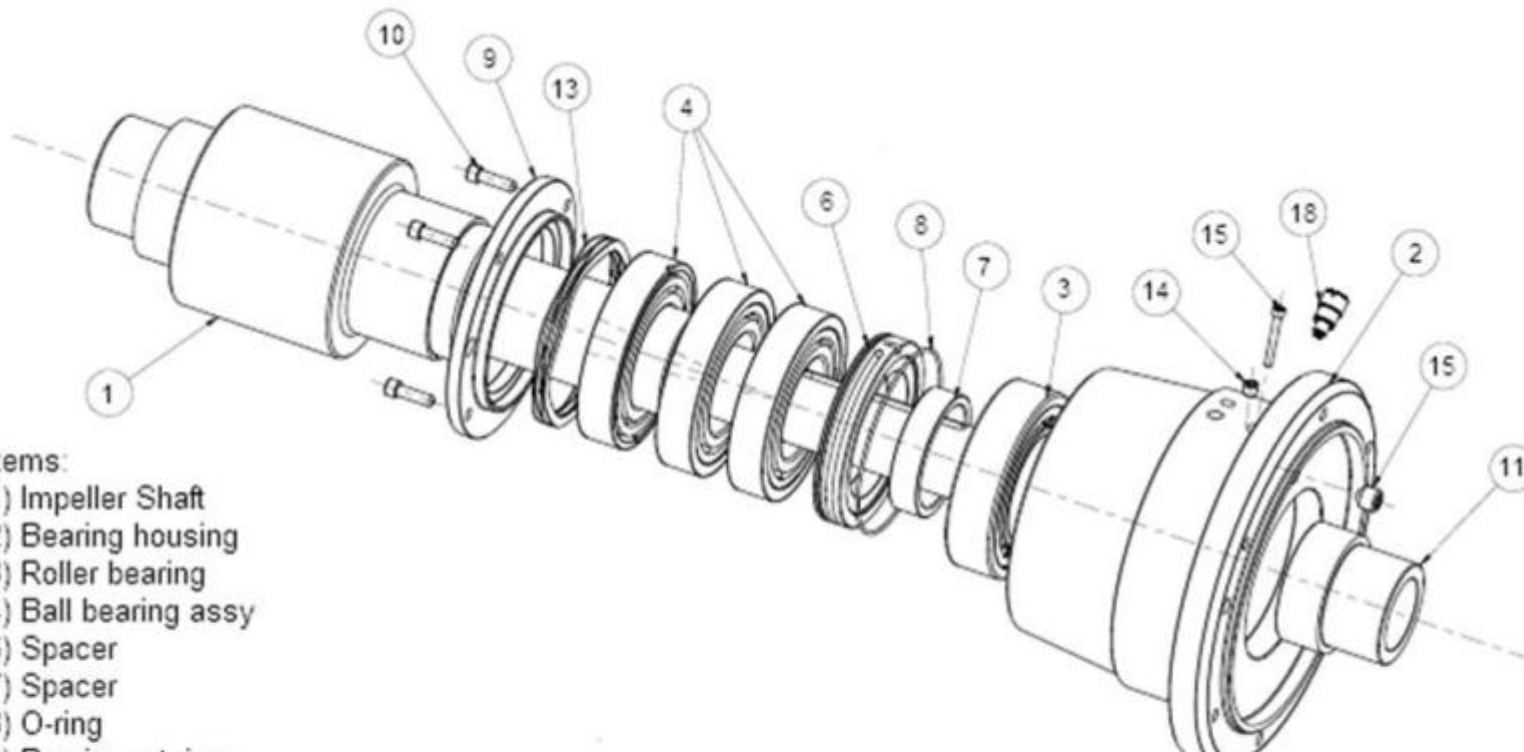
High speed shaft assembly

- 1) Impeller Shaft
- 2) Bearing housing
- 3) Roller bearing
- 4) Ball bearing assy
- 6) Spacer
- 7) Spacer
- 8) O-ring
- 9) Bearing retainer
- 10) Screw
- 11) Spacer
- 13) Wave spring
- 14) Screw
- 15) Screw
- 18) Temp sensor pin

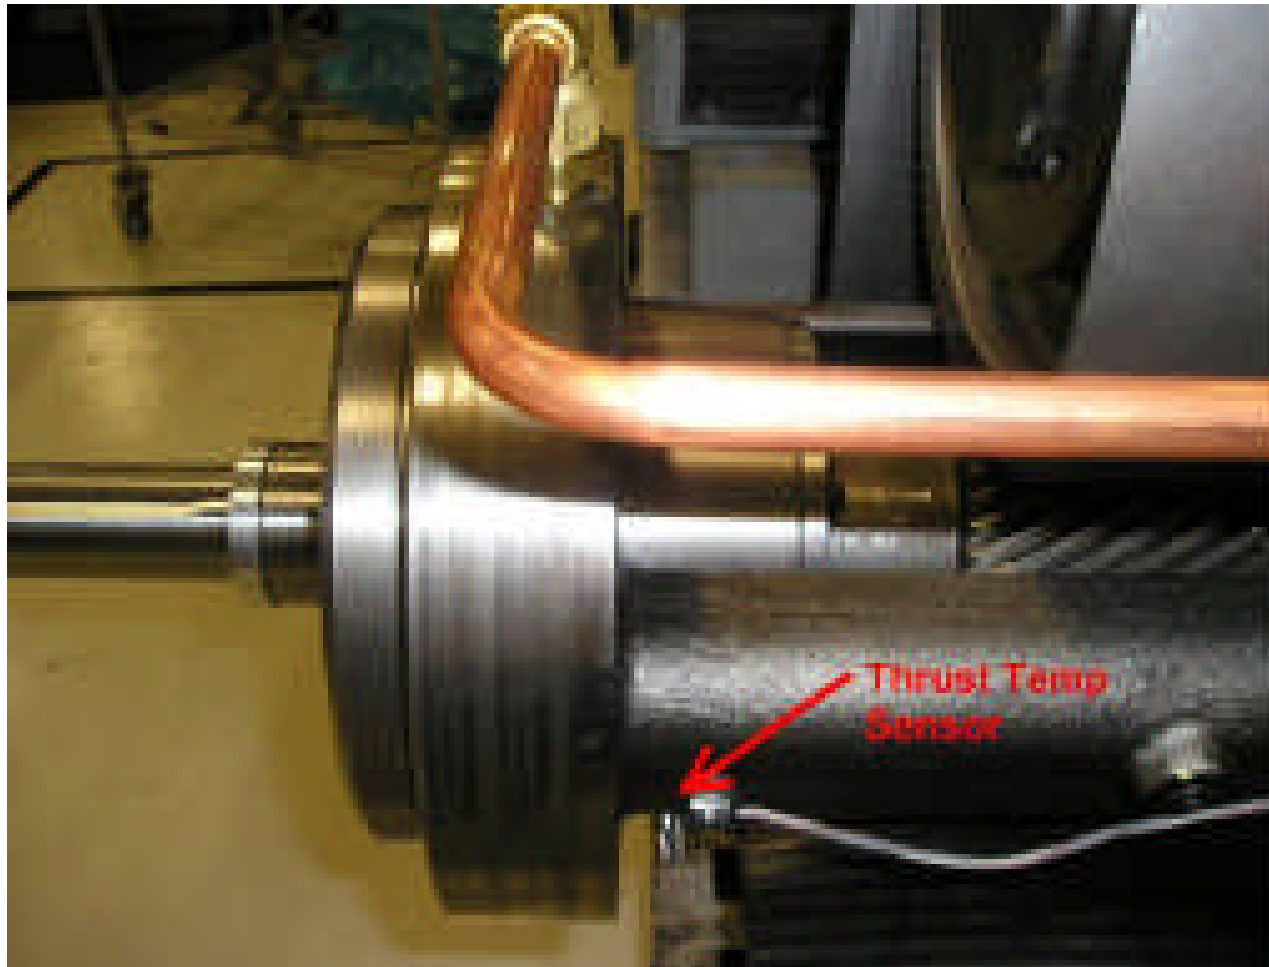
**Thrust Temperature Sensor** – spring loaded dual element thermistor screwed into transmission casting

High speed shaft assembly can be removed through impeller end of compressor

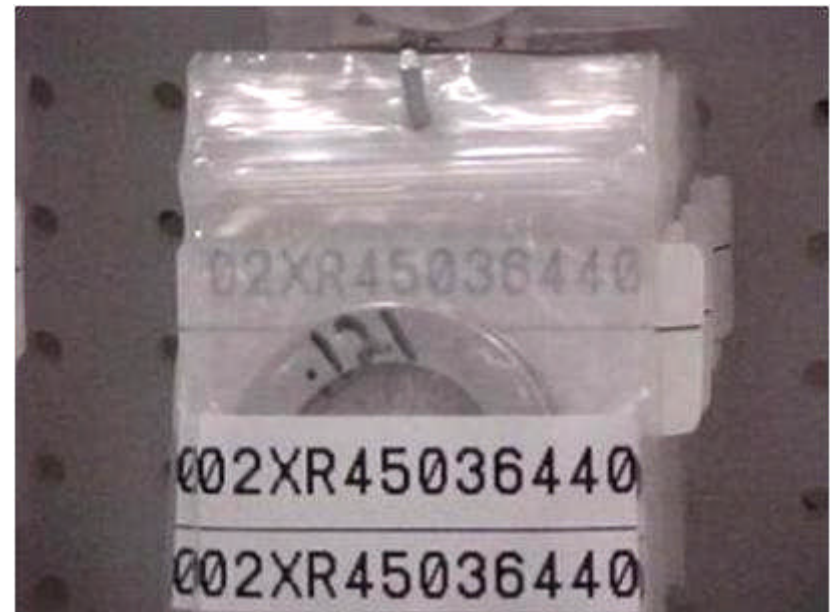
Wheel clearances being reduced to increase efficiency.

Changed to fixed wheel shim – peelable shims not used in factory anymore

XR2	.016	was .018
XR3	.016	was .021
XR4	.012	was .024
XR5	.020	was .041

Peelable shims will still be used at the field

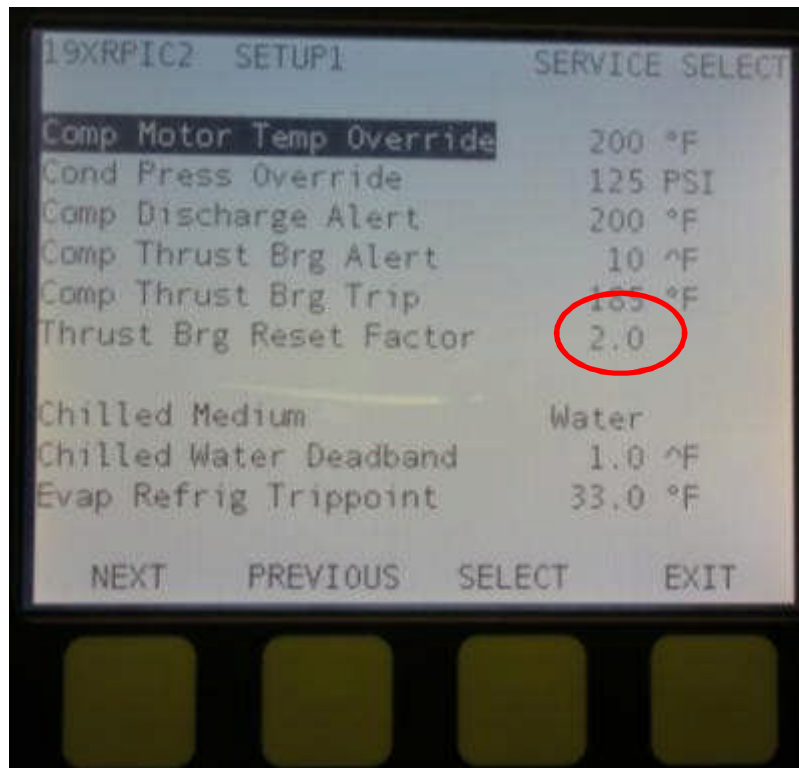
Issue: Thrust bearing Reset Factor set wrong from factory

1. Go to Service → Equipment Service → Setup1
2. Check “Thrust Brg Reset Factor, should be set to 1.2 to 1.4”

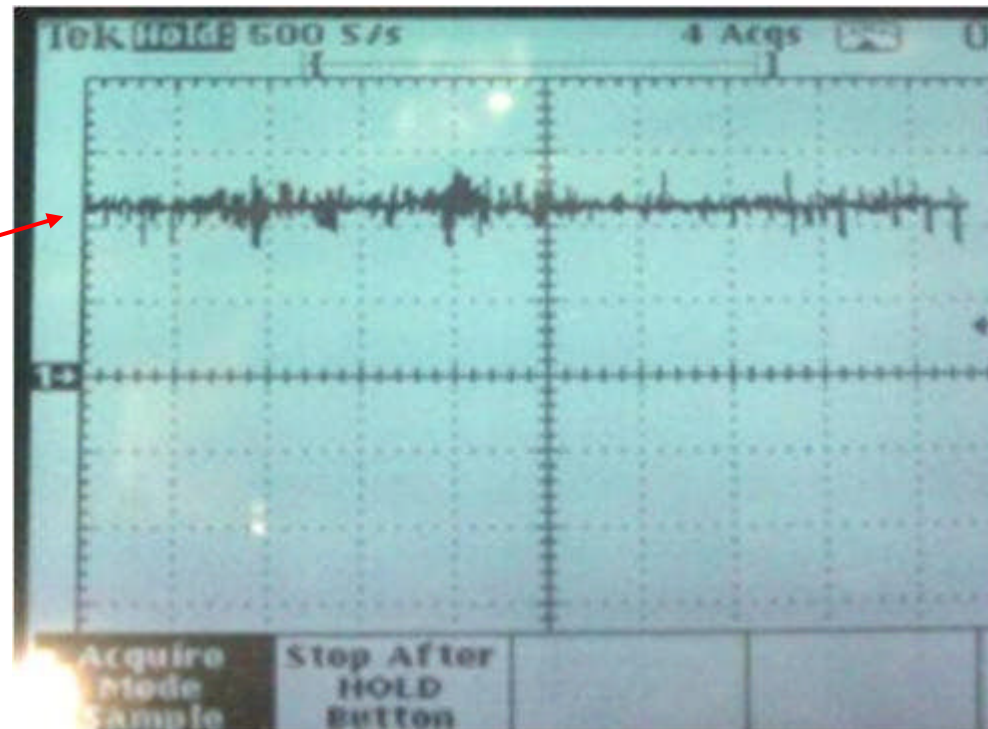
Sample reading with a scope

Diffuser pressure fluctuates for more than 76 psi for 4 or more times in 1 sec

Can be electrical interference problems with other wiring in the same wire tray

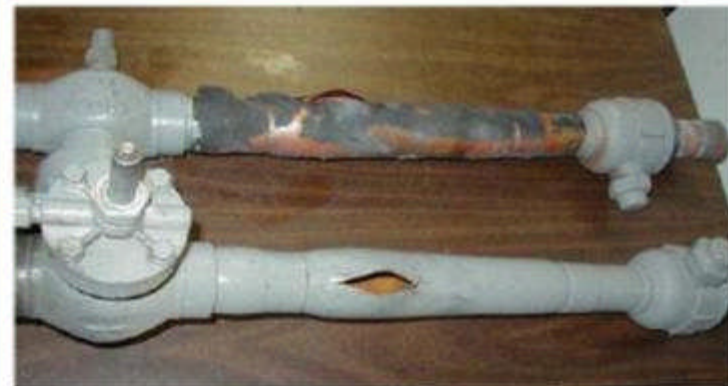
**CAT Issue Description:** Ruptured tubing in HGBP piping.

**Root Cause Findings:** Trapped refrigerant in HGBP line can cause pressure increase leading to ruptured tubing.

**Corrective Action Plan (Field):** Eliminate HGBP isolation valve. Valve has been found to be redundant in current configuration.

**Corrective Action Plan (Factory):** Short term – Position HGBP isolation valve in open position before shipment. Long term - Eliminate HGBP isolation valve. Valve has been found to be redundant in current configuration.

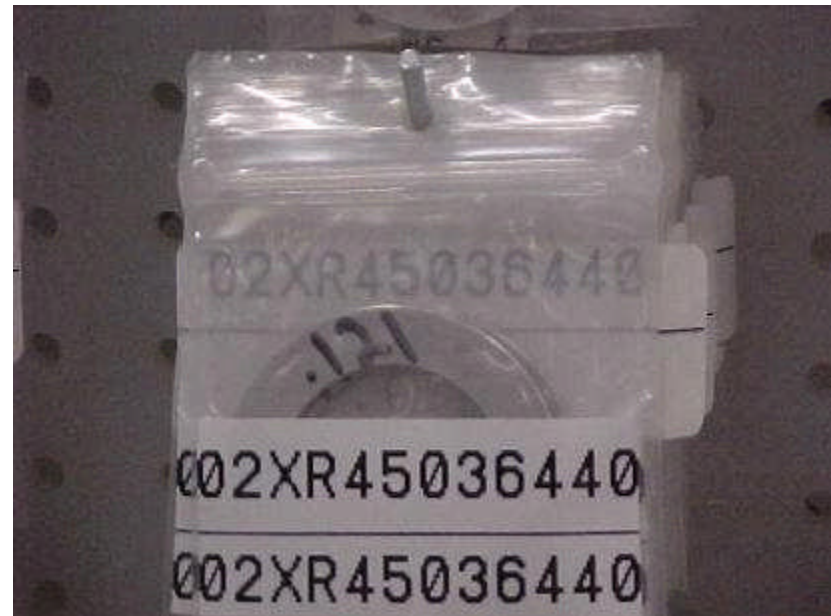
Wheel clearances being reduced to increase efficiency.

Changed to fixed wheel shim – peelable shims not used in factory anymore.

XR2	.016	was .018
XR3	.016	was .021
XR4	.012	was .024
XR5	.020	was .041

Peelable shims will still be used in field

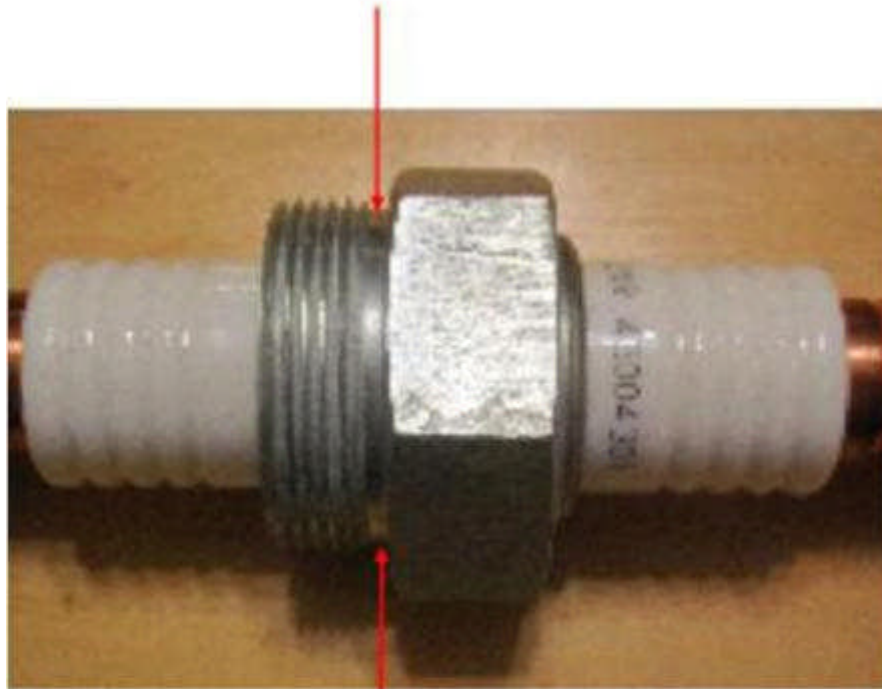
Measure o-ring groove diameter with calipers per guideline

**If Groove <1.752 inches, replace terminal**

4. Check Groove diameter, replace if <1.752 inches  
New O-ring part # 02XR45004301

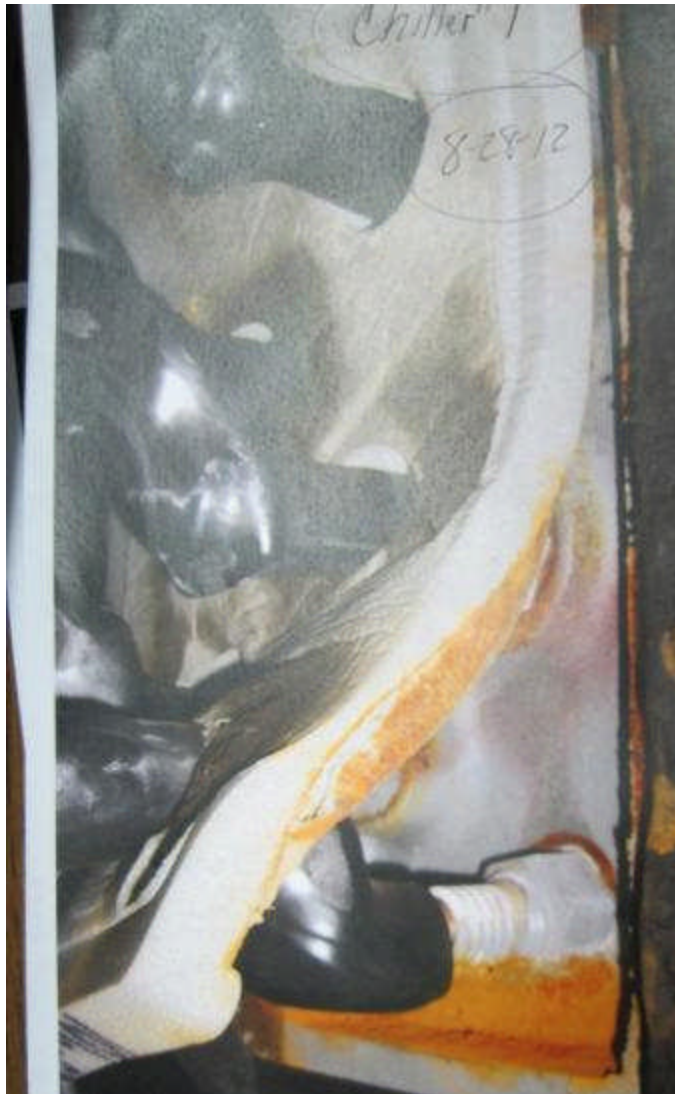
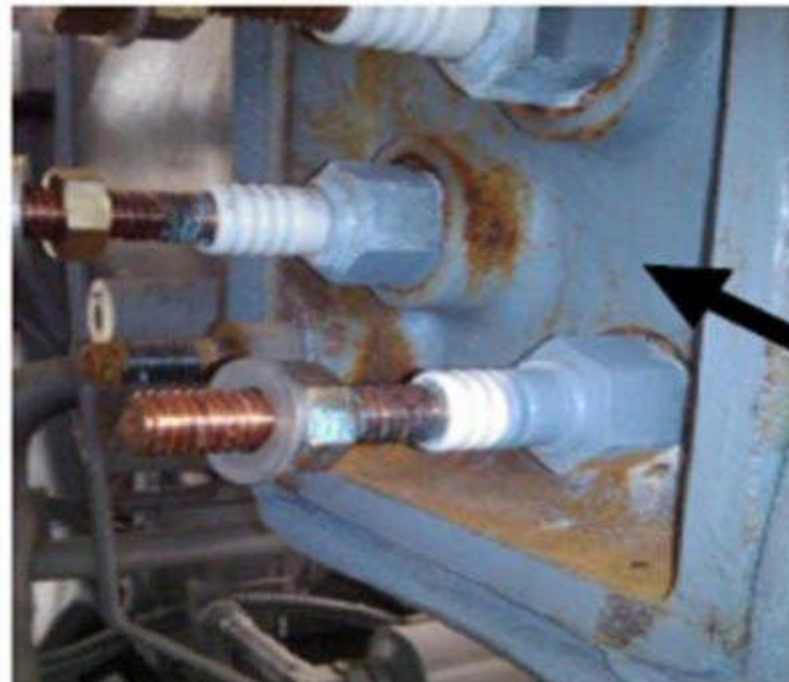
Improper insulation over motor terminals  
Moisture collects and surround terminal with water

Low mega-ohm readings phase to phase  
and phase to ground on motor terminals  
Can possibly cause VFD failure

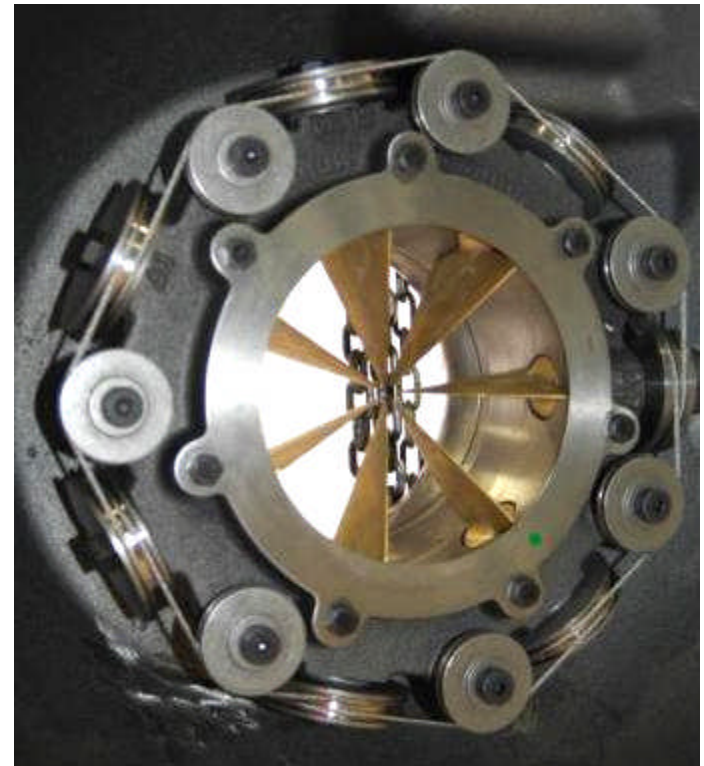
Some GV/SRD schedules require SRD to move as much as 6.0 times faster than GV

Actual diffuser position will lag behind the schedule when required rate exceeds capability.

When decreasing GV and SRD positions, this lag can result in rotating stall and impeller damage.

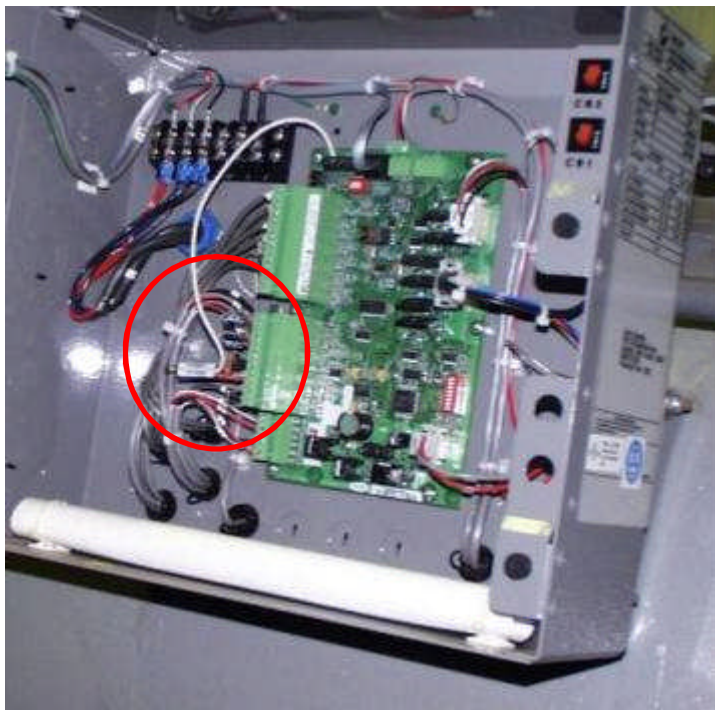
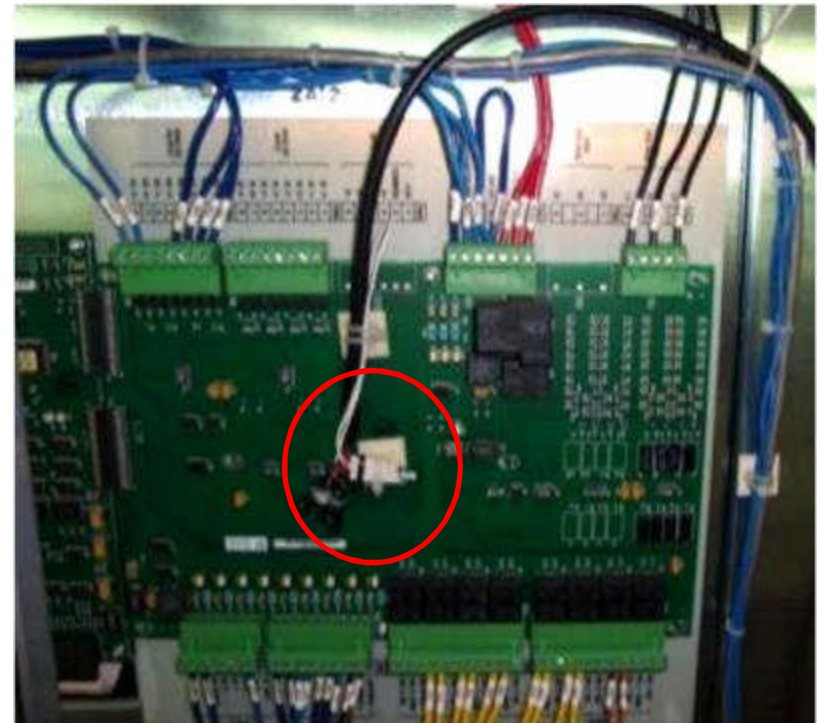
### Nuisance inverter, rectifier overheating issues

Move humidity sensor from ICVC Panel to VFD Enclosure  
Right picture shows humidity sensor mounted on Power board
