**UNITED
TECHNOLOGIES
CARRIER**

BULLETIN: CA-SB-19-D-88-109
DATE: 2/12/88
PAGE: 1 OF: 2

SERVICE BULLETIN

ESP REPLACEMENT PANELS

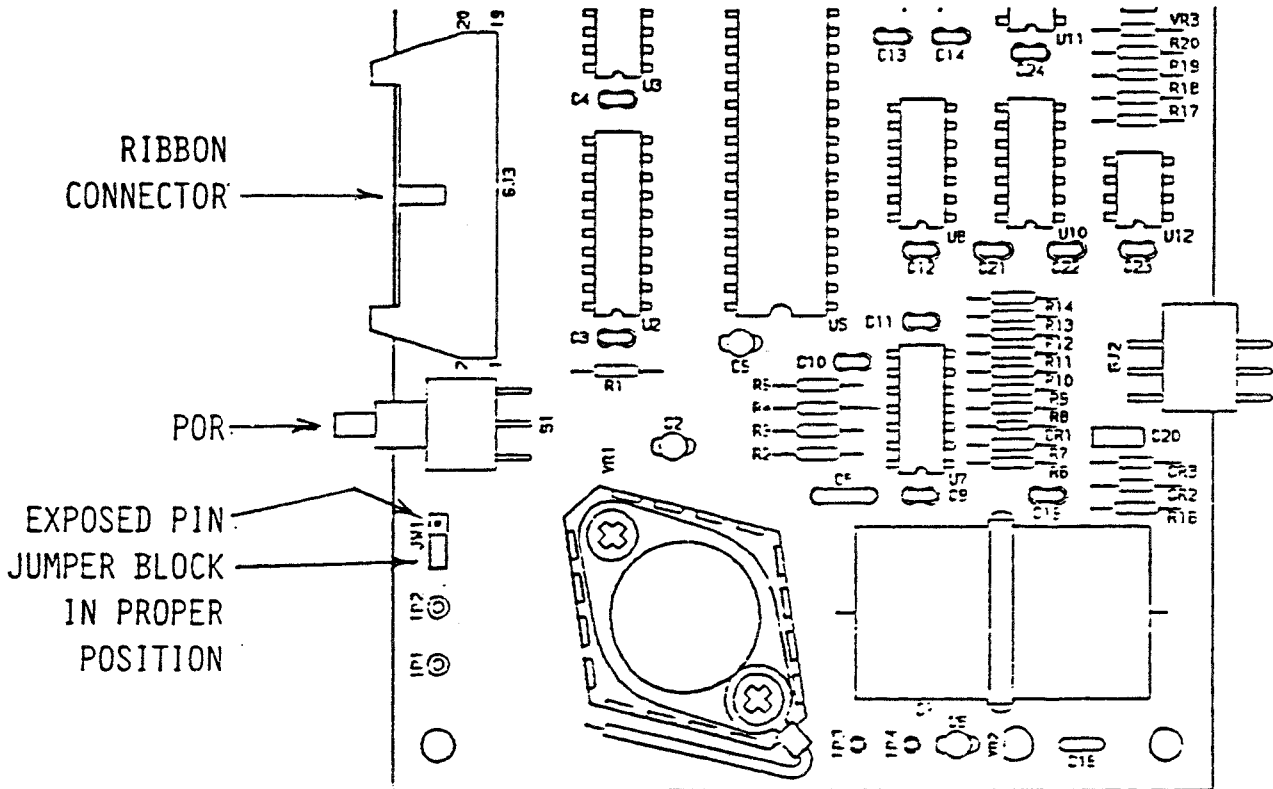
FIG. 1 REAR CIRCUIT BOARD OF ESP 11

Note: The ESP II rear printed circuit board has three small pins located in a row near the POR switch. For proper operation of the panel the center pin and the pin furthest from the POR (see Figure 1) are connected by a small blue slip-on jumper block. The vendor puts the jumper on the two pins closest to the POR for his quality test after production and then is supposed to move the jumper before shipping the panel. If the jumper is in the "factory test" position the display will be blank when the panel is powered up. If an ESP II is found with the jumper in the wrong position, just power down and move it over to the two pins away from the POR and then power up.
