Service Alert

CTV AdaptiView™ Control MP Reset Occurrence on Units with BACnet and UC800 Version 1.11 Software

Trane CenTraVac® Chillers

Literature Order Number	CTV-SVA37B-EN
Date	October 2008
Supersedes	CTV-SVA37A-EN September 2008

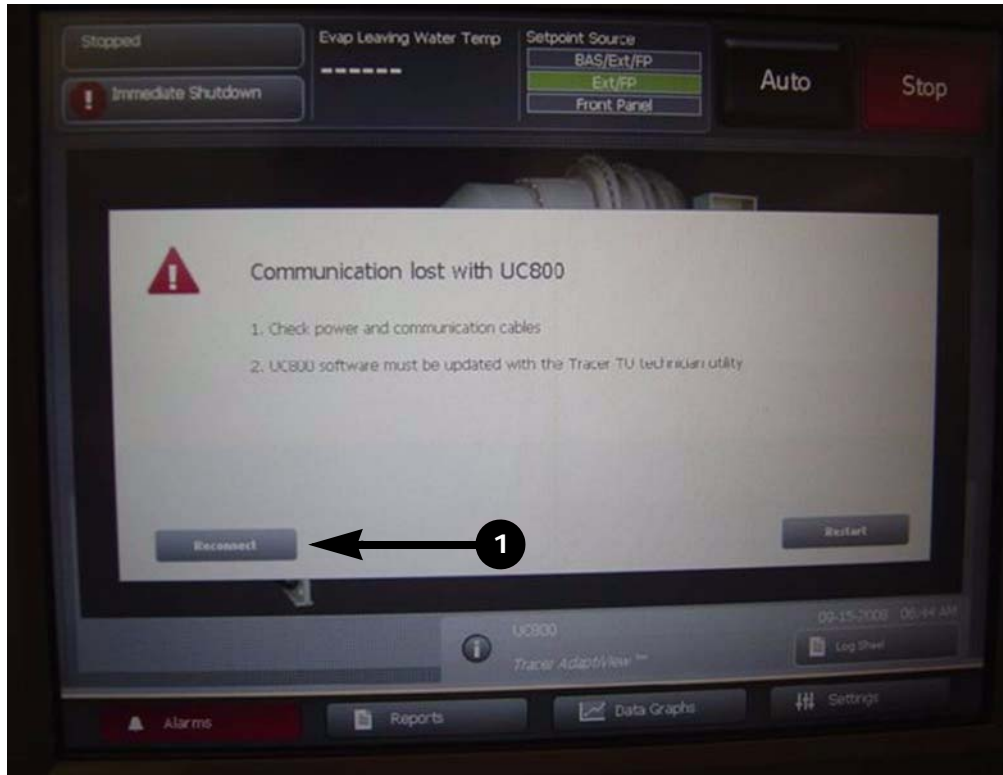
When MP reset occurs, a communication error is displayed with version 1.11 (Build Part Number 6200-456-1.11), as shown in [Figure 1](#). To reconnect the AdaptiView display with the UC800 controller following MP reset, press the lower left-hand **Reconnect** button (see [Figure 1](#)).

Figure 1. UC800 communication error displayed following MP reset (version 1.11 software)

1. **Reconnect** button

Already started units with BACnet: Upon next visit and availability, upgrade to the newest Simplex UC800 firmware version 2.06.

Units not started: Upgrade to the newest Simplex UC800 firmware at startup version 2.06.
