Confidential Service Bulletin

Insulated Bearing and Brush Kit

For units with LF2.0 drives

Order Number: CTV-SVC15B-EN

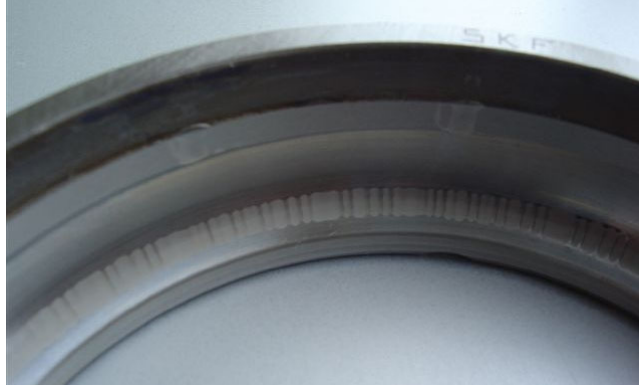
Figure 1. Photo of typical spark discharge damage in a bearing race

A situation may occur in some LF 2.0 equipped units where the chiller motor experiences a shaft voltage. The shaft voltage created may seek a path to ground through the thrust bearings, resulting in damage to the thrust bearing.

For an LF 2.0 equipped chiller with a standard steel thrust bearing BRG01209 or BRG01210 that has failed due to spark discharge, with or without a brush kit: Order and install the insulated bearing assembly, new design brush, and (if needed) a new bearing inspection cover. See the parts ordering information below for details.

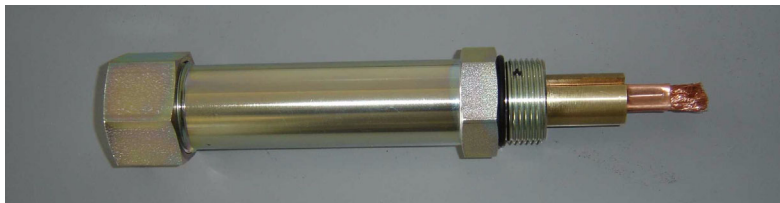
Figure 3. New Design Grounding Brush

- Properly install the new bearing inspection cover onto the chiller.
- To install the new brush into the inspection cover, first remove the plug (if present) from the center fitting of the cover, then clean the threads. The threads and o-ring of the new style brush should be lubricated with Trane compressor oil OIL00022. The brush can then be inserted into the cover and tightened to a final maximum torque of 150 lb.-ft.

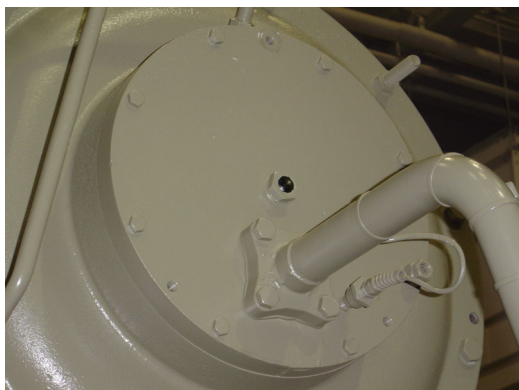
Figure 4. Original Bearing Inspection Cover without brush fitting or brush.

For affected units shipped prior to 9/24/2004, or that have the older design brush kit installed, order one replacement New Design Bearing Inspection Cover per Table 3.

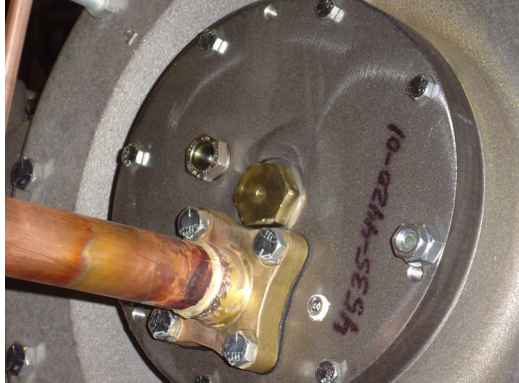
Figure 5. New design Bearing Inspection Cover with brush fitting, but without the brush installed. This cover is standard on LF 2.0 equipped chillers since 9/24/2004.

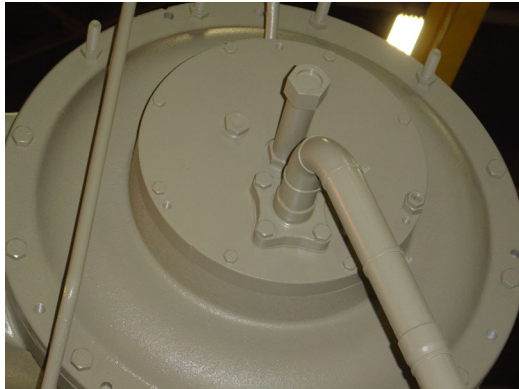
Figure 6. New design Bearing Inspection Cover with new design Grounding Brush installed.
