# General Service Bulletin

## CVHE-F with Rockwell LF 2.0 Drive

ORDER No.: CTV-SVB04A-EN

### **Inductor mounting inspection and adjustment (Refrigerant Cooled Only)**

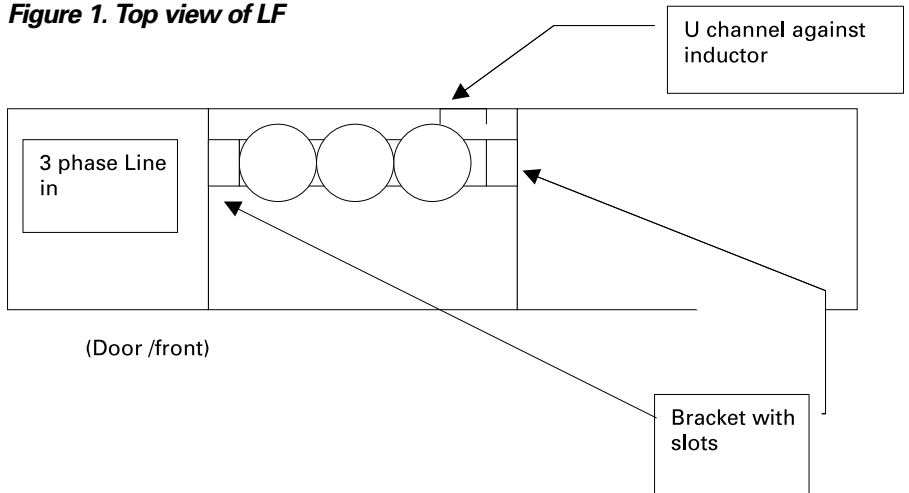
**Figure 1. Top view of LF**

The problem area can be inspected by opening the left hand front door and reaching in at the top to feel for the clearance between the rightmost upper winding and the cabinet frame. See figure 1. Rockwell has changed the assembly and are now providing approximately 1/2 inch of clearance.

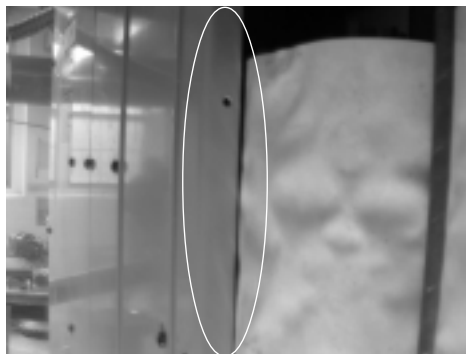
The LF 2.0 Drive has inductors in the center enclosure portion towards the rear of the enclosure. The inductors may be mounted such that is in contact with the enclosure "mullion" (U channel support) which can wear through the insulation materials which then can short to the unit chassis.

Figure 2 is a picture of the inductor in a new LF2.0 608amp Rockwell drive. This picture illustrates an inductor too close to the u channel.

**Figure 2. Illustration with no clearance. View is from rear of drive. Back cover removed.**

- In the field we would like an 1/2 inch if possible, however the existing slots and adjustments will likely not provide an 1/2 inch in all cases.

- There is insulation paper between all inductor conductors and the U channel. The absolute minimum is 3/16 inch.

It is desired to have 3/16" (4.75mm) to 1/2" (12.7mm) between the inductor and the u-channel. Refer to Figure 2.

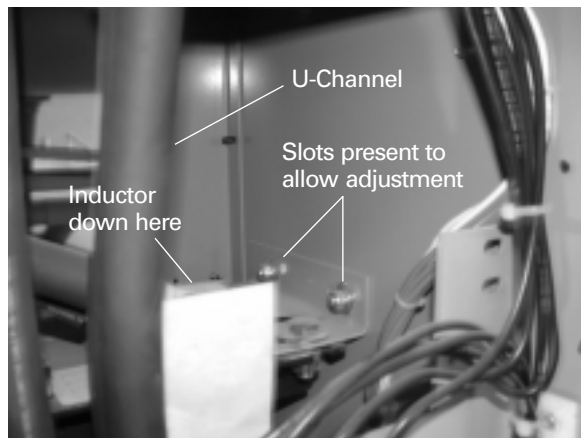
Front view looking in at starters center section. Bolts can be loosened and the assembly slide forwards in slots to provide clearance required at rear.

There are slots on the top angle brackets accessible from the front side. If the clearance cannot be attained by top only adjustment the bottom can also be loosened. There are four bolts at the bottom also. To access the rear two bolts the drive enclosure rear cover will need to be removed. There are approximately 20 torque head bolts holding the rear cover on. The four lower bolts can be loosened. Do not allow the nuts to drop off the bolts as they are not accessible.

Slide the inductor brackets forward then secure the mounting bolts. If the lower inductor frame mounting bolts were loosened, determine if there is a gap at the rear. A gap at the lower rear can be created from sliding and securing the top of the indicator assembly forward. If necessary fabricate shims from washers or sheet metal to take up the space. Tighten the four lower mounting bolts.
