General Service Bulletin

Re-torquing of flat gaskets before start-up

Order Number: CTV-SVB17C-EN

DATE: October 2005

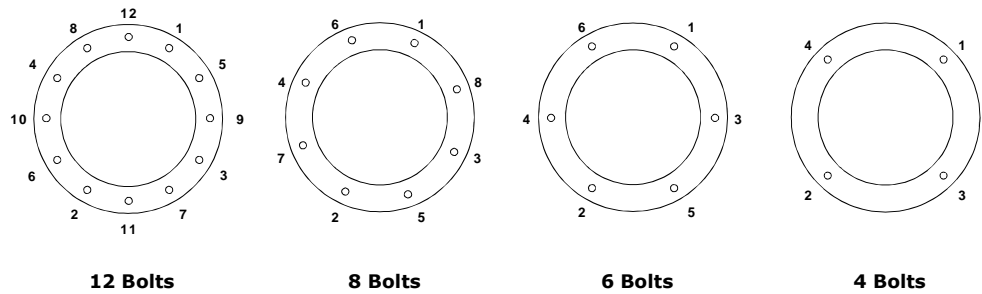
During the installation of any of the below listed La Crosse-built chillers, all economizer flange bolts should be re-torqued to current factory specifications as follows.

This service should be performed once the holding charge has been removed from the unit. Once the unit is charged and or running the re-torquing procedure discussed in this bulletin may not prevent the leak from occurring.

Torque all bolts using a calibrated, good quality torque wrench. All bolts shall be tightened in three stages and in a star pattern as shown in Figure 1.

Stage 1 - Cordless Drill - Driver to 5 ft-lbs.
 Stage 2 - Hand torque wrench to 15 ft-lbs.
 Stage 3 - Hand torque wrench to final torque as per Table 1.
