TRANE®

Confidential Service Bulletin

Rockwell LF 2.0 Drives AFDE Service Pak upgrade

Order Number: CTV-SVC30C-EN

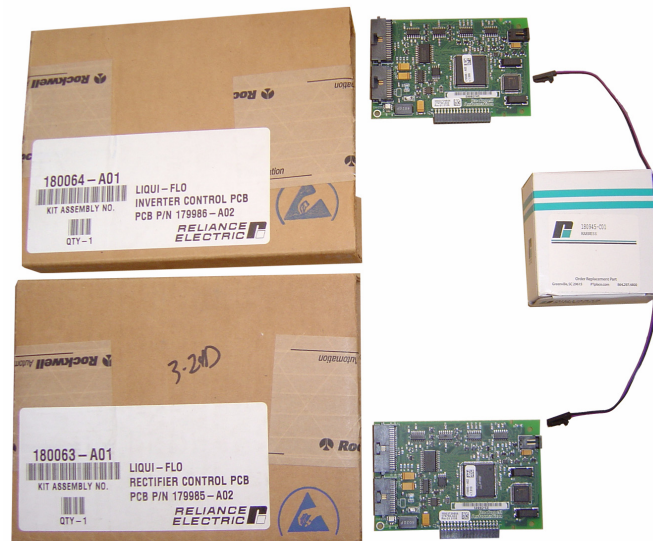
KIT 14713

- 1 pc 180063-A01 Rectifier Control Board
- 1 pc 180064-A01 Inverter Control Board
- 1 pc 180945-C01 Harness Cable

Note: If the two PCBs become mixed up, look at the white sticker on the large 1C chip as it will be on the appropriate box as well.

Item 1. Frame 3 Drives: Install the Line Carrier frequency synchronization hardware KIT14713, and enable the synchronization feature.

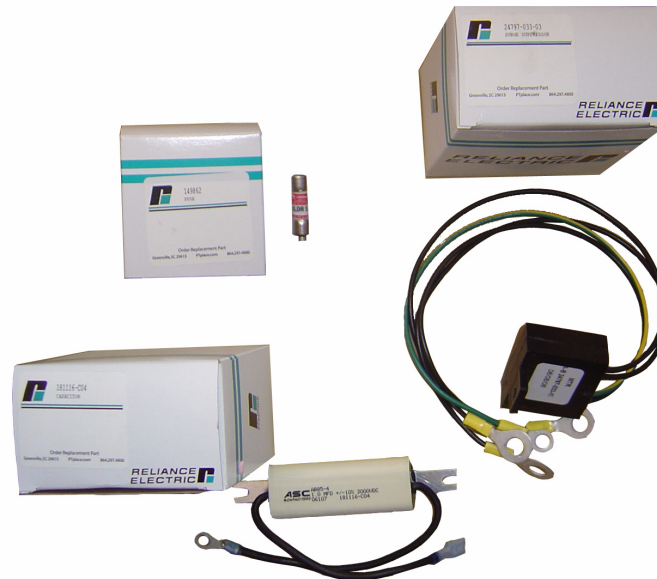
- KIT 14714
- 1 pc 24797-033-03 MOV Assembly
- 1 pc 149862 5 amp Control Fuse
- 1 pc 181116-C04 1mfd Capacitor

2.1) Install MOV and 1 uF cap to the 2A6 filter assembly. The purpose of a Metal Oxide Varistor and 1 micro farad capacitor are to dissipate electrical disturbances that could be harmful to the drive electronic components (such as IGBT).

2.2) additionally, only on Frame 3 (405 and 608amp) drives, we will upgrade to a 5 amp 2F3 fuse. The Fuse 2F3 was 4 amps and periodically this has been found to blow. This has been changed to 5 amps on Frame 3 Drives.
