General Service Bulletin

Rockwell water cooled AFDD liquiflow 1.5 PIC board field repair on 350, 450, 600, 750 & 1000 HP drives (CVHE, CVHF, CVHG Units)

ORDER No.: **CVHE-SVB10A-EN**

DATE: October 2002

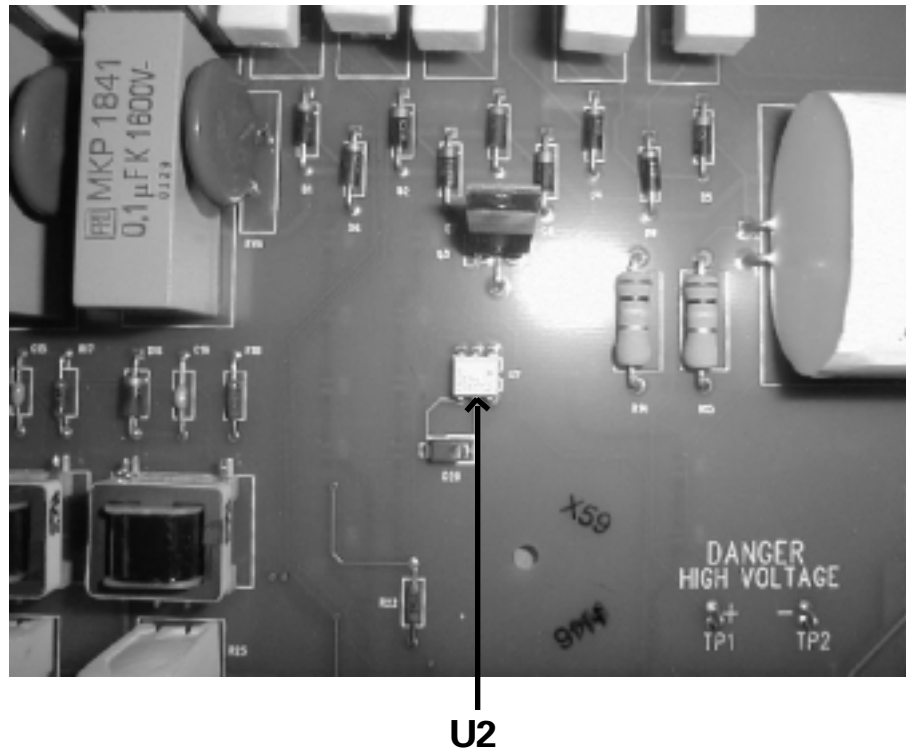
Figure 1: Close-up View of U2 Location

It has been determined that in a few isolated instances, that when high input line voltage conditions exist along with variations with board components on the Pic board component failures on the board may occur due to voltage spikes. The spike has in some cases damaged components causing failure of the Pic board.

When you look at the board, (Figure 1 and Figure 2), there is a component called a opto-coupler. It is a small square white part approximately ¼" square.

The optocoupler is located in the center of the board, as shown in the following pictures:

Removal of the optocoupler referenced as U2 on the following PIC PCB assemblies is required for proper operation:

2. In this retrofit, the PCB can remain mounted while performing the necessary procedures. However, utilize proper grounding procedures when working with the Printed Circuit Board.
3. Locate PIC board on respective drive (please reference manual for board location).
4. Remove the component U2, by clipping each of the six (6) pins on the topside at the board level.
5. Verify that none of the remaining pins are able to short together.
6. Confirm all ribbon cables are connected properly and reapply power.

If the unit has not been started, this opto-coupler needs to be removed. If the unit has already been started it does not have to be removed. The opto-coupler switches a bleeder resistor in and out of the circuit. When we remove it we disable the function so the bleeder resistor is always in the circuit to dampen short voltage spikes at startup.
