TRANE®

Service Alert

Tracer CH530 / CH531 Electronic Modules (LLID) Failures

Order No: CTV-SVA05A-EN

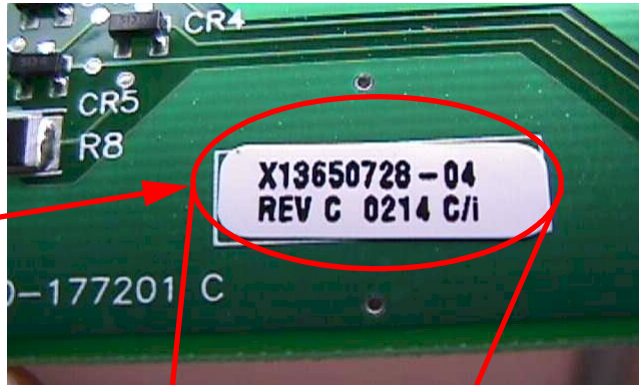
Figure 1 - LLID Date Code Label.

Determine date code of suspected LLID. (Example here is 0214:
02 = 2002
14 = 14th week)

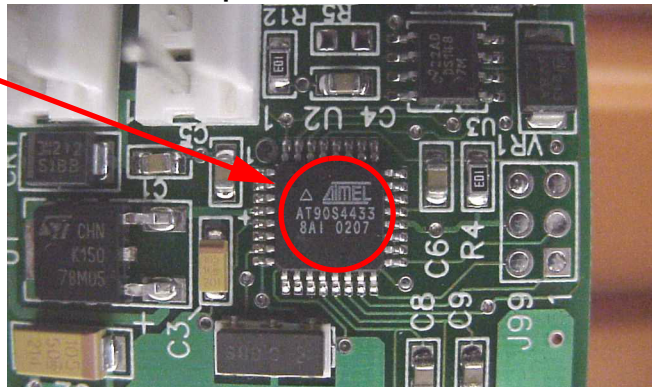
Figure 3 - Panel mounted LLID Microprocessor date code detail

Microprocessor
(Example here is 0207:
02 = 2002
07 = 7th week)

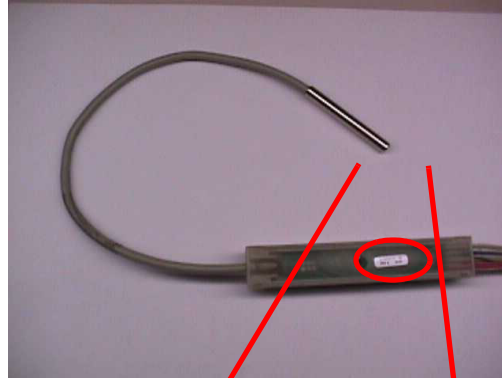
Figure 4 - Frame mounted LLID; Temperature sensor example with back side label shown.

- Frame Mounted LLID's (temperature sensors mounted outside the control panel) have a label with LLID date code on the backside of the assembly. Check this label for the same date code range of 0311 to 0314. The Microprocessor date code is not visible on frame mounted LLID's (see figures 4 & 5).
- Inspect the IPC bus and connectors to be sure they are not the cause.
- Or, LLID's with green status in binding view communicate the LLID date code to TechView. The LLID date code when viewed via TechView will have a 10311 to 10314, look at the 2nd through 5th digits to determine if LLID has suspect date code.

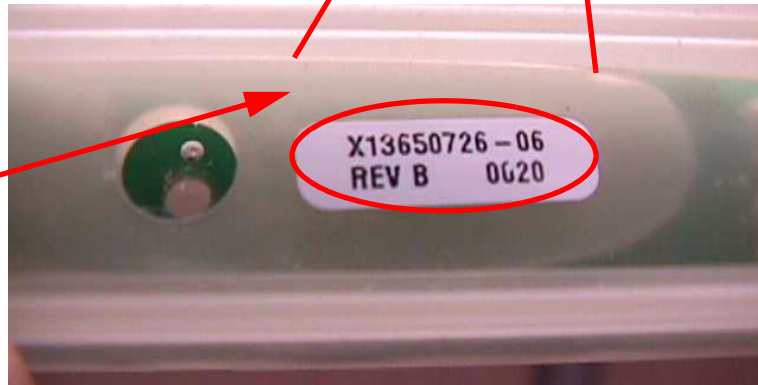
Figure 5 - Frame mounted Label detail.

Date code of suspected LLID is 0311 to 0314. (Example here is 0020:
 00 = 2000
 20 = 20th week)
 Look for 0311 to 0314 in the same position.
