Bearing Fluting

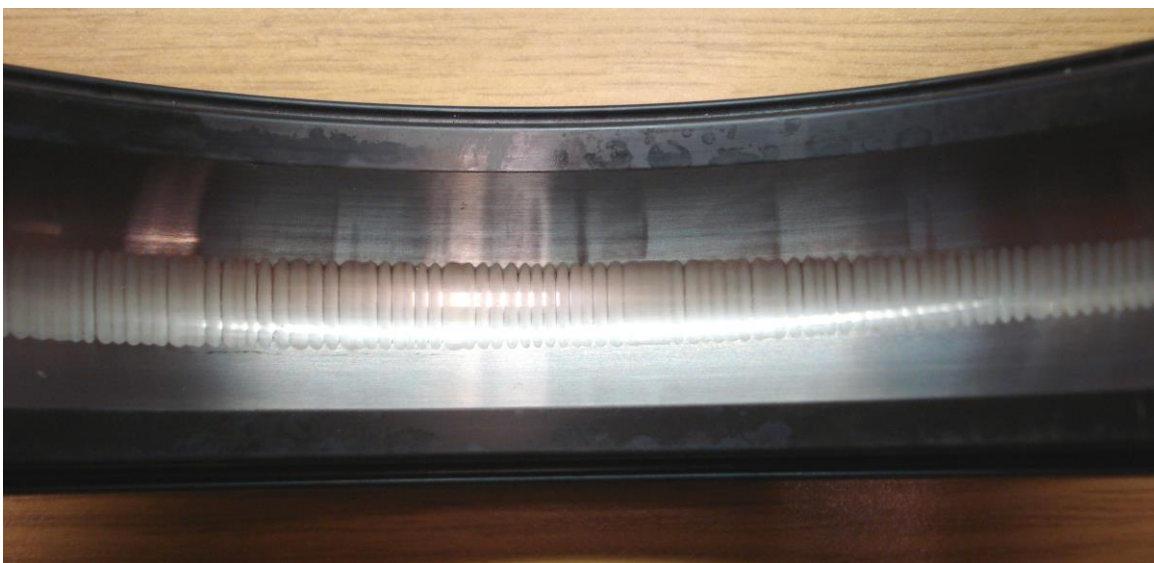
Bearing Fluting is a term to describe early deterioration of bearings due to an electrical current passing across the grease film in the normal wear path of the bearing. Tiny pits created during each electrical discharge form a wash-board like pattern of parallel oval marks around the wear path. In the early 1900's this condition was typically caused by magnetism, shaft eddy currents, or asymmetrical currents in a motor. However, today this same deterioration can be caused by variable speed drives (VSDs).

Fluted Bearing

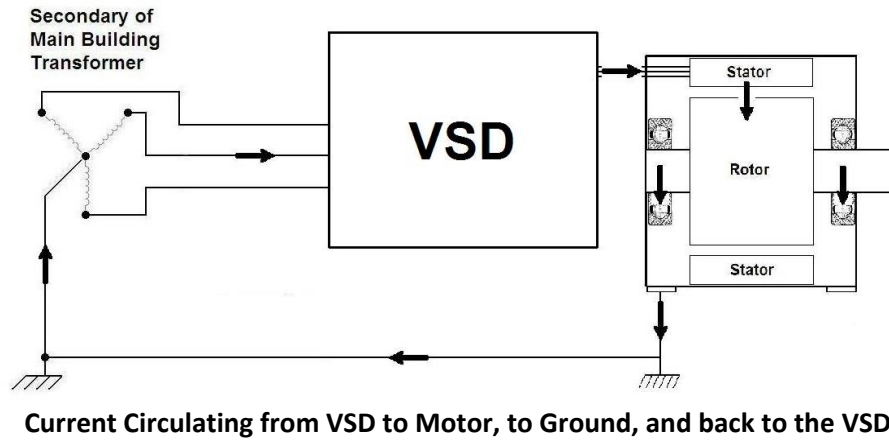
Research in 2008 found that when fluting occurs, currents circulate from the VSD, to the motor, across the bearings to ground, and back through the building electrical system to the VSD. We also found that these currents can be eliminated by placing an impedance in series with this circuit path. This could be accomplished by adding three-phase line inductors in front of the VSD, or after the VSD – or, by placing inductors on both sides of the VSD's DC bus. Our 790HP and 1100HP VSDs did not have inductors on both sides of the DC bus, and only 790HP and 1100HP VSDs had been found to sometimes experience fluting, so we created kits to retrofit existing DC bus inductors to place ½ of the inductance on the

positive side of the bus and the other ½ on the negative side. This has proven to eliminate bearing fluting in most cases, and has now become standard in all new 790HP and 1100HP VSDs shipped since December of 2009.

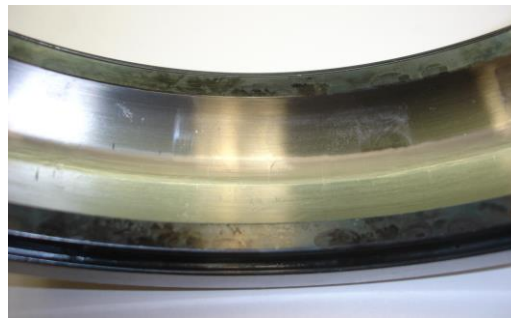
Although our inductor modification proved to correct bearing fluting in most of the isolated cases that developed, some of those locations were later found to be so severe that a mild frosting of the bearing surface continued to occur.

Frosted Bearing

Further research in 2009 found this frosting to be caused by additional currents which circulate from the motor-rotor, across one bearing, to the frame, and back across the other bearing to the rotor. This circulating current occurs entirely within the motor, and is the same current path that exists when parts of the motor become magnetized. The only means of stopping this current is to break the circuit path by replacing one of the bearings with a non-conductive bearing. Special bearings are now being made with non-conductive balls made of silicon nitride material, which is harder, and higher-rated, than standard steel. These special bearings are now available through the York Parts Distribution Center.

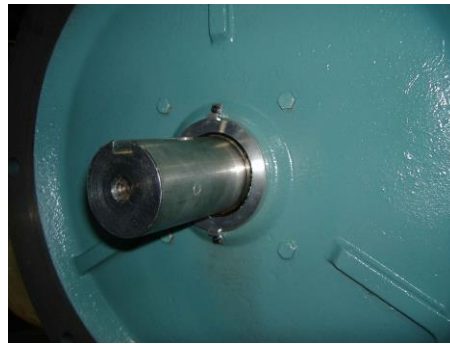
Shaft Grounding Ring

Although we plan to continue to use shaft grounding rings in combination with non-conductive bearings, keep in mind that testing has proven that grounding rings alone do not eliminate fluting. Even if grounding rings would be applied after modification of the VSD inductor, this will not eliminate the frosting that can occur. Grounding rings are applied solely to maintain a lower shaft voltage after the addition of a non-conductive bearing.
