1. INTRODUCTION

This document presents our findings with regards to the component failures from the 608 Hp Variable Speed Drive installed at 740 Progress Avenue in Scarborough, Ontario, Canada.

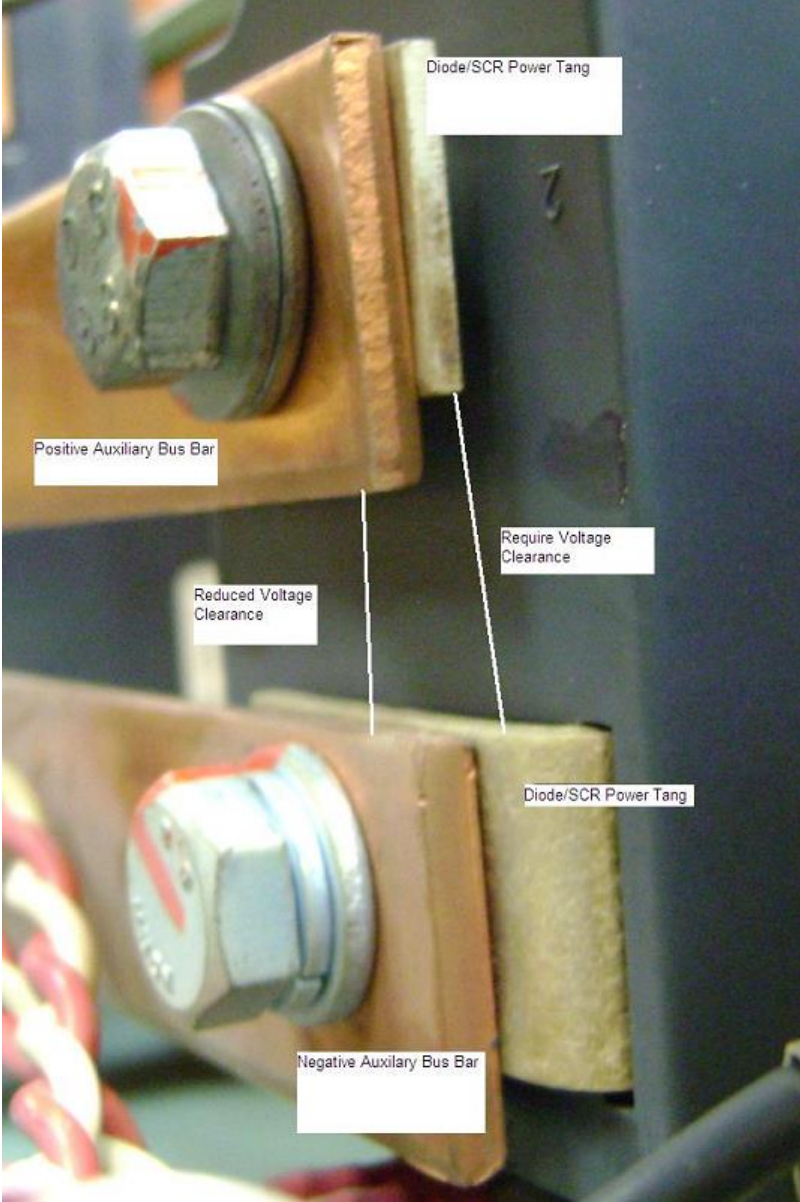
As part of the factory analysis, the engineering team investigated the manner in which the components were assembled for proper procedure and tolerances. The returned components were found to have the positive auxiliary bus bar on the diode/SCR module installed upside down. When installed in such a manner, the voltage clearances between the positive and negative bus bars are less than designed. In general, bus bars should never be any closer together than the space provided by the device they are connected too. Below attached are the pictures #1 and #2 noting this fault:

In summary, and although not conclusive, our findings indicate the manner in which the drive components were assembled were incorrect and could have contributed to the failure of the VSD drive. The newly ordered components that we plan on installing into Chiller #1 at 740 Progress have been individually inspected by our factory representative to ensure proper assembly of the components.
