BY JOHNSON CONTROLS

FLUTING ON MOTOR BEARINGS

TECHNICAL DATA

Form 160.00-TD7 (710)

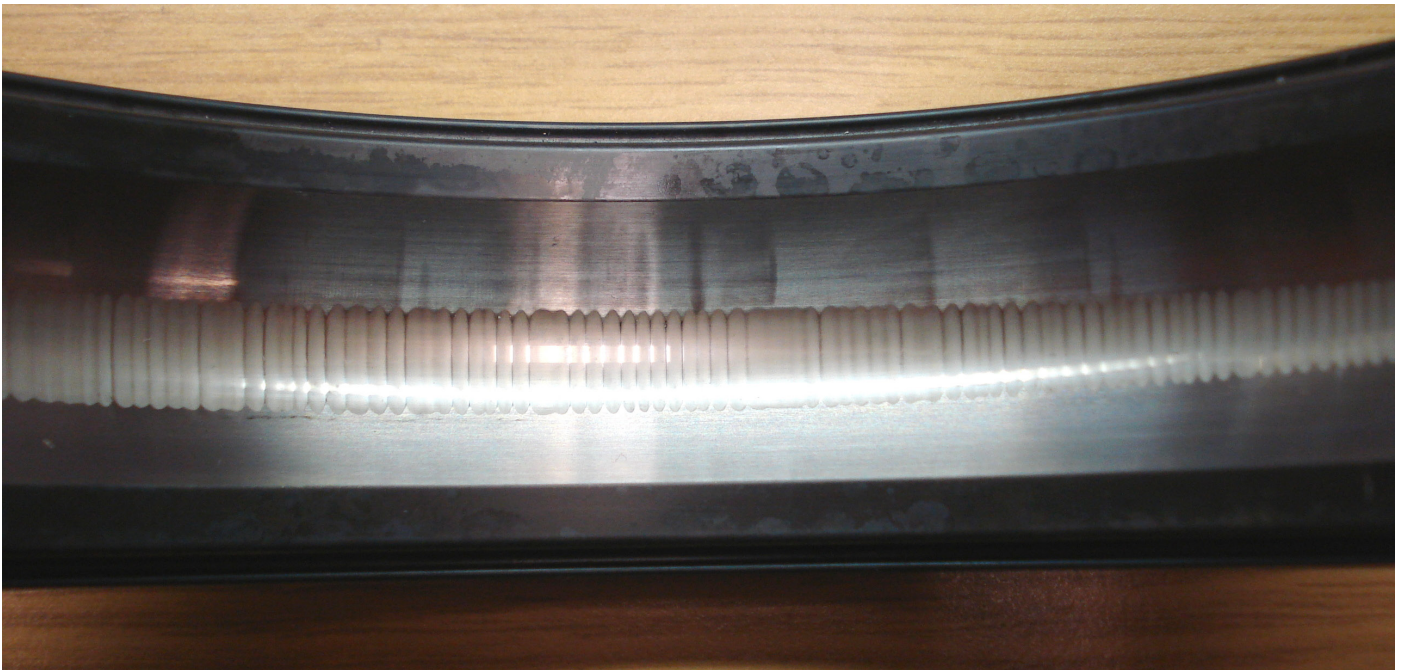
Bearing fluting is a term to describe early deterioration of motor bearings due to an electrical current passing across the grease film in the normal wear-path of the bearing. Tiny pits created during each electrical discharge form a washboard-like pattern, or “picket fence”, of parallel oval marks around the wear-path. In the early 1900s, this condition was typically caused by magnetism, shaft eddy currents, or asymmetrical currents in a motor. Today this same deterioration can be caused by variable-speed drives (VSDs).

FIG. 1 – FLUTED BEARING

Our 790HP and 1100HP OptiSpeed drives did not have inductors on both sides of the DC bus, and only 790HP and 1100HP VSDs had been found to experience occasional fluting. Johnson Controls now creates kits to retrofit existing DC bus inductors, placing $\frac{1}{2}$ of the inductance on the positive side of the bus and the other $\frac{1}{2}$ on the negative side. This has proven to eliminate bearing fluting in most cases, and has now become standard in all new 790HP and 1100HP VSDs shipped since December of 2009.

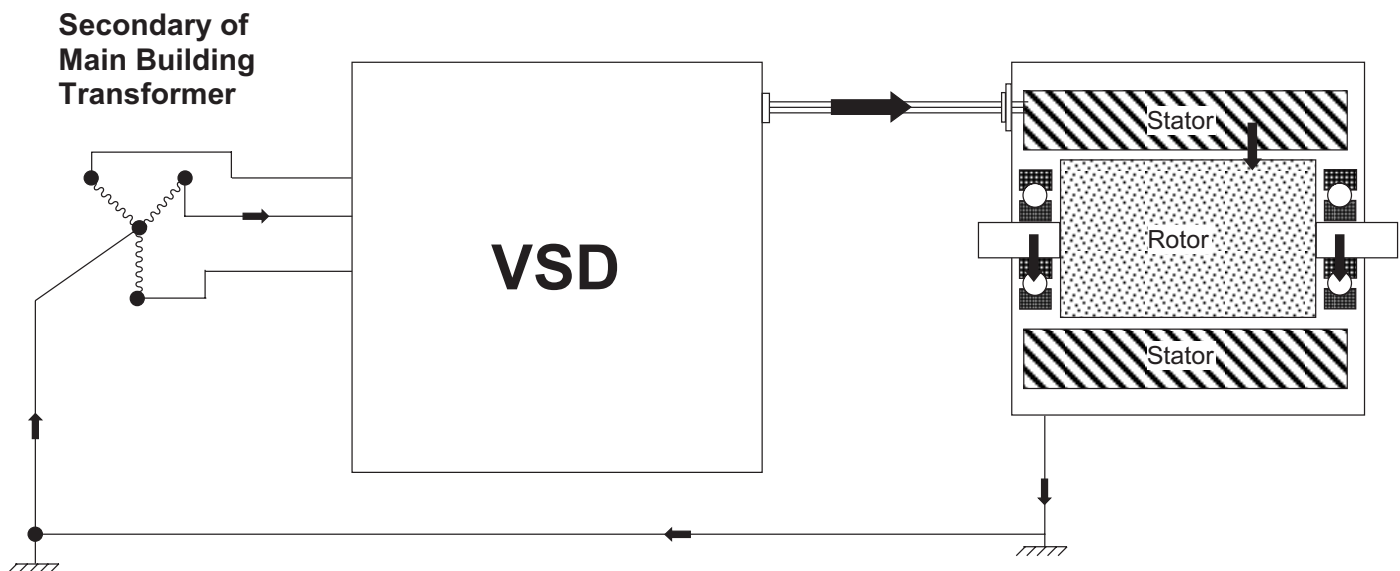
Research in 2008 found that when fluting occurs, currents circulate from the VSD to the motor, across the bearings to ground, and back through the building electrical system to the VSD. It was also determined that these currents can be eliminated by placing an impedance in series with this circuit path. This could be accomplished by adding three-phase line inductors in front of the VSD, or after the VSD, or by placing inductors on both sides of the VSD's DC bus.

FIG. 2 – CURRENT CIRCULATING FROM VSD TO MOTOR, TO GROUND, AND BACK TO THE VSD

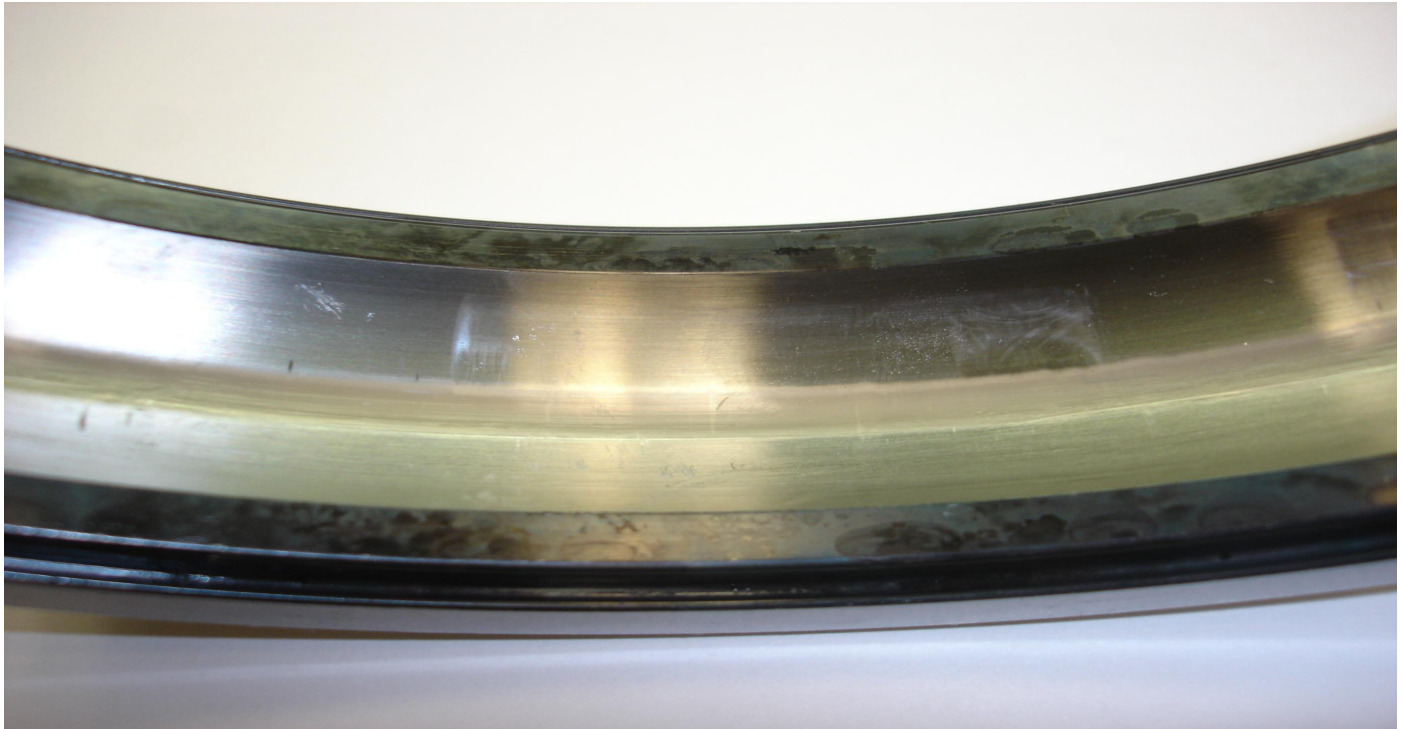
Although our inductor modification has corrected the bearing fluting in most of the isolated cases that developed, some of those locations were later found to be so severe that a mild frosting of the bearing surface continued to occur.

FIG. 3 – FROSTED BEARING

Further research in 2009 found this frosting to be caused by additional currents which circulate from the motor-rotor, across one bearing, to the frame, and back across the other bearing to the rotor. This circulating current occurs entirely within the motor, and is the same current path that exists when parts of the motor become magnetized. The only means of stopping this current is to break the circuit path by replacing one of the bearings with a non-conductive bearing. Special bearings are now being made with non-conductive balls made of silicon nitride material, which is harder and higher-rated, than standard steel. These special bearings are now available through the Johnson Controls Parts Distribution Center.

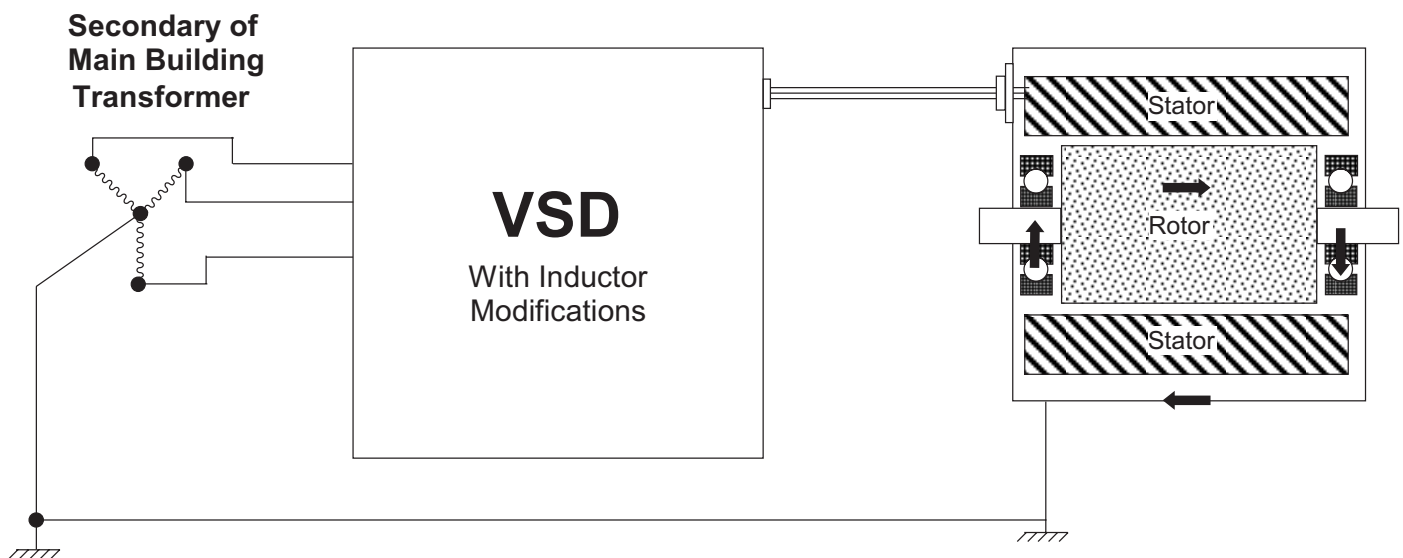
FIG. 4 – CURRENT CIRCULATING WITHIN THE MOTOR

Additional testing of motors using this non-conductive bearing has proven that it eliminates the circulating currents which cause frosting in the wear-path. Although these currents no longer exist, we have discovered that the voltage on the shaft, with respect to ground, actually increases. So, to prevent the higher shaft voltage from creating any potential issues, we have elected to apply a shaft-grounding ring to any motor that has been modified with a non-conductive bearing. This keeps the shaft voltage at design levels.

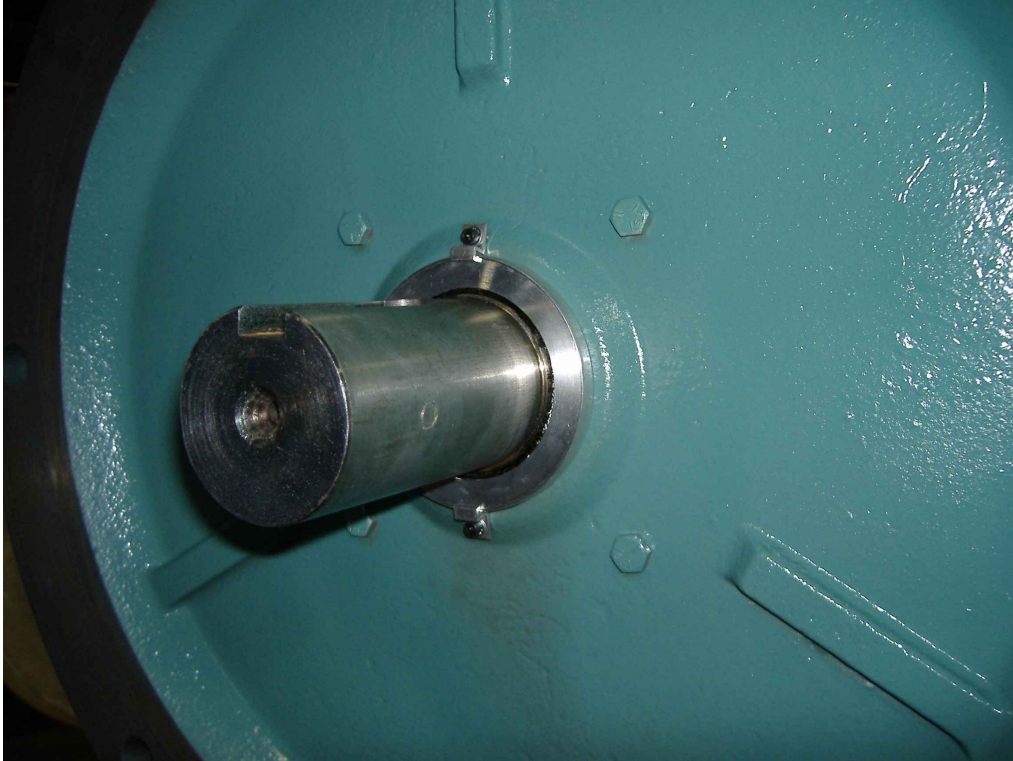
FIG. 5 – SHAFT-GROUNDING RING

Although continued application of shaft-grounding rings in combination with non-conductive bearings is expected, keep in mind that testing has proven that grounding rings alone do not eliminate fluting. Even if grounding rings are applied along with the modification of the VSD inductor, bearing frosting is not eliminated. Grounding rings are applied solely to maintain a lower shaft voltage after the addition of non-conductive bearings.
